AAD Inspection Corp.

Property Inspection Report

Subject Property: **Street Address, City, State and zip code**

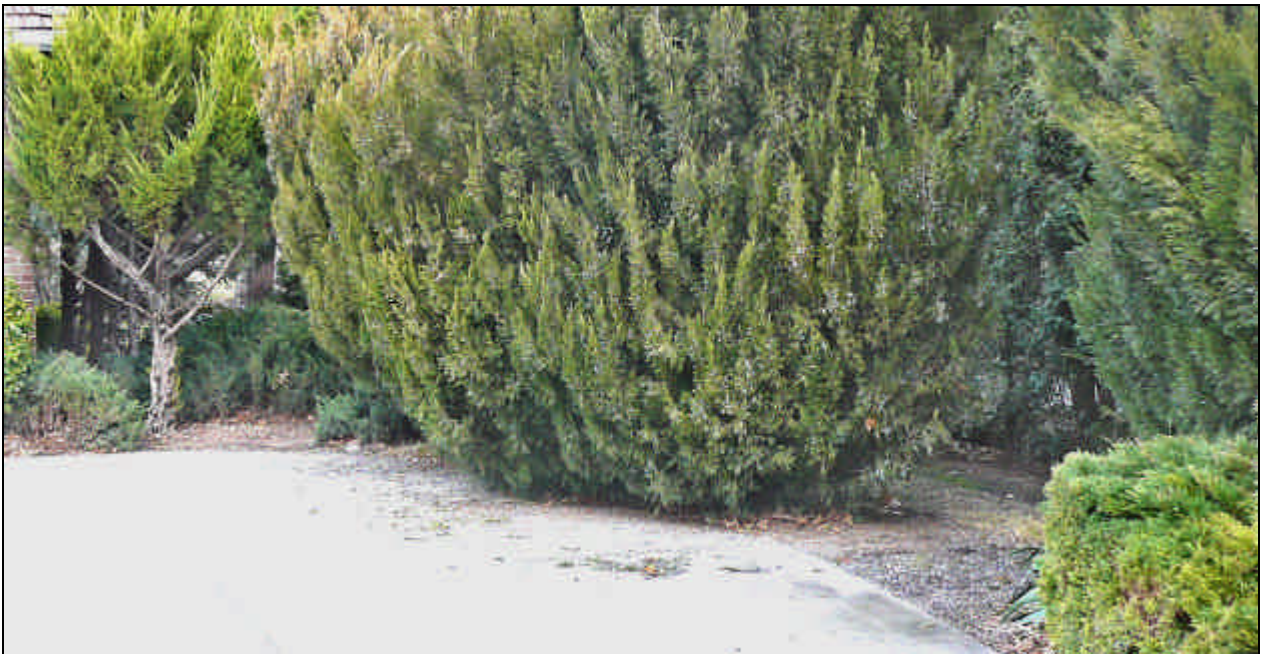
1. The juniper shrubs at the northeast (right rear) corner of the driveway extend out over the concrete enough to possibly interfere with vehicles backing out of the garage. Perhaps they should be trimmed back.

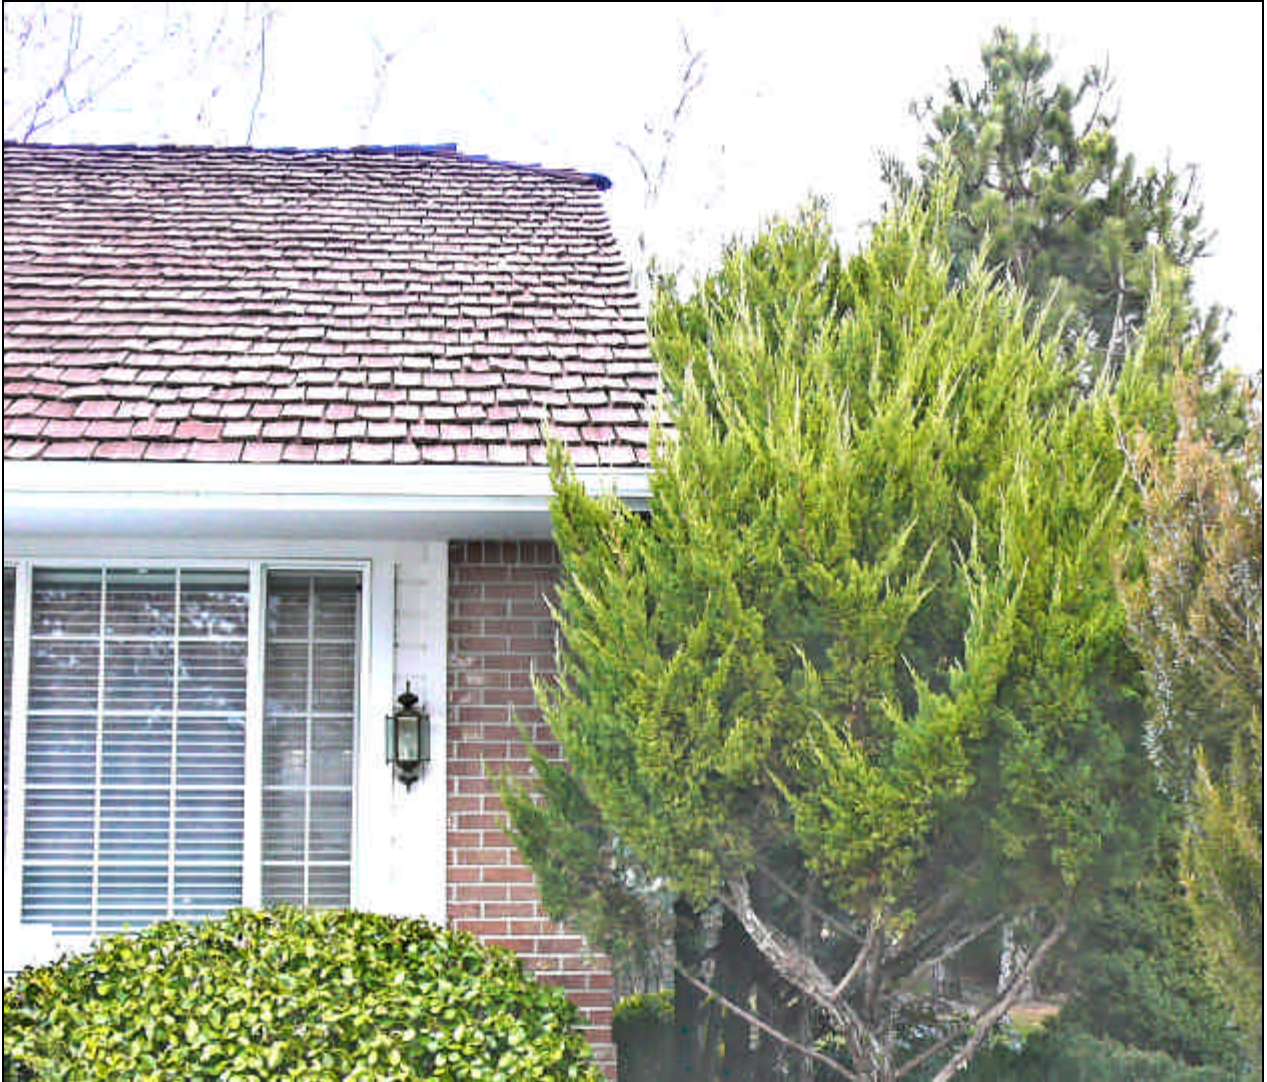
-
2. The row of junipers planted along the right side of the house has matured enough to begin impinging on the side of the house and soon upon the roof. They need to be trimmed away at this time. As long as these junipers remain in place, they should be trimmed annually to keep their branches from touching the house.

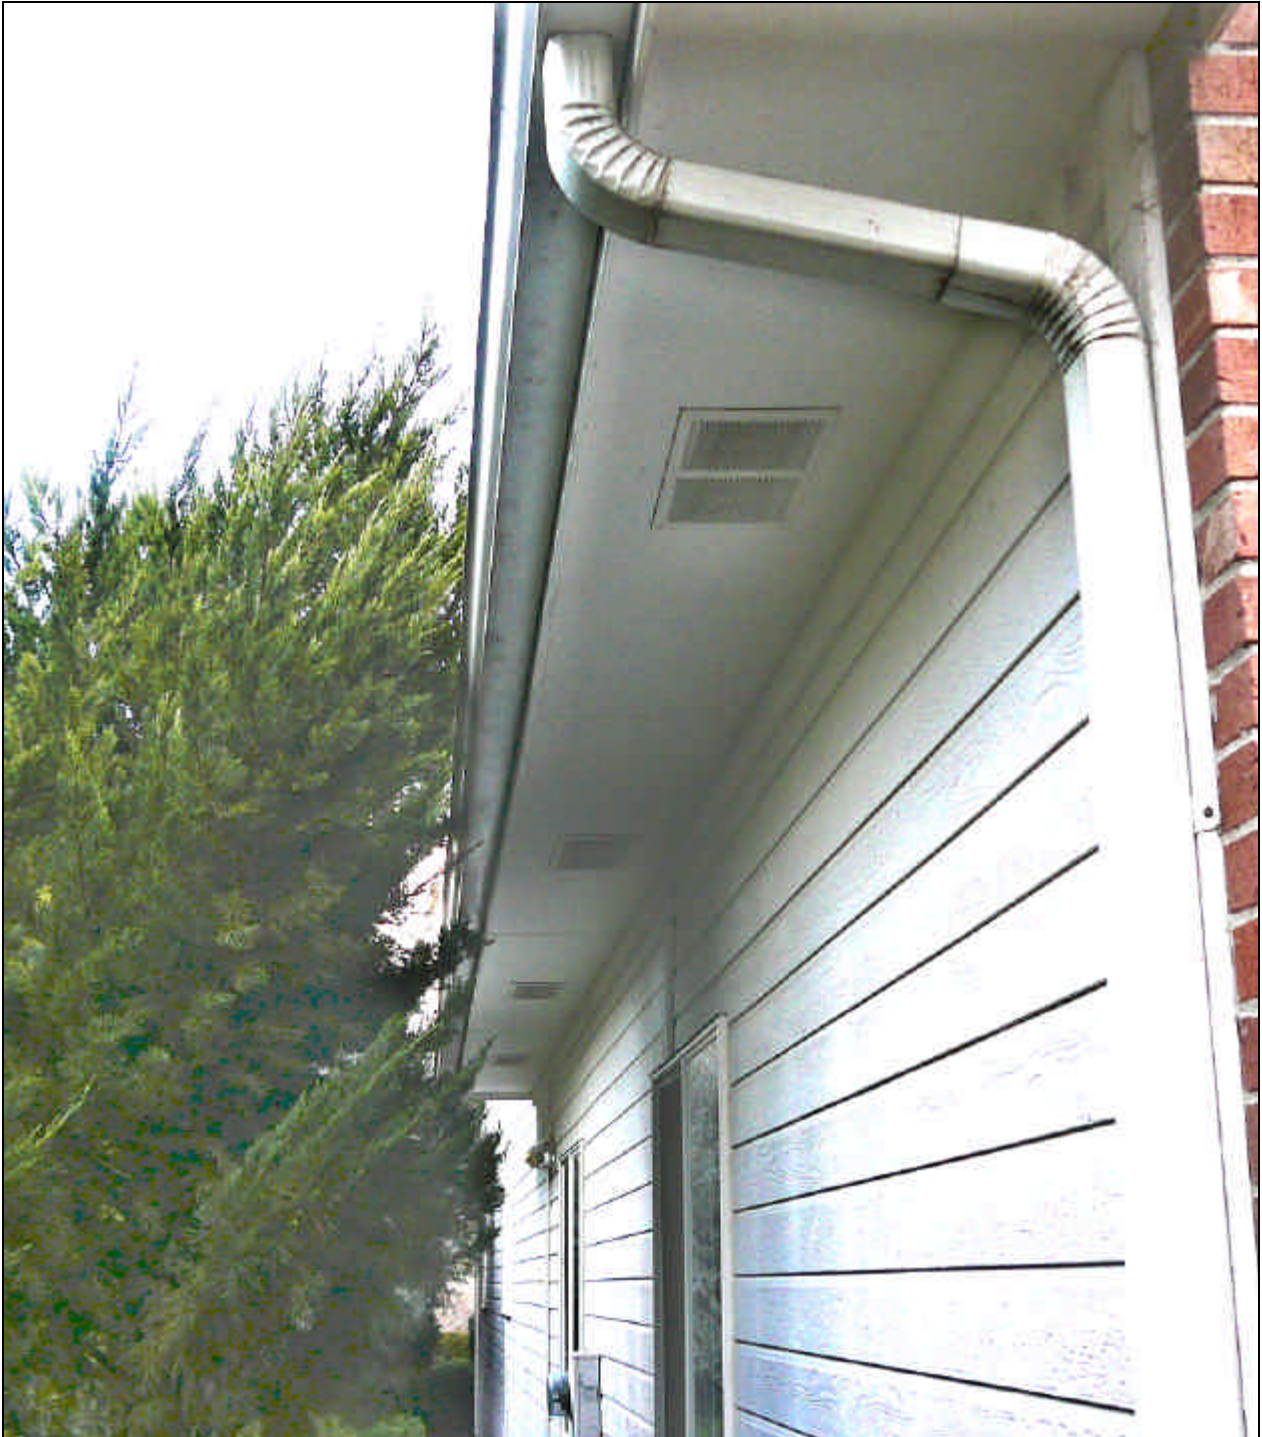
4. The juniper tree at the left front corner of the house is impinging on the roof. Its branches should be kept pruned away annually.

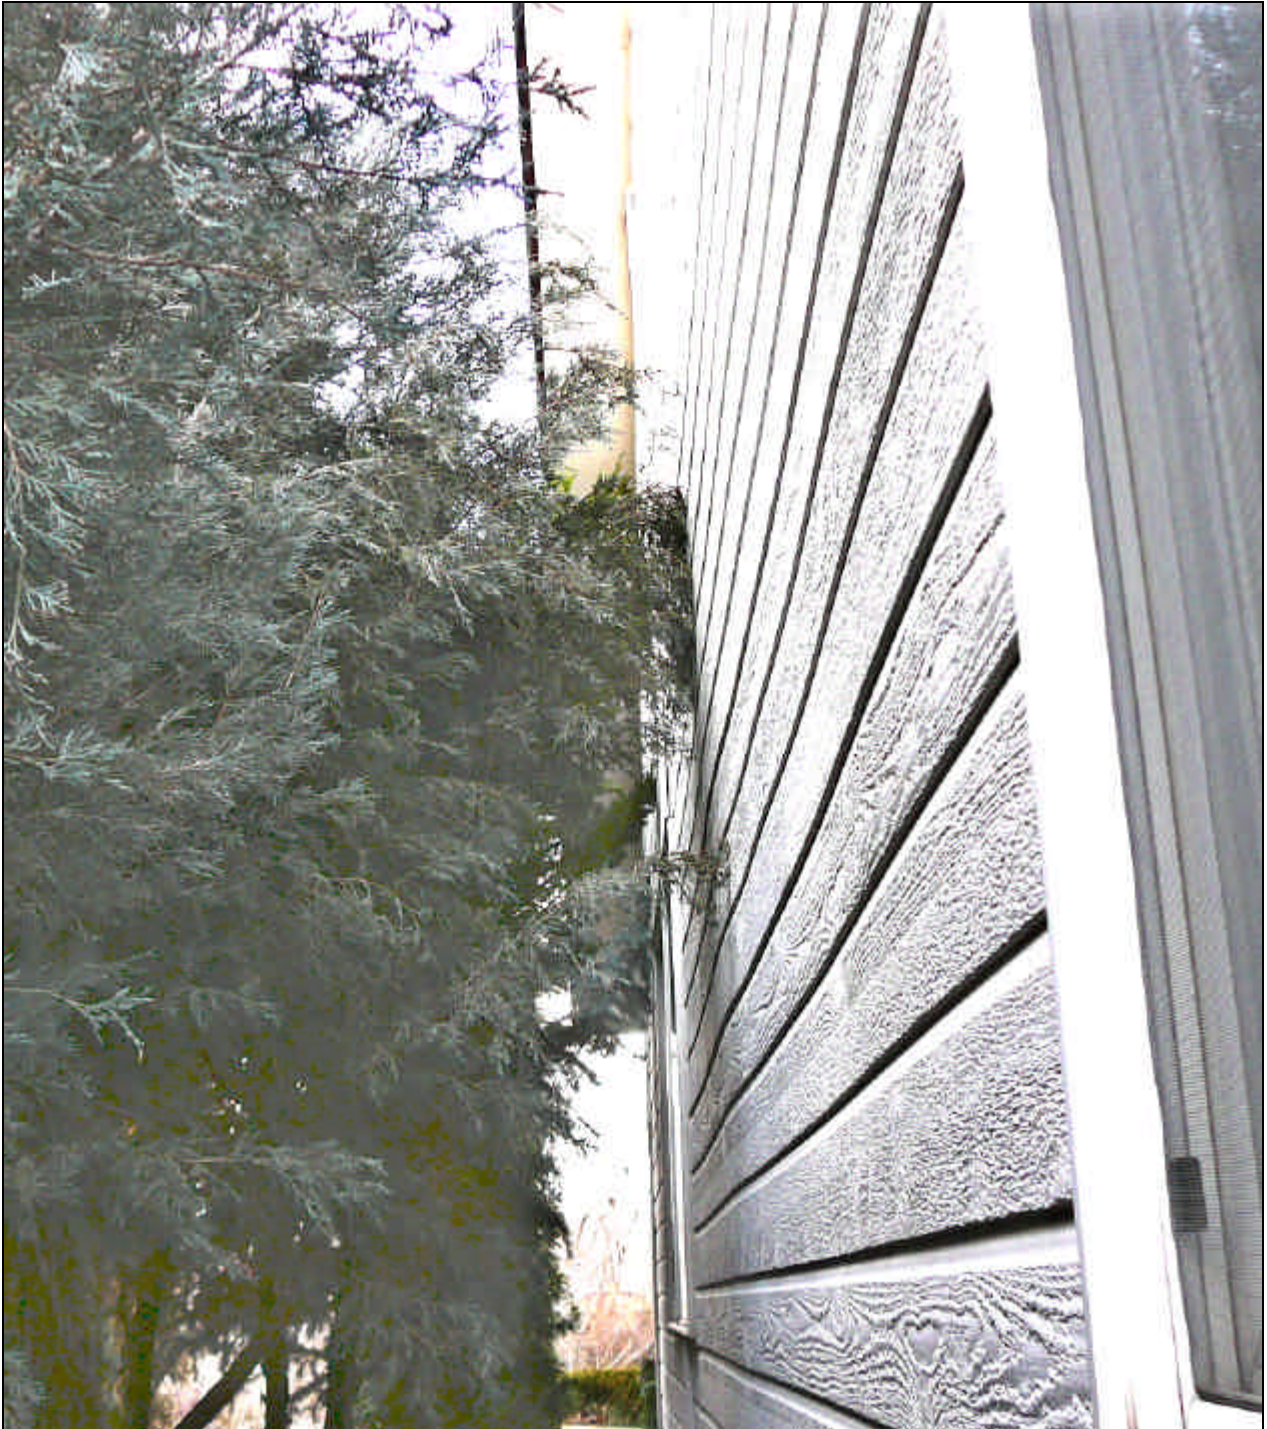
5. The small trees near the left rear corner of the house are impinging on the house and roof. They should be trimmed back annually.

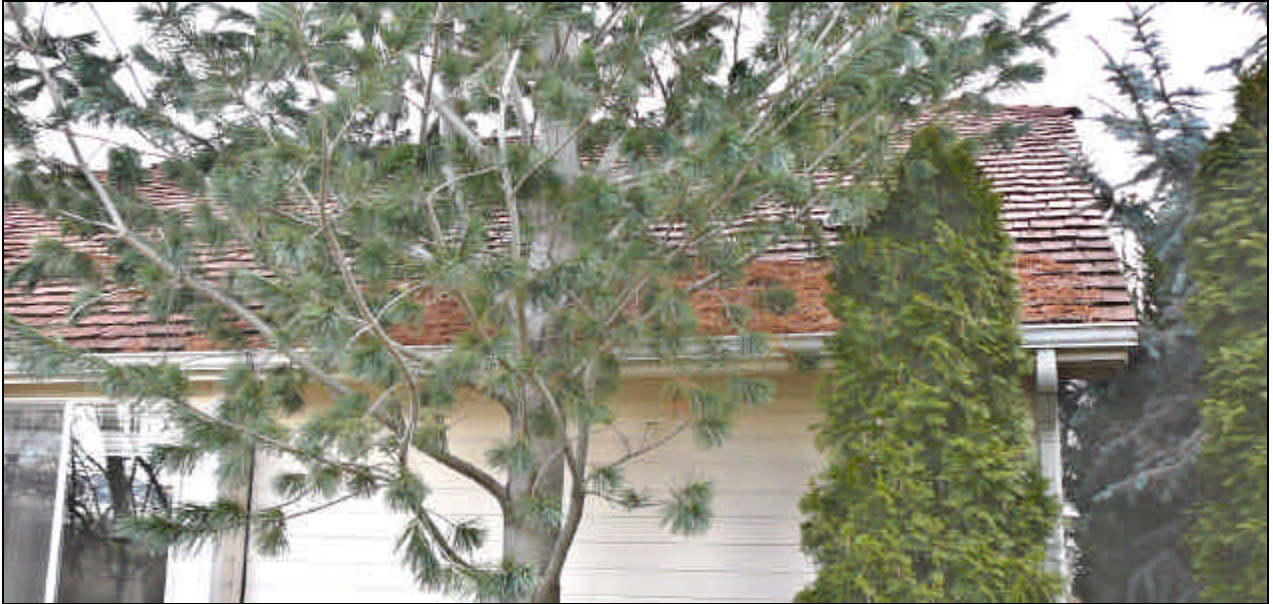
6. The pine tree near the left rear corner of the house may be planted too close to the foundation. As it matures further, its trunk will be pushing on the roof eave. It's also possible that its roots may eventually threaten the foundation. Therefore, I strongly suggest having an experienced tree surgeon address this issue. If this tree is to remain in place, it is important to rake the dead pine needles from the wood roof covering to avoid trapping moisture that may lead to dry rot damage.

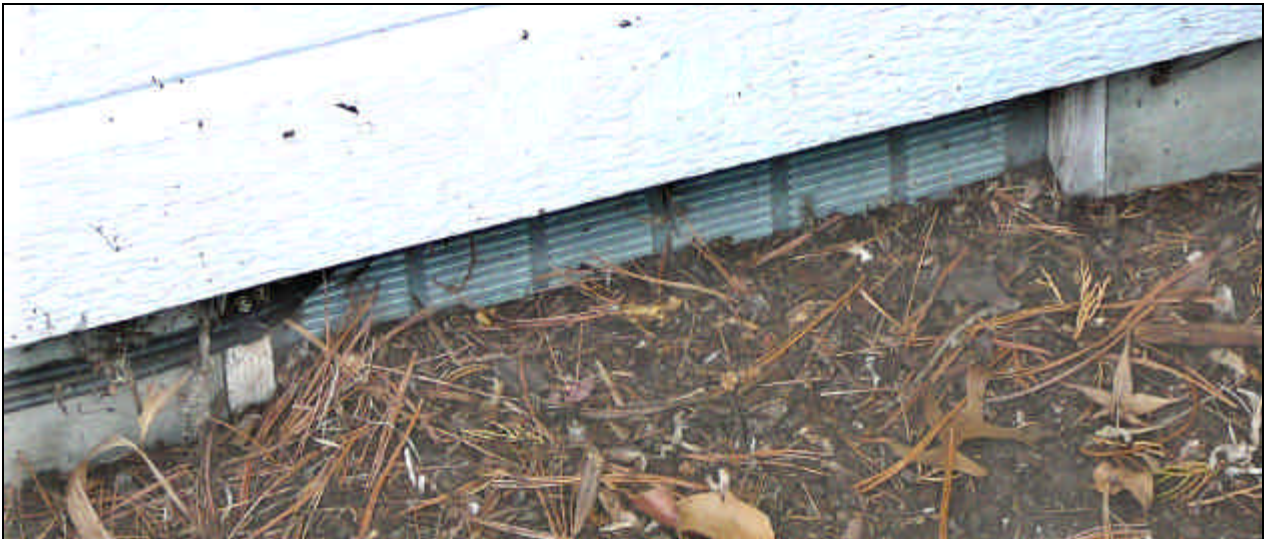
7. A number of foundation perimeter vents are partially covered by landscaping soils. I suggest placing vent wells in front of them.

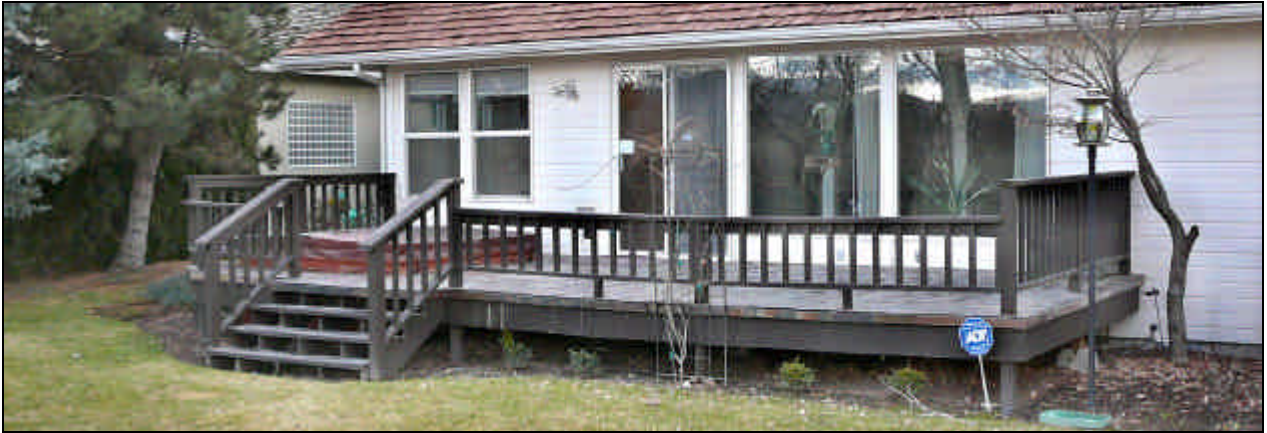
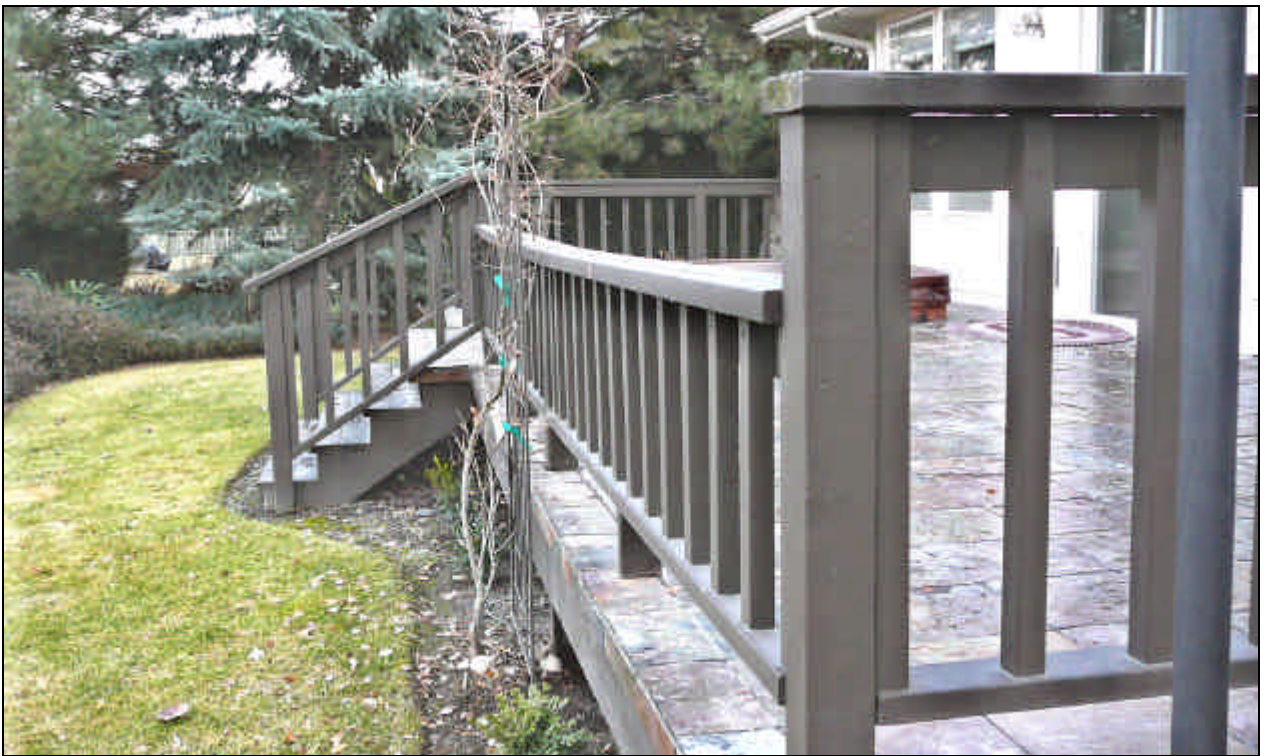
8. Most of the vertical support posts for the redwood deck behind the house appear to have no substantial footings. I suggest temporarily bracing the deck from intermediate posts and replacing the post bases of each permanent footing. I further suggest that masonry footing blocks be placed under each post to avoid direct wood-to-earth contact as much as possible. At this time, the north perimeter of the deck is sagging noticeably due to the lack of support from the posts. This sagging can be seen in the following two photos.

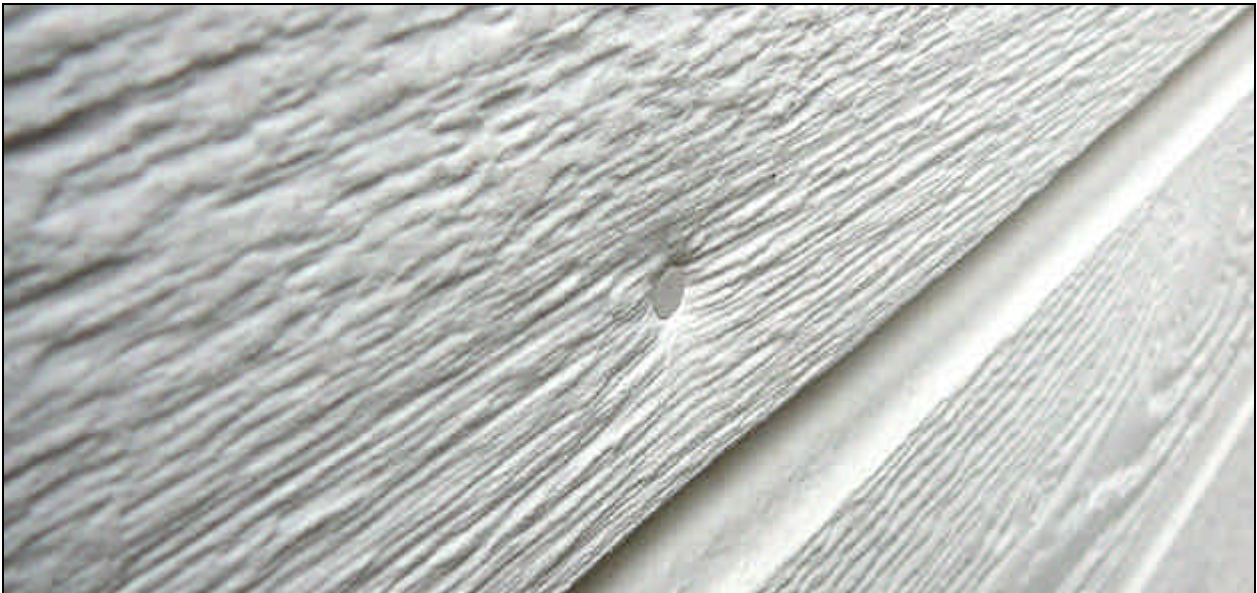
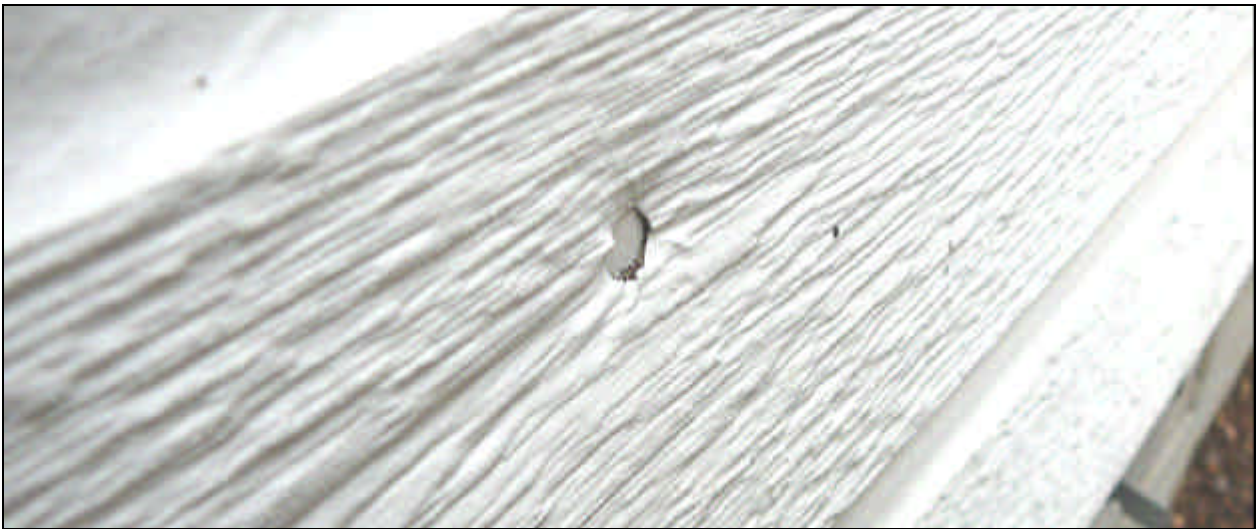
9. Portions of the fiberboard siding (up to about 30 inches from the ground) along the right side of the house have absorbed water enough to cause “pillowing” around the nails. However, at this time the siding still feels rather firm when poked with a screwdriver. I strongly suggest ensuring that all over-driven nail heads are sealed against further water absorption. I also suggest ensuring that the bottom edges of each 16-inch-wide siding strip is well sealed along its bottom edges. (If further water absorption is stopped at this time, this slight amount of cosmetic distortion to the wood should be acceptable.) The following two photos show close-ups of the siding “pillowed” near nail heads.

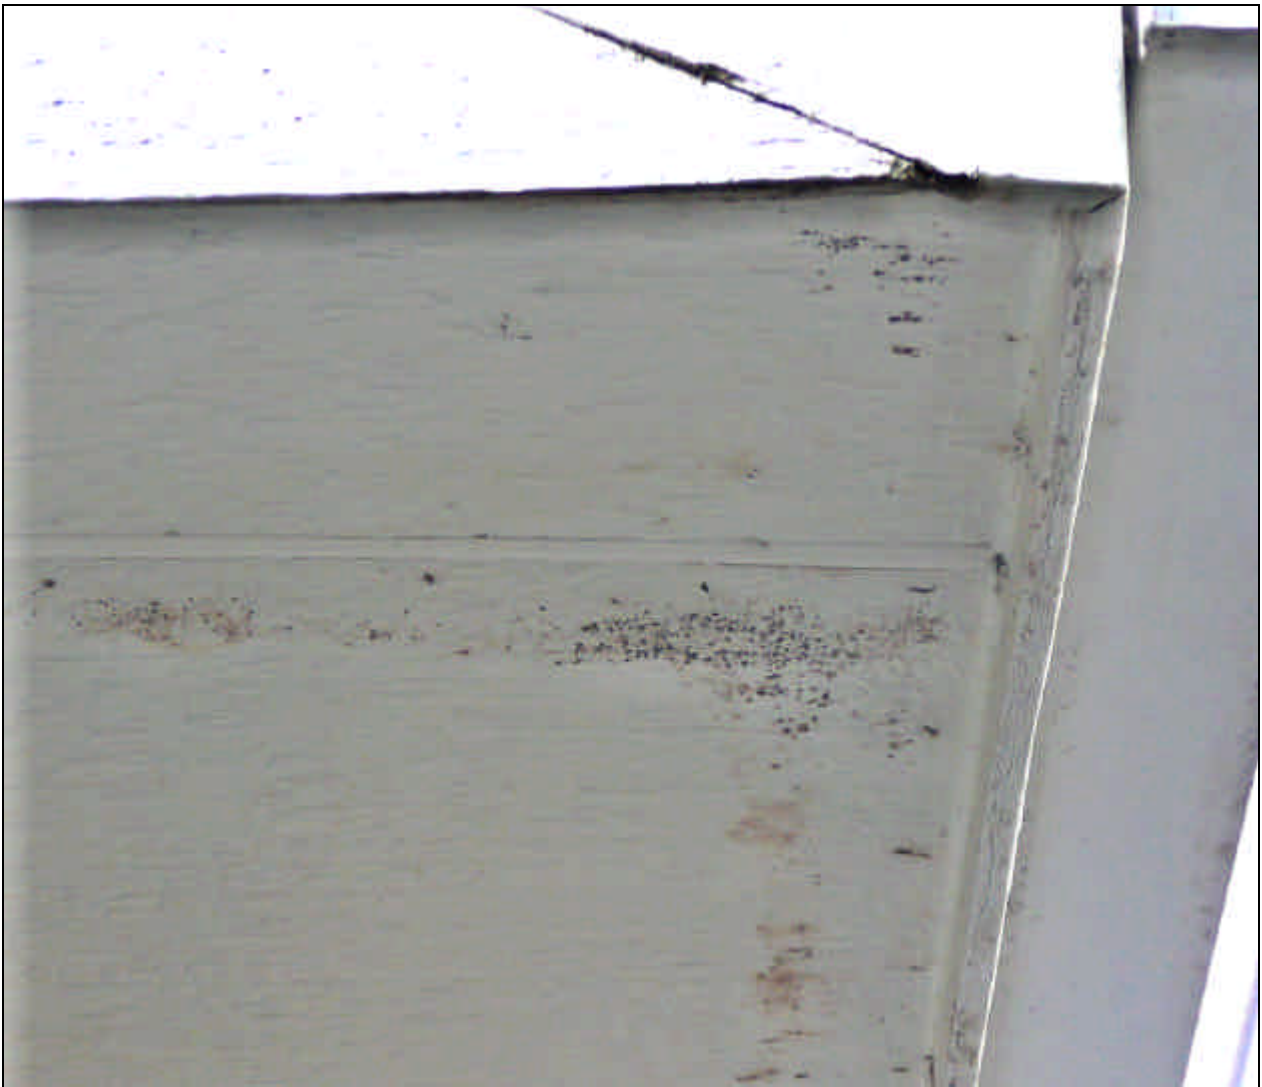
10. It appears that water has been leaking through the cedar shake roof covering, behind the eave fascia, and into the soffit box cavities along the rear of the house, about over the hot tub area. The following two photos show some swelling and discolorations due to this effect. I suggest having a qualified roofing contractor address this issue further. Additionally, similar stains are also noted on the painted surfaces of the soffit panels at the right front corner of the house. I also noted some similar moisture evidence at the left rear (northwest) corner of the garage. At this time, no real damage has been done to the soffit panels. If the leaks are effectively stopped, the stained areas of the soffit panels should be coated with stain-blocking primer and repainted to reasonably match the surrounding surfaces.

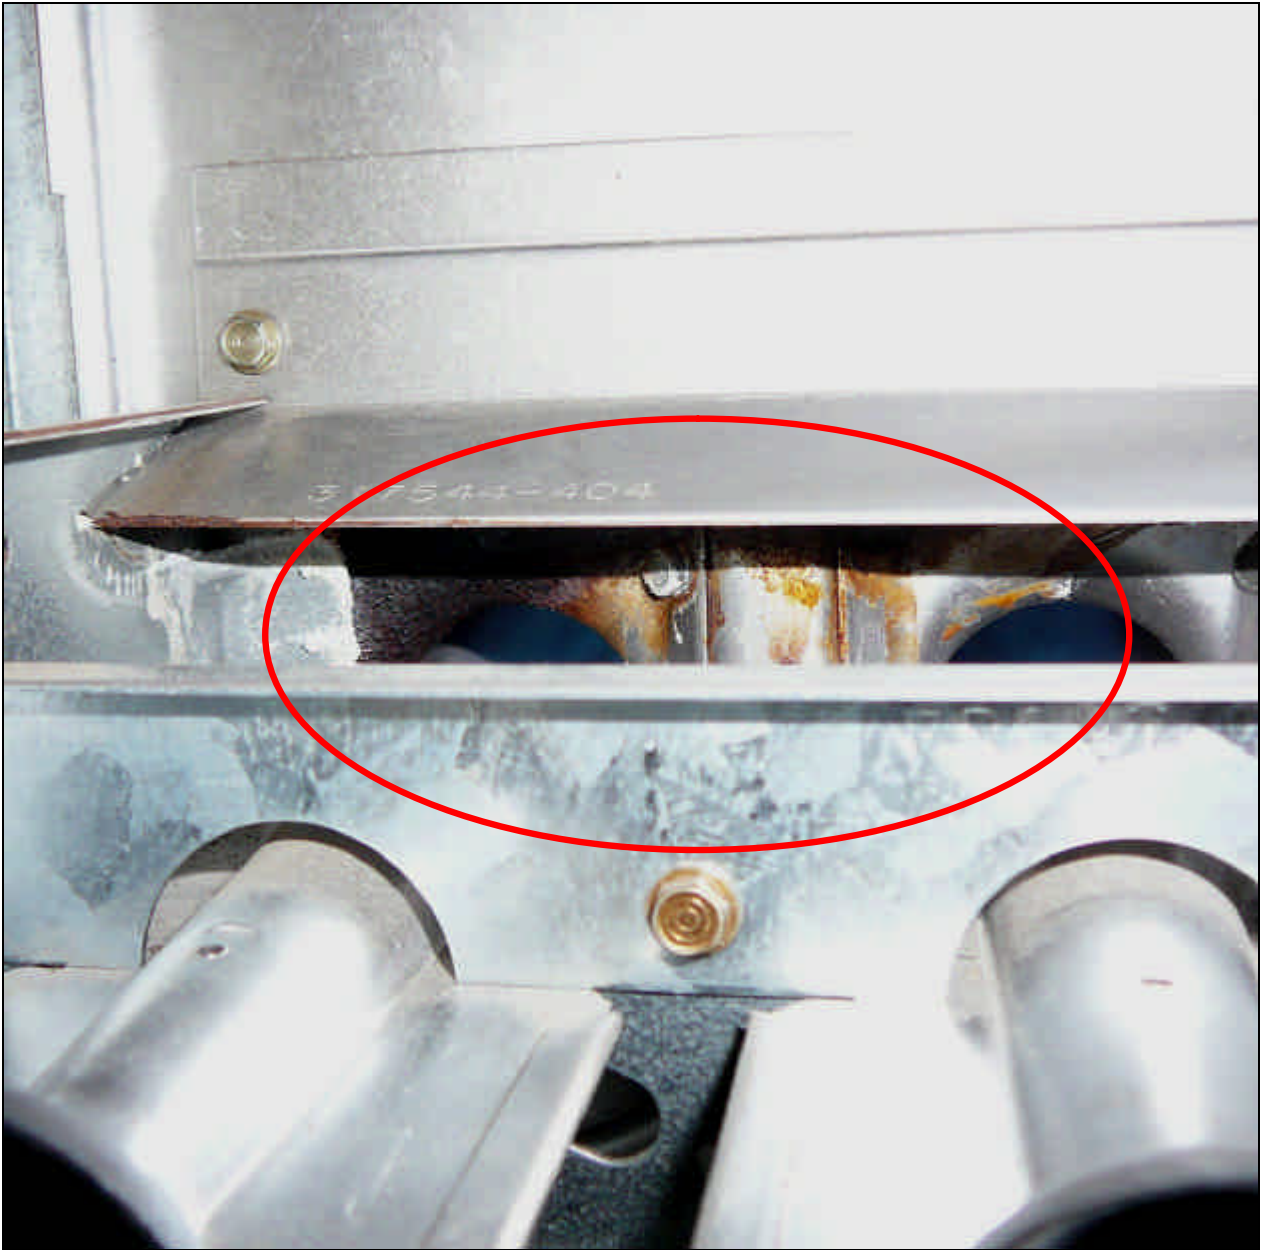
11. The electronic “eyes” of both overhead garage doors’ stop-and-reverse safety feature are mounted about 8 inches above the floor. I suggest considering lowering these to no more than 4 inches above the floor to provide greater protection for children and small animals. (Note: This suggestion is not found in building codes.)
12. The wash sink in the garage is not adequately secured to the wall to protect its plumbing connections. I suggest securing it further.
13. NOTE: Most houses of this size and value have gas water heaters sized from 50 to 65 gallons in capacity. However, the water heater in this house is only 40 gallons. (The prospective buyers asked me to offer opinions on such matters during this inspection.)
14. Some corrosion is noted on the front face of the furnace’s heat exchanger at the upper left corner of the row of flame ports, as shown in the following photo. I can

not explain why the corrosion would have formed at that location. Although I do not perceive any significant threat to the integrity of the furnace due to this corrosion, perhaps a qualified HVAC contractor could lend further valuable insight.

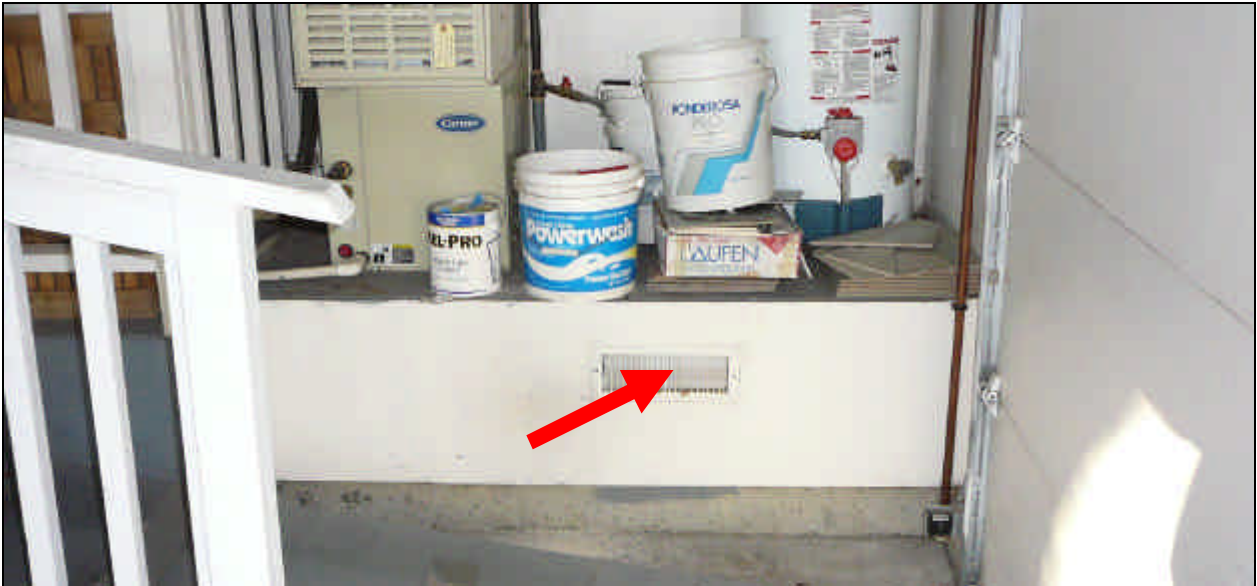
15. The feed-air register brought out into the garage below and in front of the furnace and water heater platform is not allowed by codes. (There should be no direct flame paths between the garage and the house air. Furthermore, this could be a possible

route to pass carbon monoxide gasses from the garage into the house.) Therefore, I suggest removing this register or blocking it off. A qualified HVAC contractor should address and/or correct this issue, as necessary.

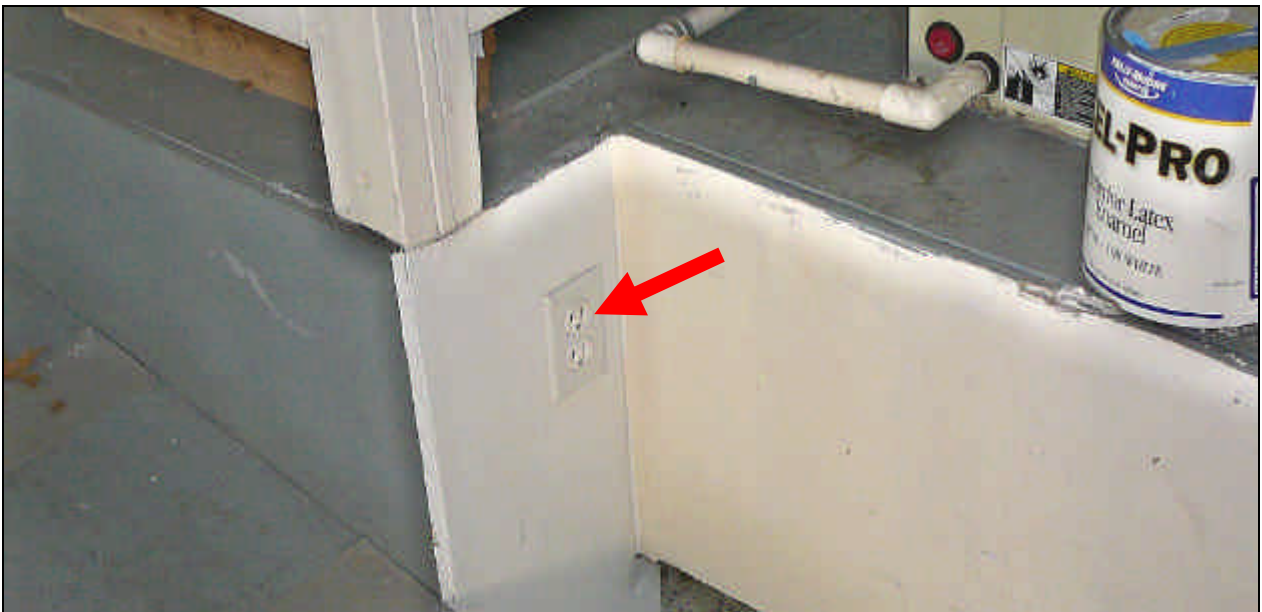
16. The electrical outlet below the front of the furnace in the garage is grounded, but not GFI-protected. A qualified electrician should address and/or correct this issue, as necessary. (This outlet might not remain if and when the wheelchair ramp is removed.)

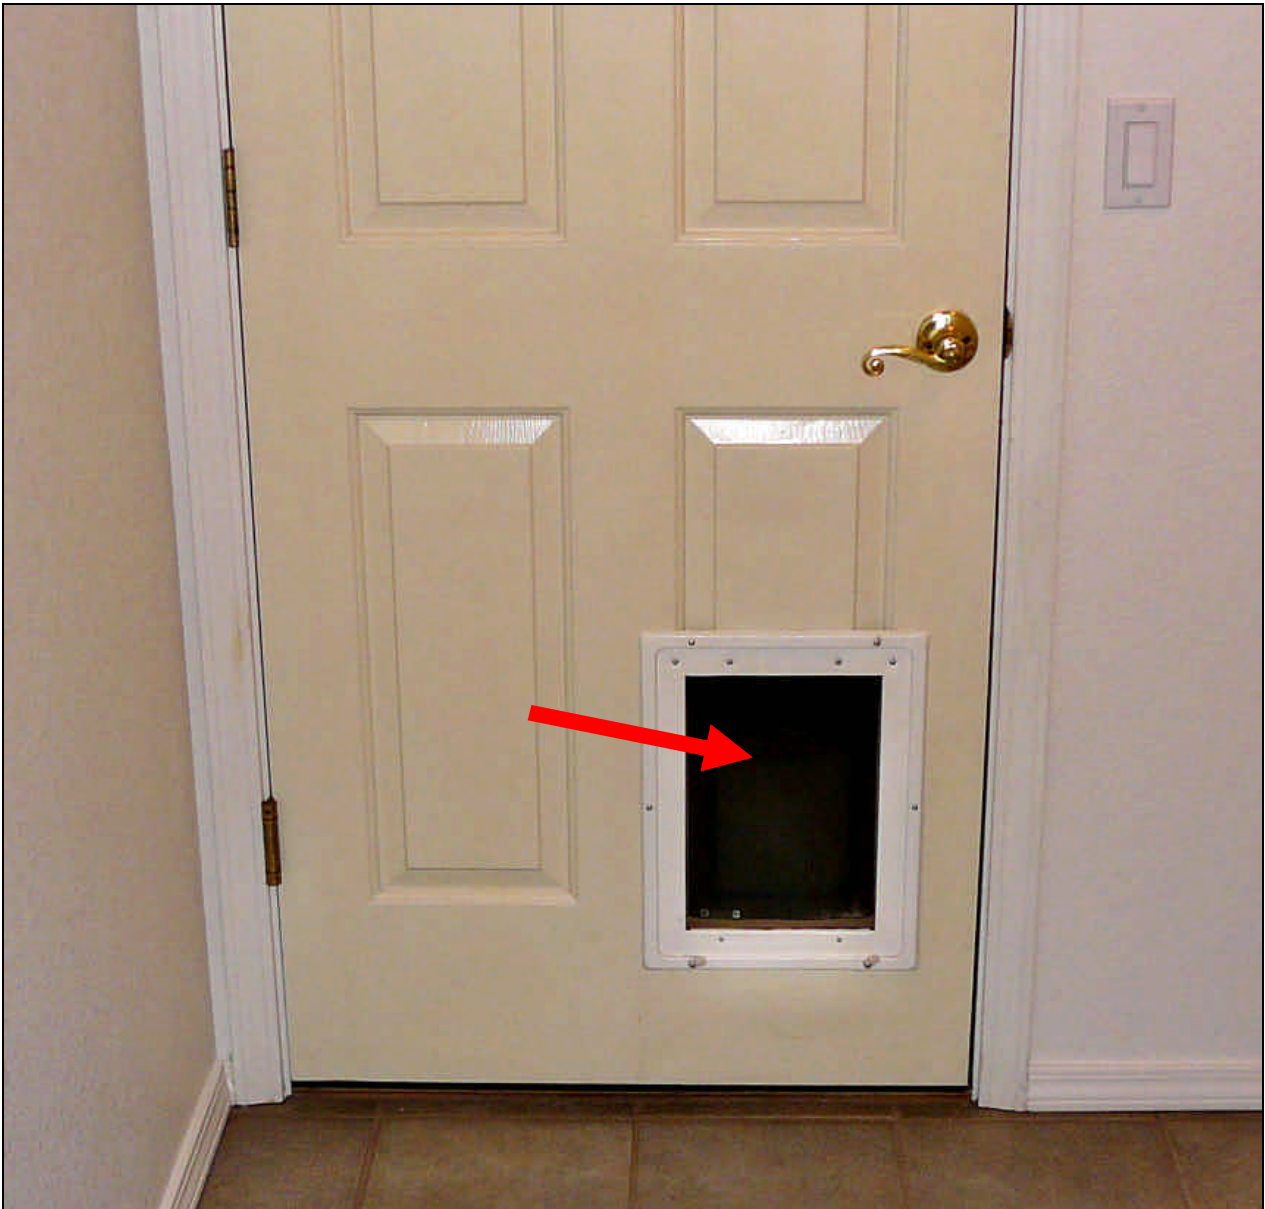
17. NOTE: By peering through the storage doors at the west end of the wheelchair ramp structure in the garage, I noted that the original stoop and steps from the garage-house entry door down into the garage are still in place. (However, I had no way of verifying their integrity or suitability.)
18. The pet opening installed through the garage-house entry door reduces the door's ability to perform as a fire barrier. Therefore, I suggest considering replacing the door.

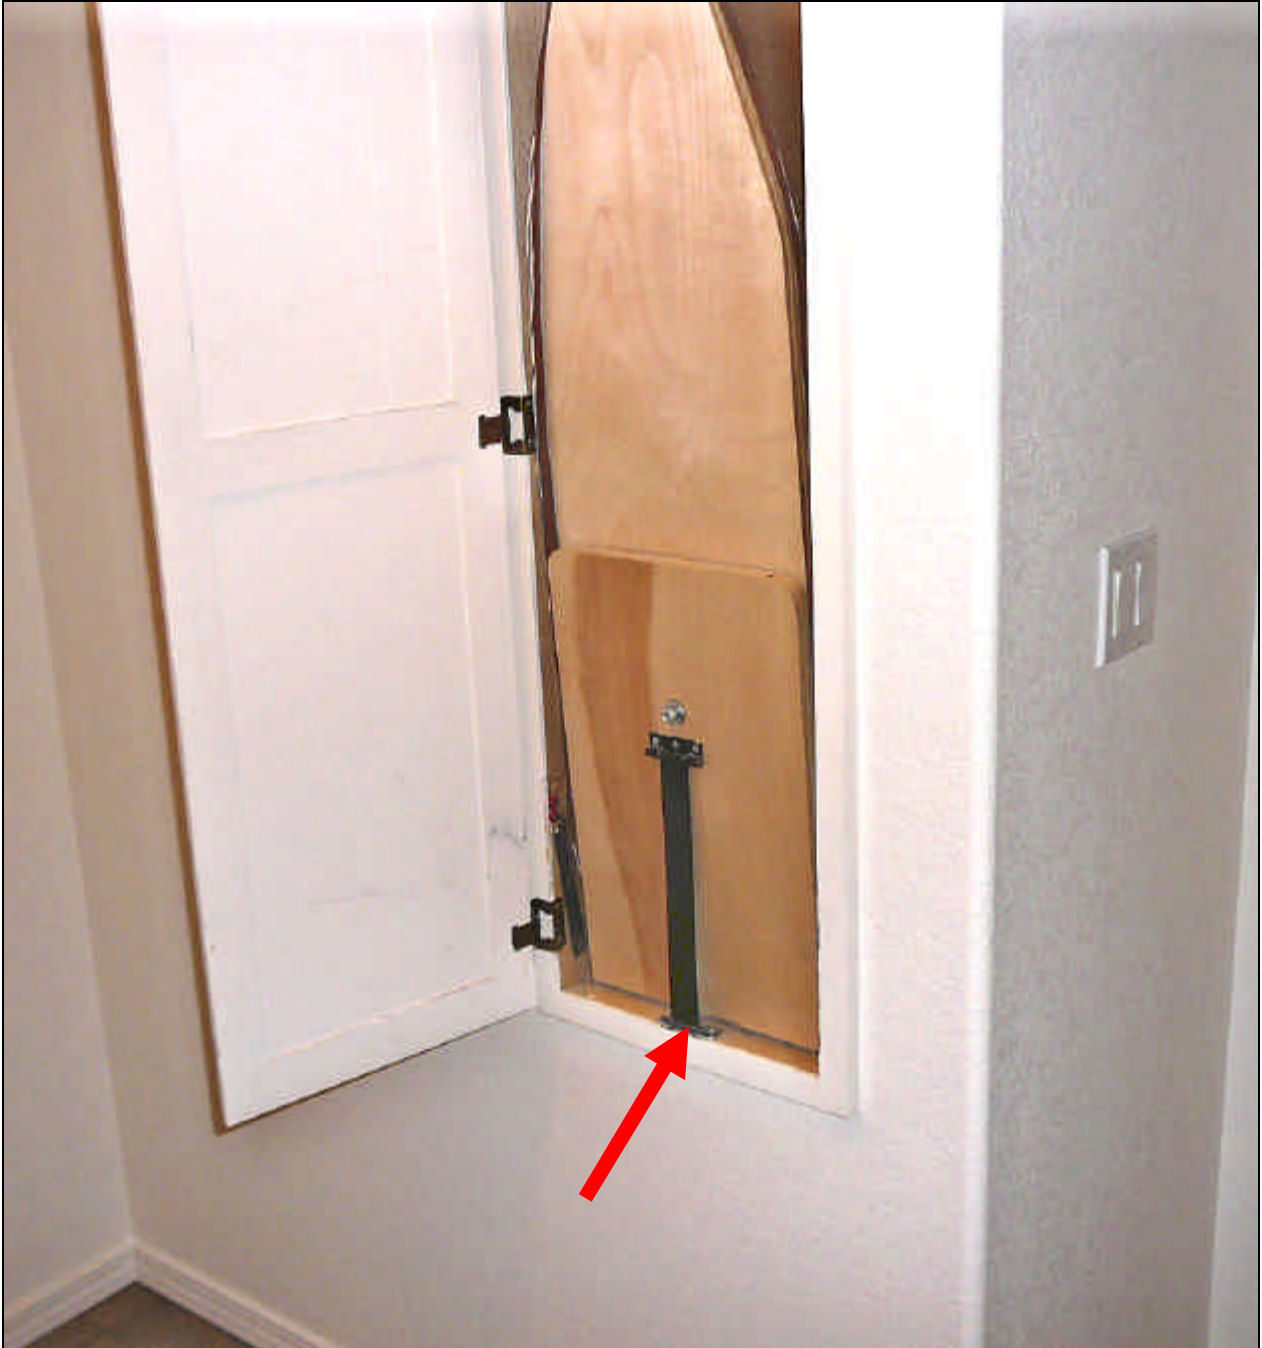
19. The bottom bracket for the tilt-down ironing board in the laundry room is too loose to be effective. The rear guide pipe came out of its track on the first attempt to lower the board into its use position. Perhaps some repairs or modifications could be made. The arrow in the following photo points to the loose bracket.

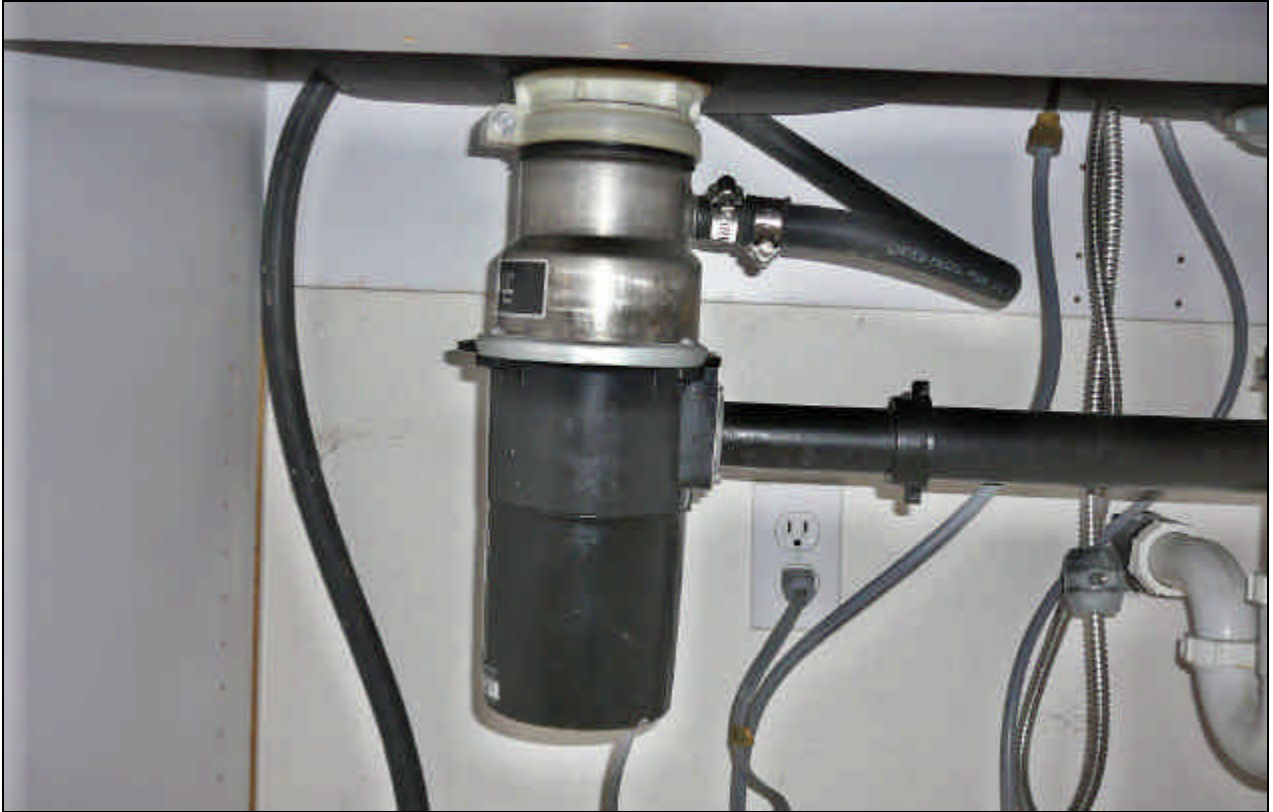
20. NOTE: The garbage disposer under the kitchen sink is about the smallest and least powerful appliance that could have been purchased. A larger, more powerful appliance will probably help drain away food particles to avoid nuisance clogs. (The prospective buyers asked me to provide such opinions during the inspection.)

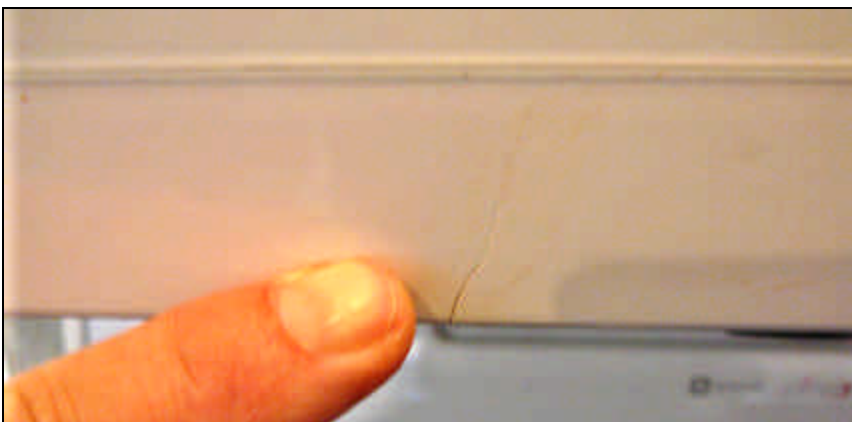
21. The bottom rail of the plastic door frame for the microwave appliance is cracked upward about 1½ inch, as pointed to in the following photo.

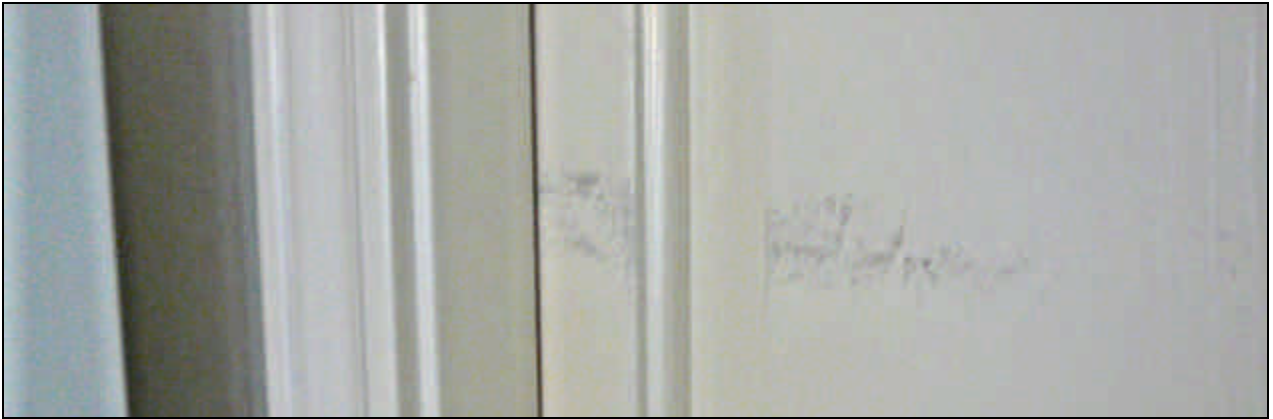
- 22. The kitchen side of the pocket door rubs in its wall pocket at about neck level. This lack of clearance will eventually scrape the paint off the door. I suggest having a qualified door contractor address this issue.

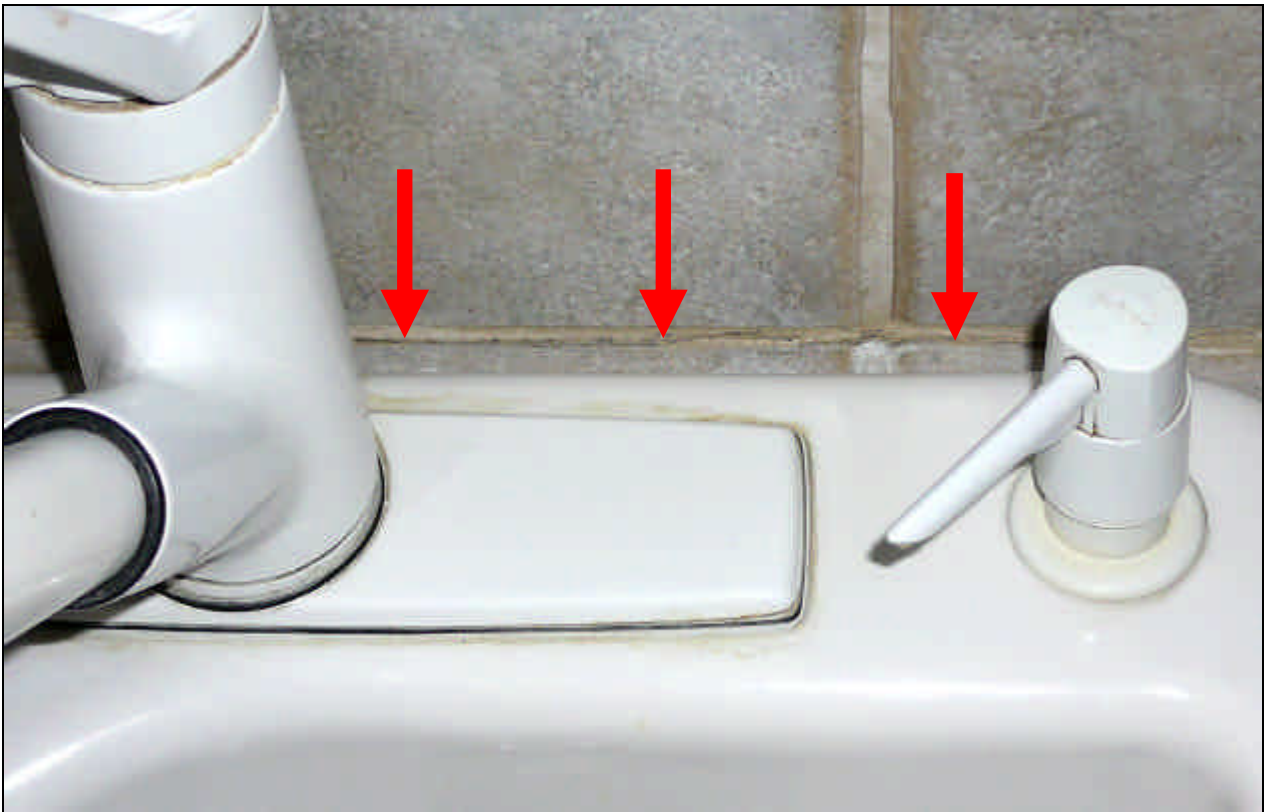
- 23. The kitchen countertop has settled away from its backsplash just enough to form a slight crack behind the kitchen sink, as shown in the following photo. I suggest filling the crack with matching grout or caulking.
