AAD Inspection Corp.

Property Inspection Report

Subject Property: **Street Address, City, State and zip code**

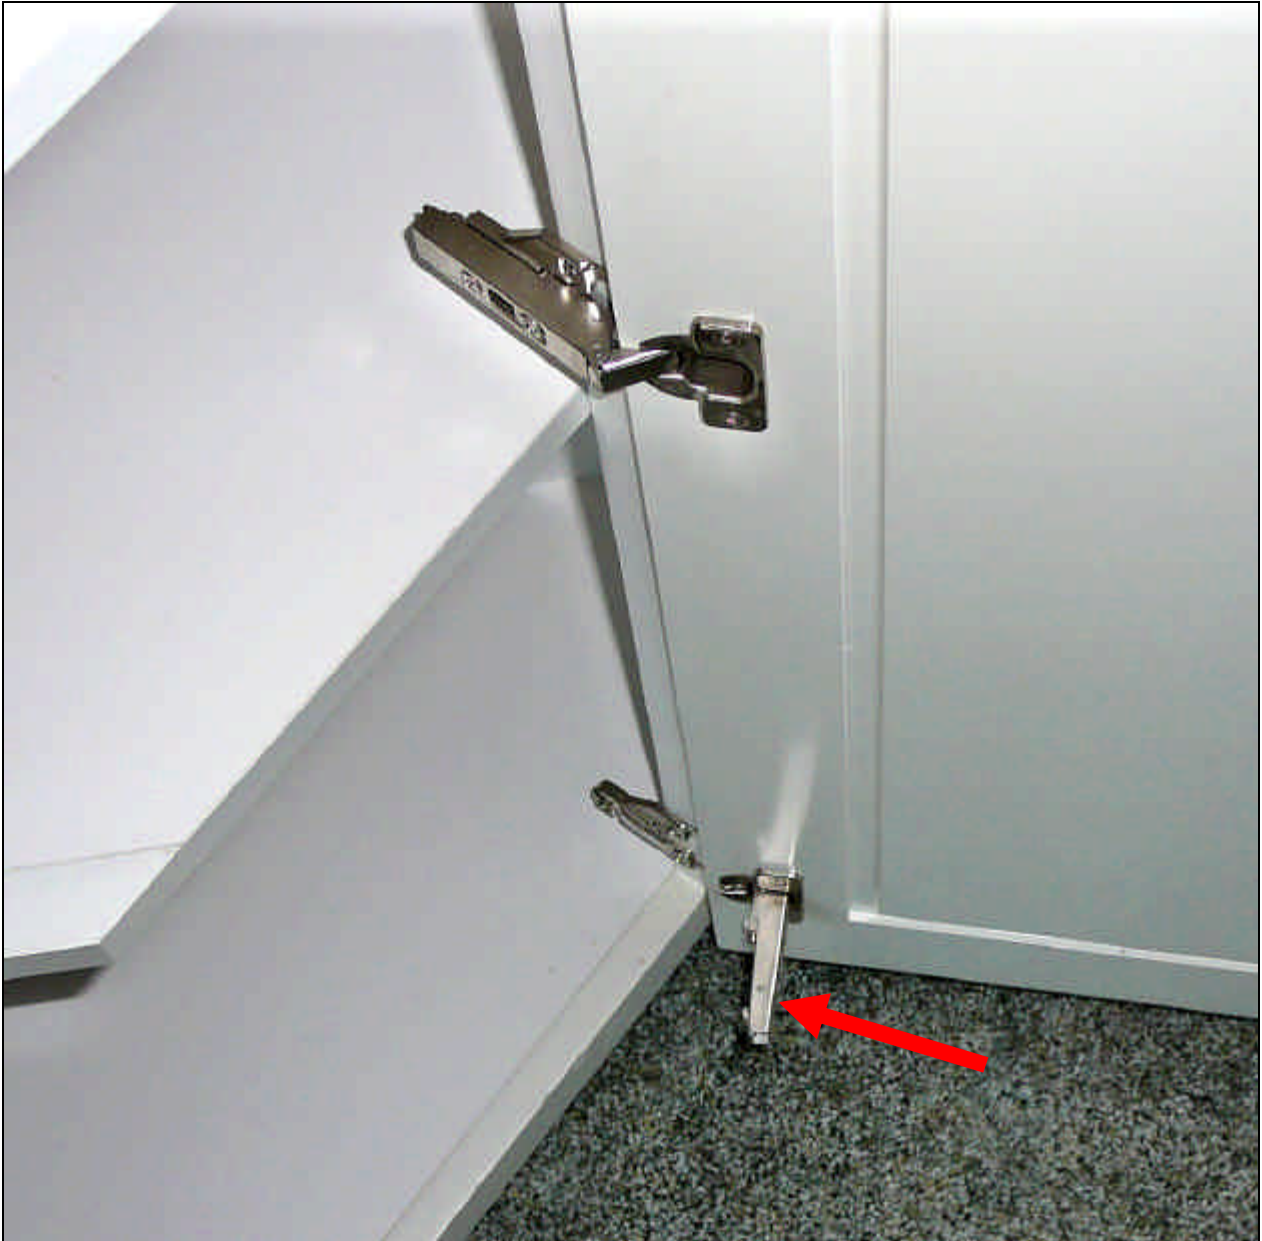
- 24. NOTE: The two French-style pocket doors separating the formal dining room from the formal living room already rub rather heavily on the carpeting. If thicker padding or carpeting is installed, these doors will absolutely need to be shortened.
- 25. Part of the bottommost pantry door hinge for the right pair of bifolding doors at the northwest corner of the formal dining room is detached. I suggest having a qualified cabinetmaker or handyman address this issue.

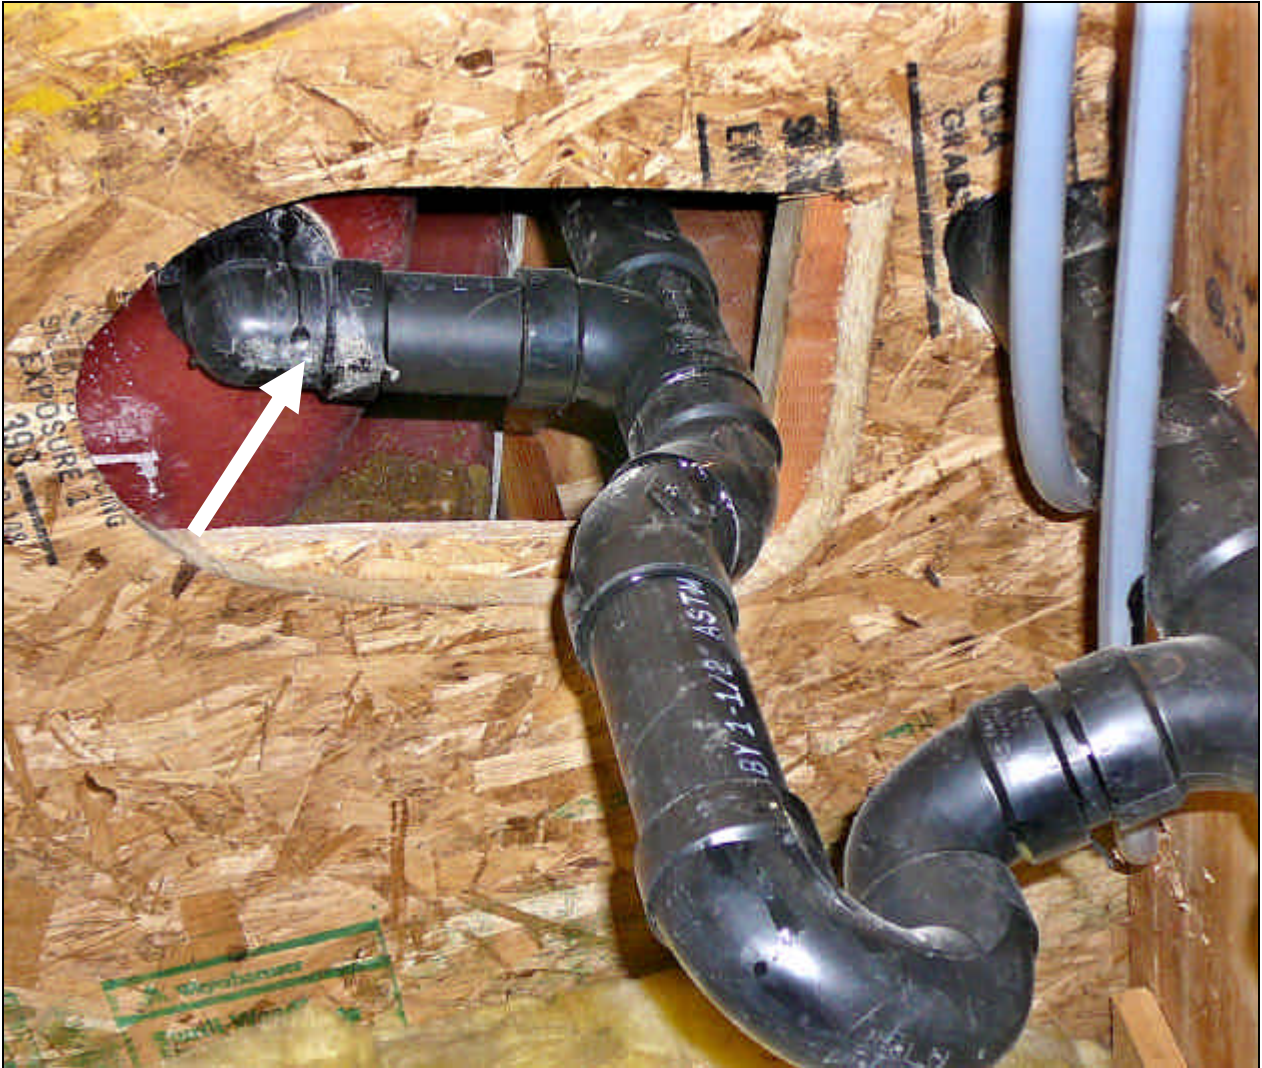
26. The large master bathtub is leaking into the crawl space at its drain flange gasket. A qualified plumber should address and/or correct this issue, as necessary.

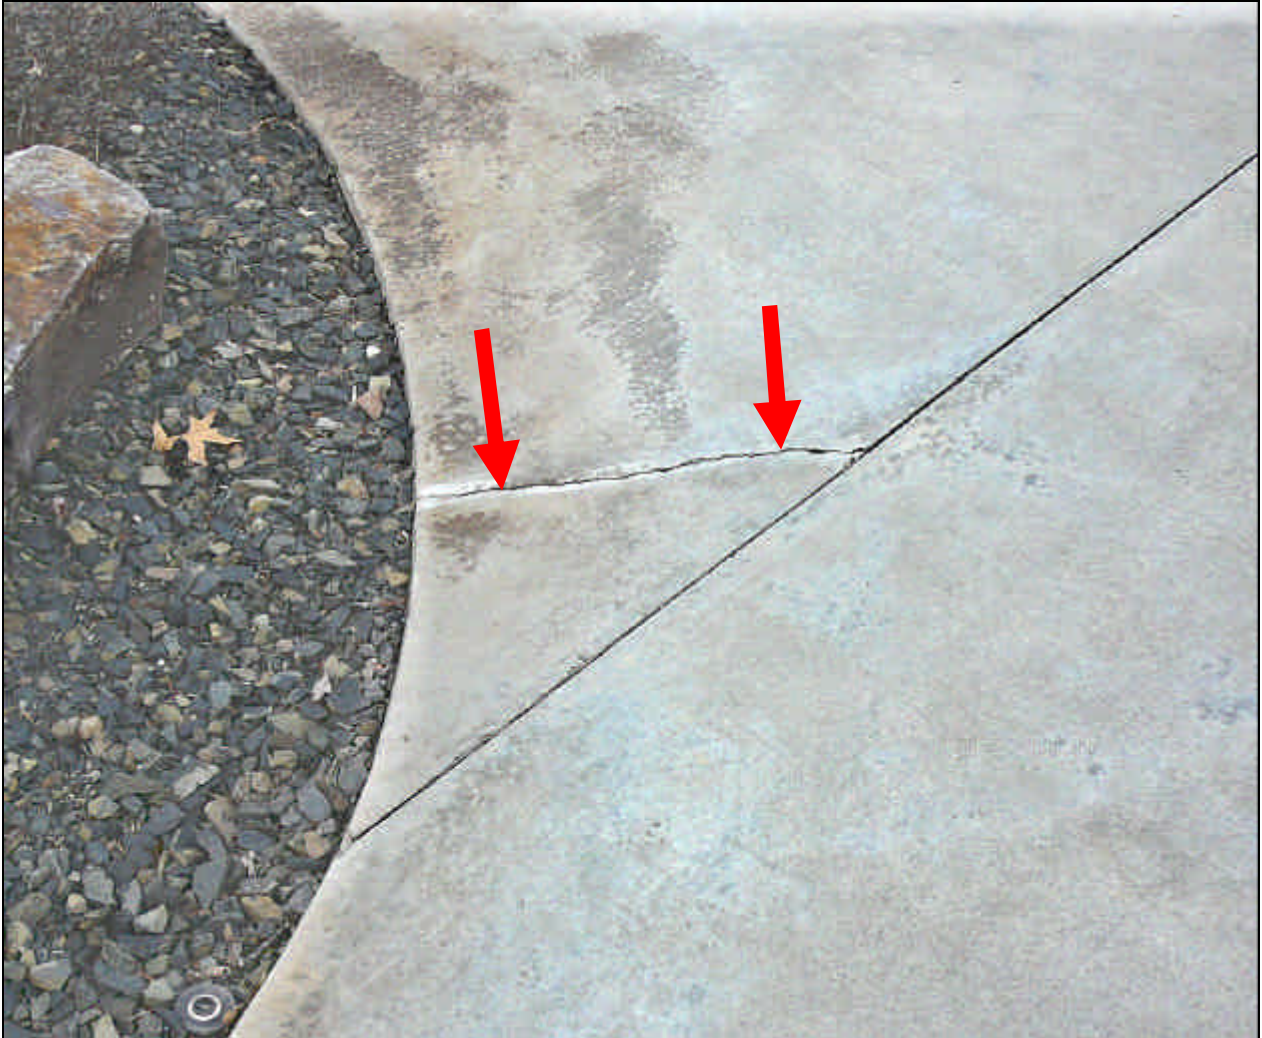
28. I noticed only one small crack in all the sections of the expansive concrete driveway. It is at a location that makes cracking nearly inevitable.

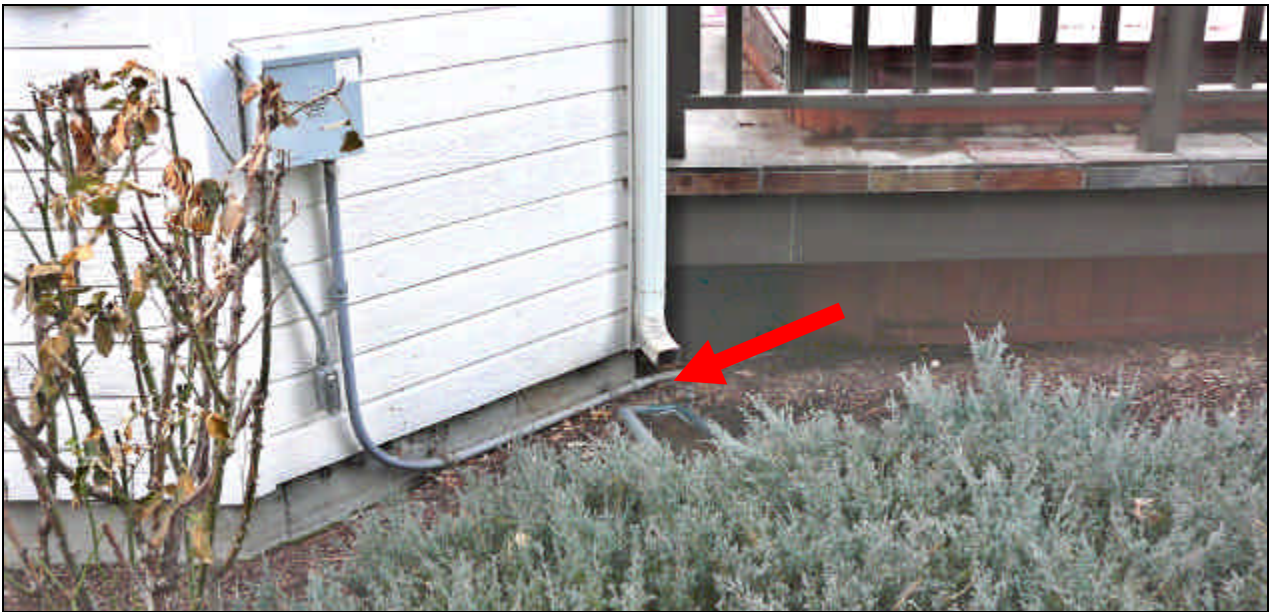
30. The gutter downspout at the right rear corner of the house discharges onto an area of ground that does not slope effectively away from the house. However, inspection from within the crawl spaces under the house indicates that exterior surface waters have not caused any flooding in the adjacent crawl space areas. Therefore, I see no need to recommend corrections to grading or downspout extensions at this time.

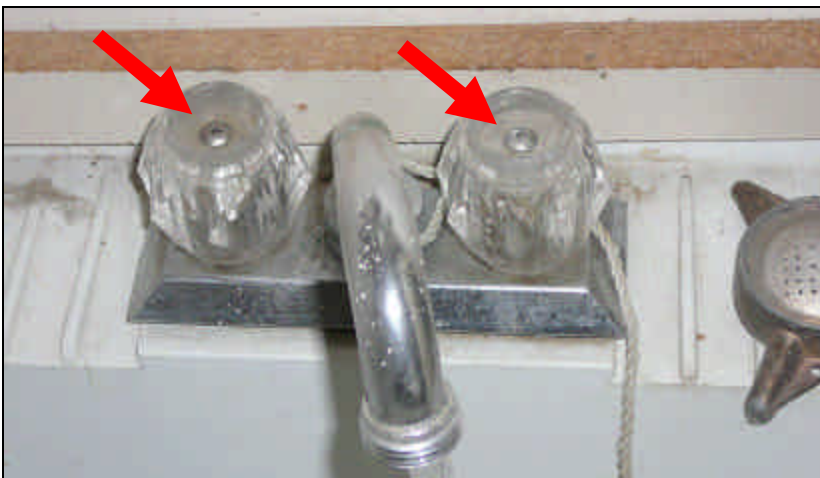
31. There are some minor vertically oriented cracks in the concrete foundation that are of cosmetic concern, only. (These are typical for this climate.)
32. Both pop-in plastic buttons for the tops of the wash sink faucet valve handles in the garage are missing.

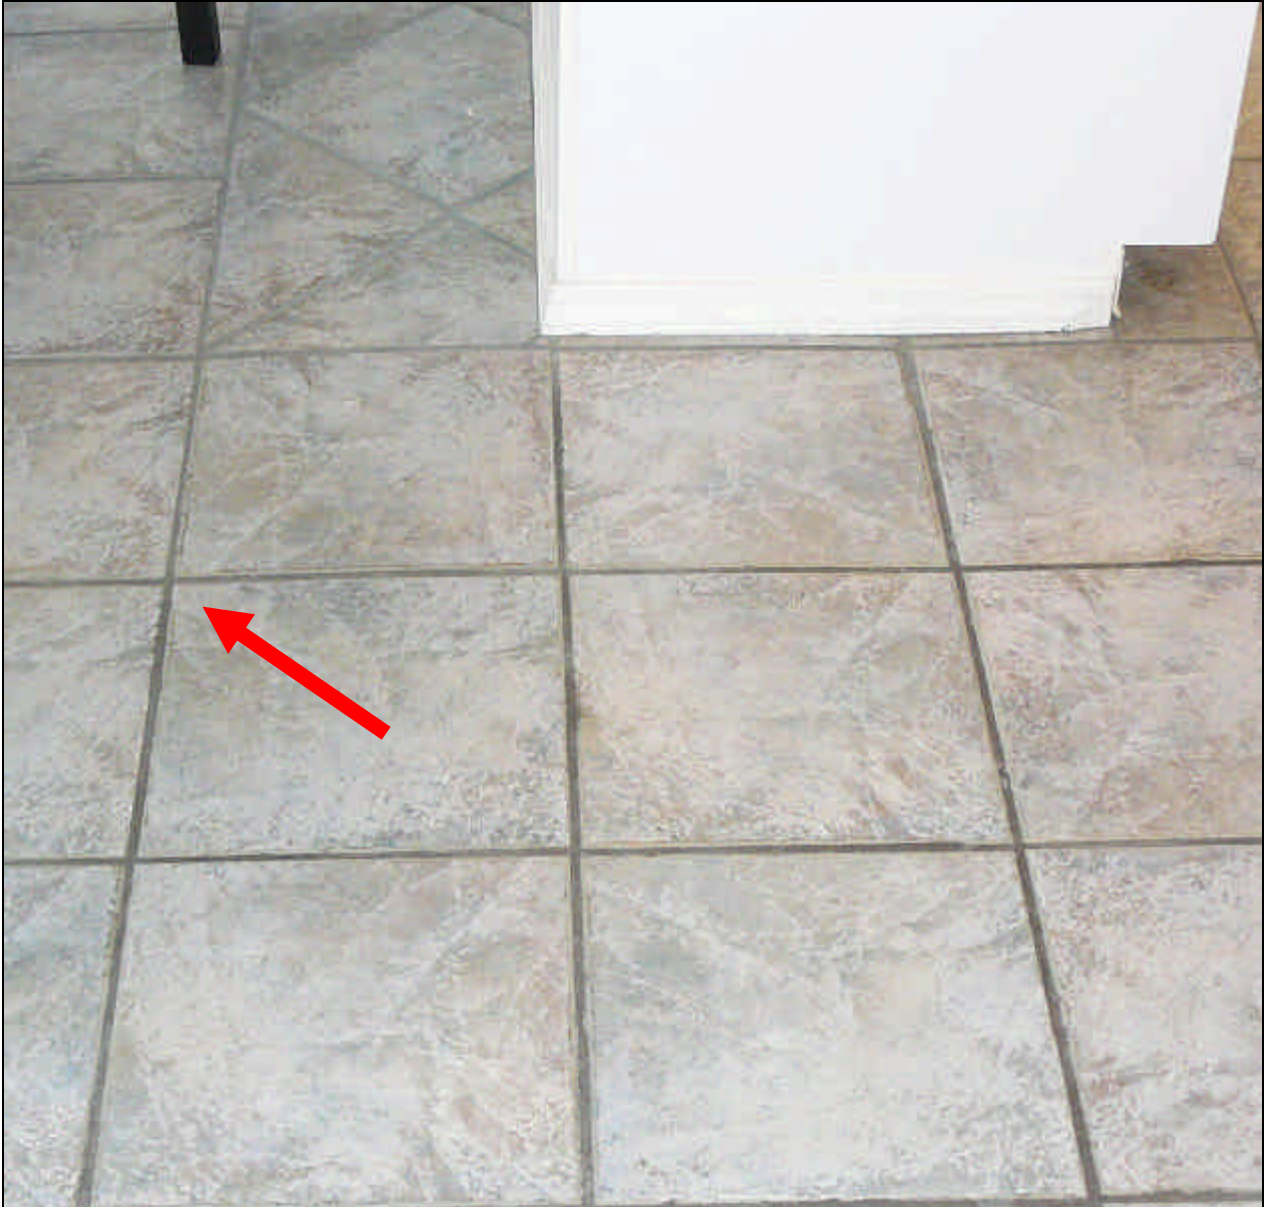
33. One of the 12x12-inch ceramic tiles on the kitchen floor makes a popping noise at its northeast corner when stepped upon. This one tile is no longer securely seated to its substrate. I suggest having a qualified tile setter address this issue. The arrow in the following photo indicates the loose corner.

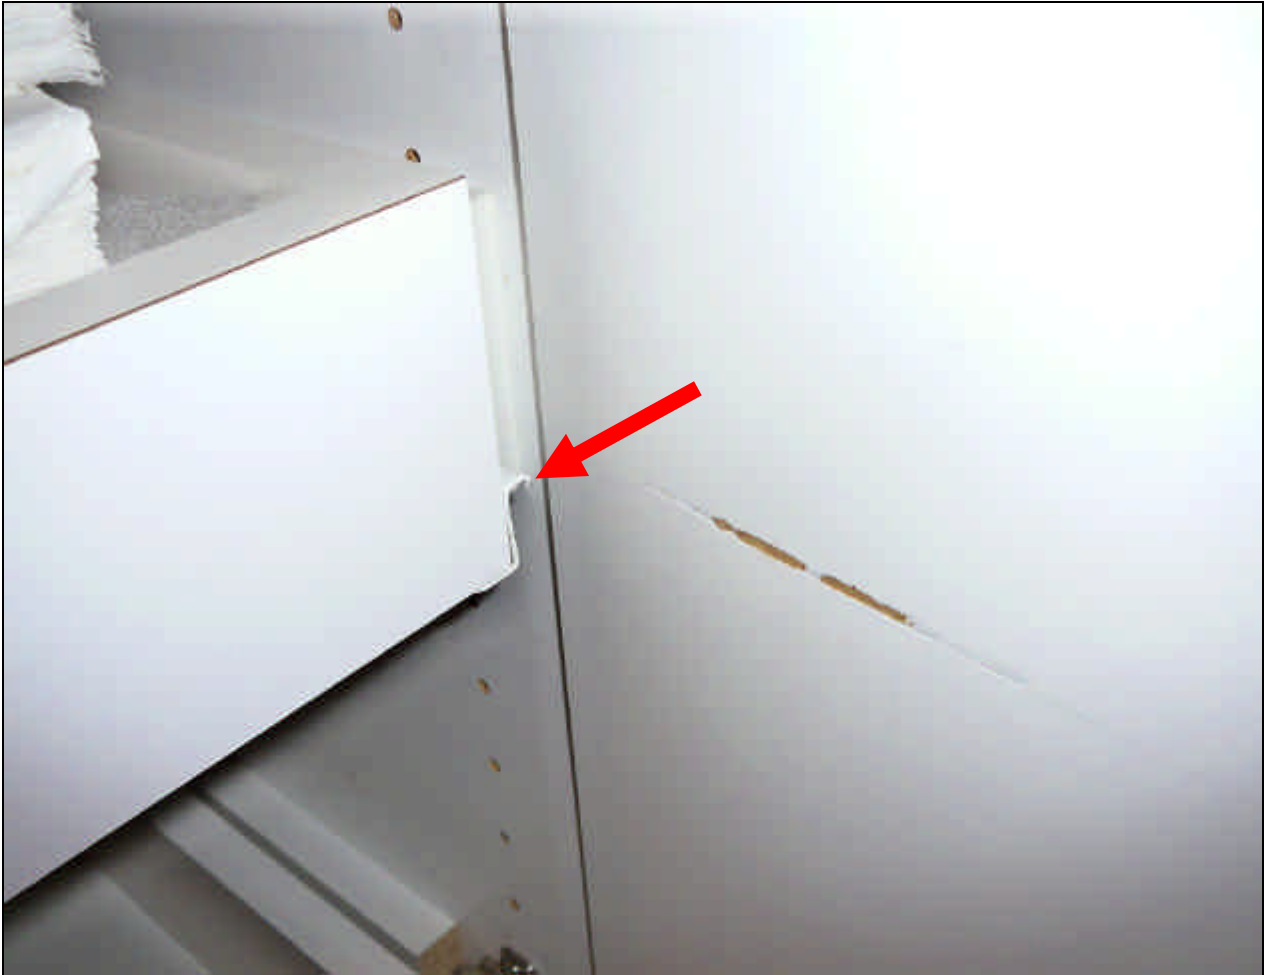
34. The sharp metal corners at the fronts of the roll-out shelf hardware in the kitchen base cabinets can easily scratch the interior surfaces of the adjacent cabinet doors. For this reason, I suggest considering installing white vinyl protectors made for this

purpose. The arrow in the following photo indicates the position of placement for the protectors. (I noted scratches only on one of the four cabinet doors.)

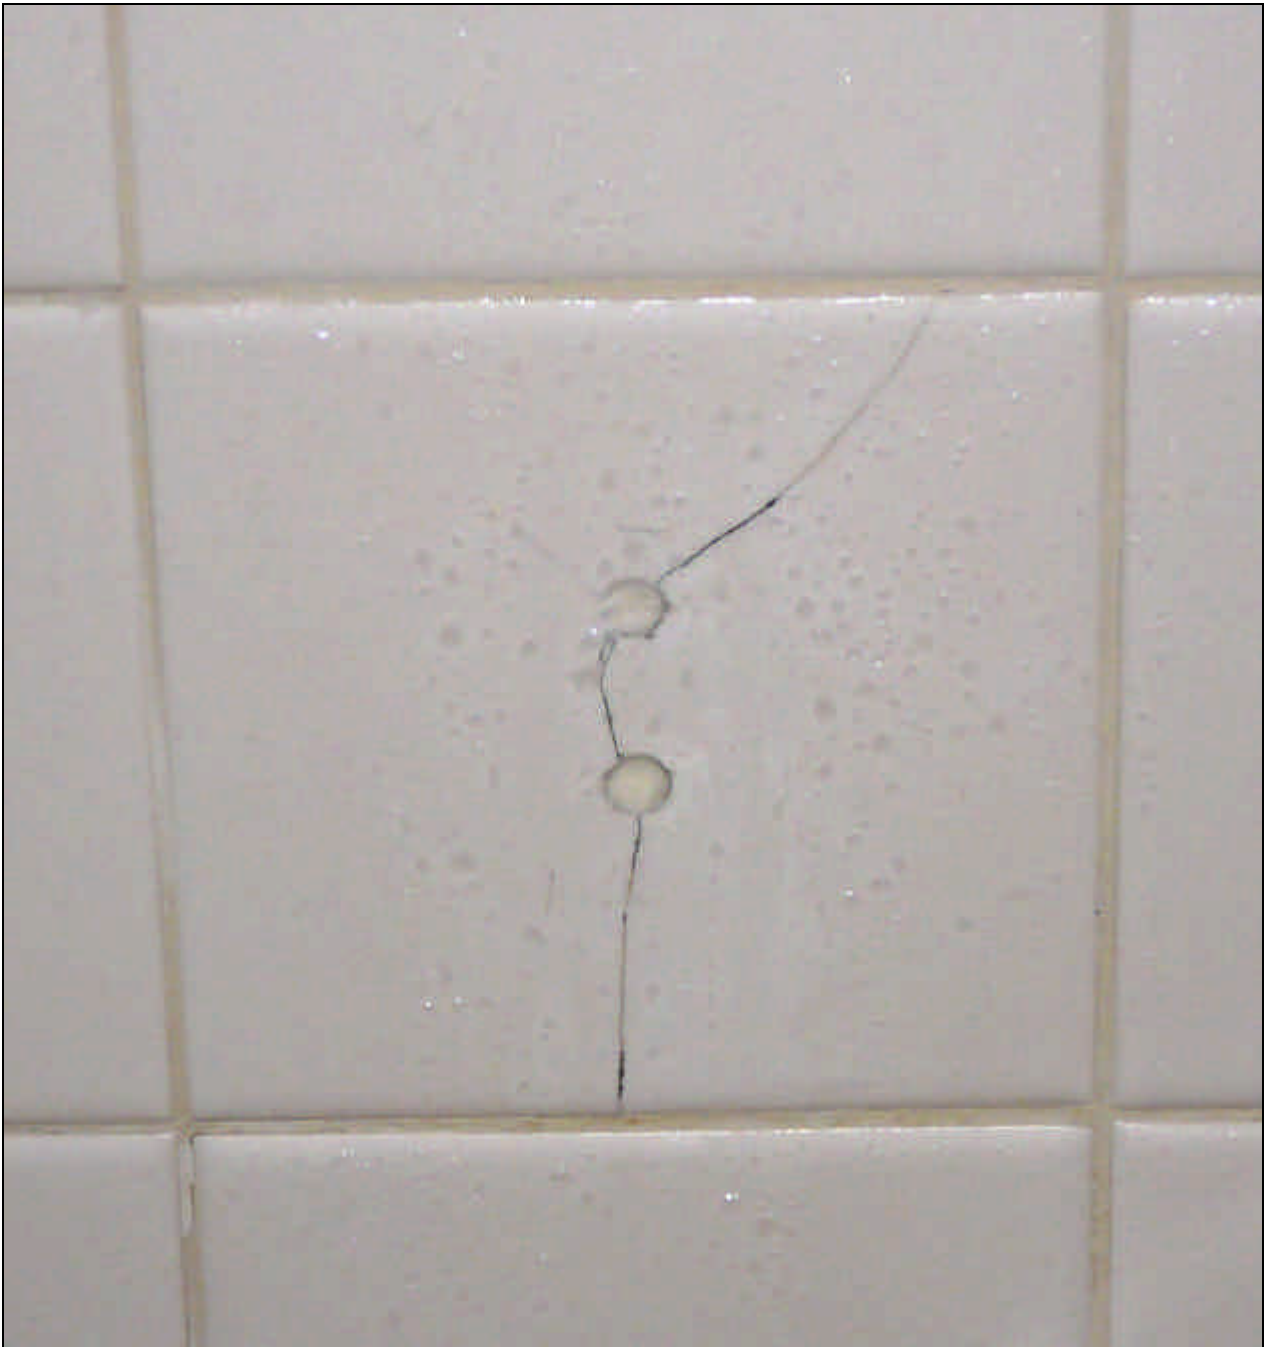
37. One of the 4x4-inch ceramic tiles on the west wall of the master shower at about chest height is cracked because of holes drilled in it for something that was previously mounted on the shower wall. I suggest having a qualified tile setter address this issue, if desired.

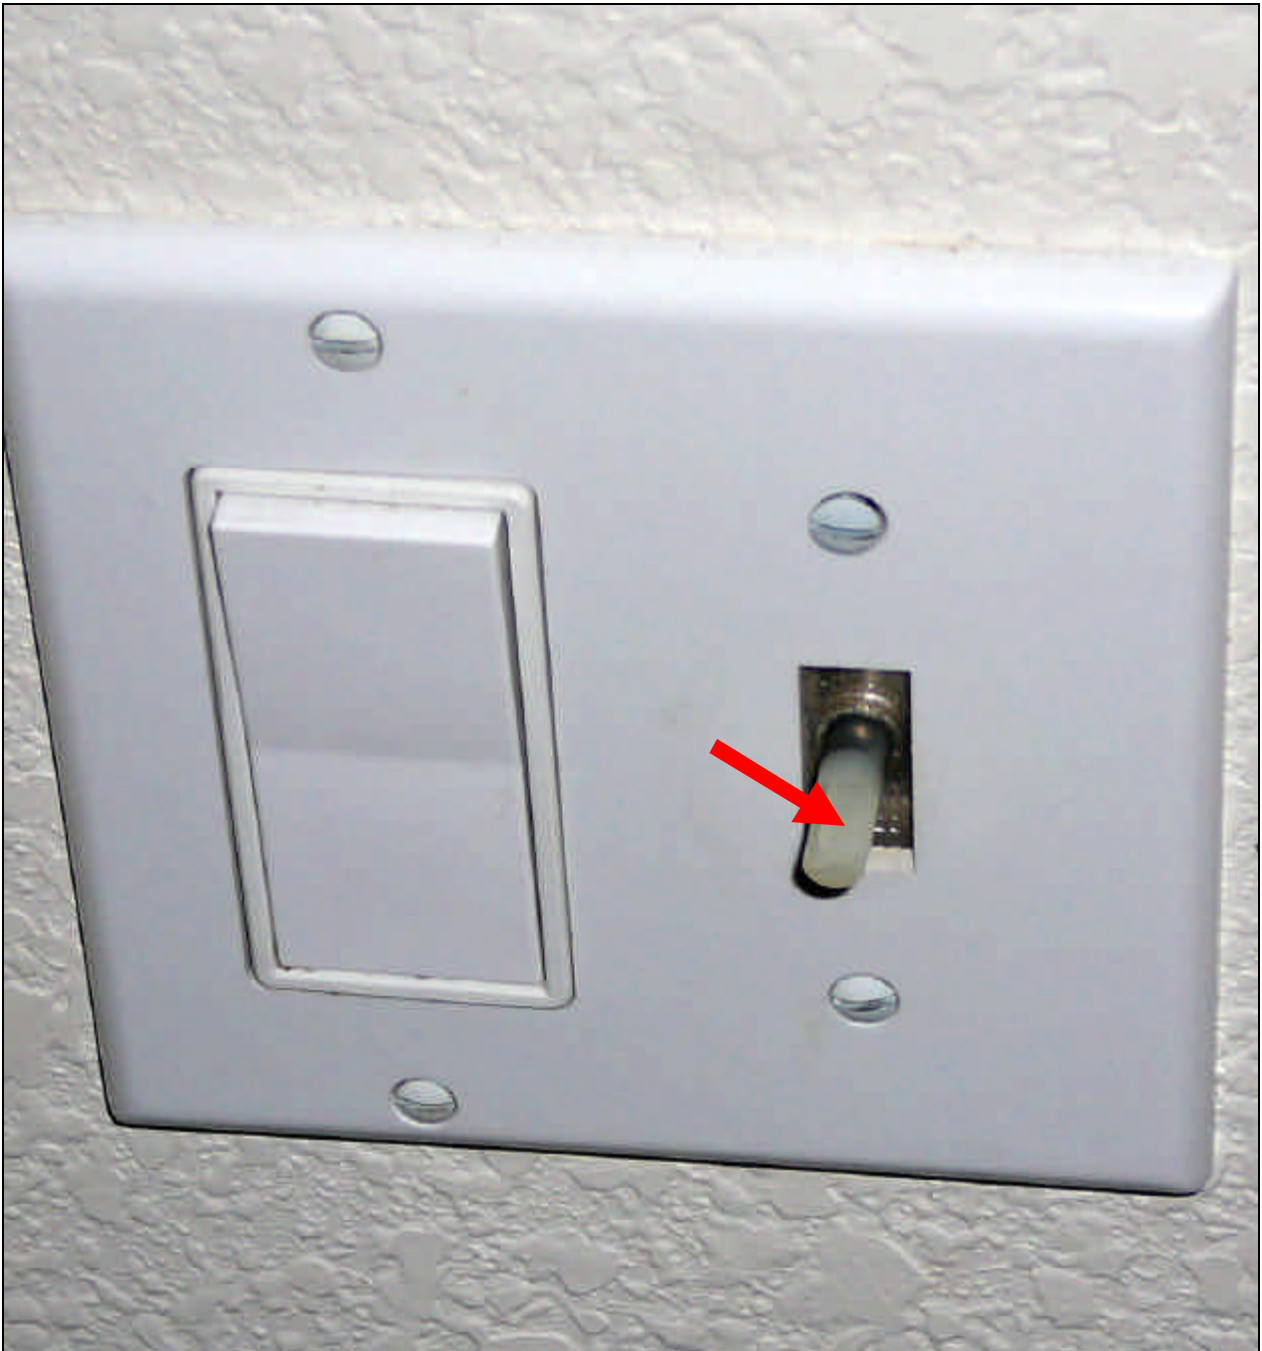
38. The control knob for the dimmer switch near the latch jamb of the rear sliding glass entry door is missing. However, the switch still operates adequately. Most likely, a whole new dimmer switch would need to be provided, rather than simply trying to find a matching knob.

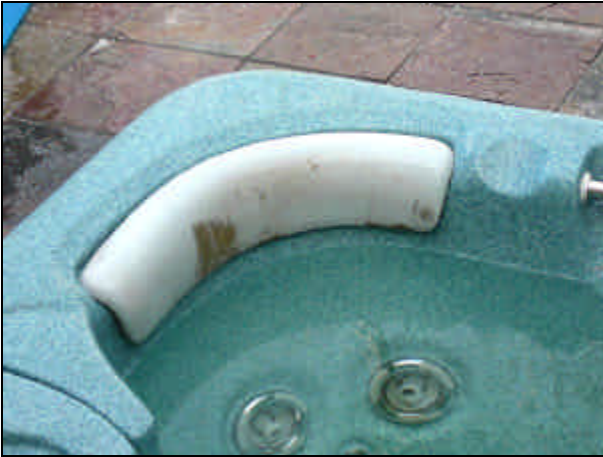
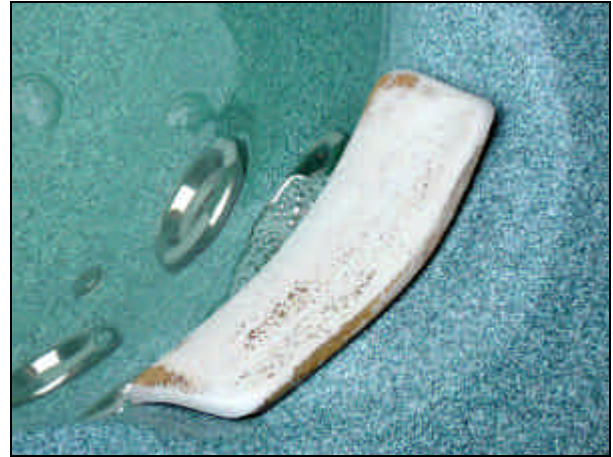
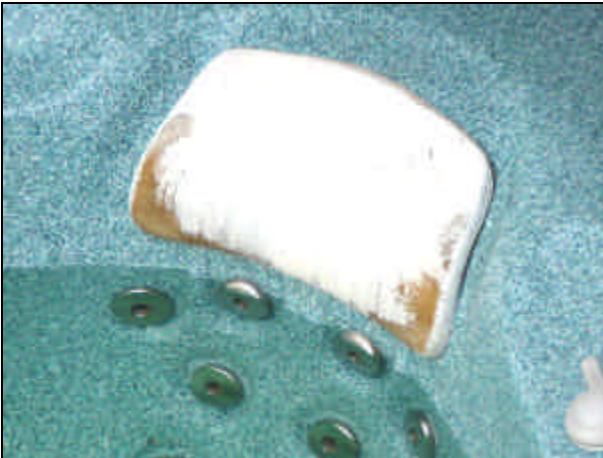
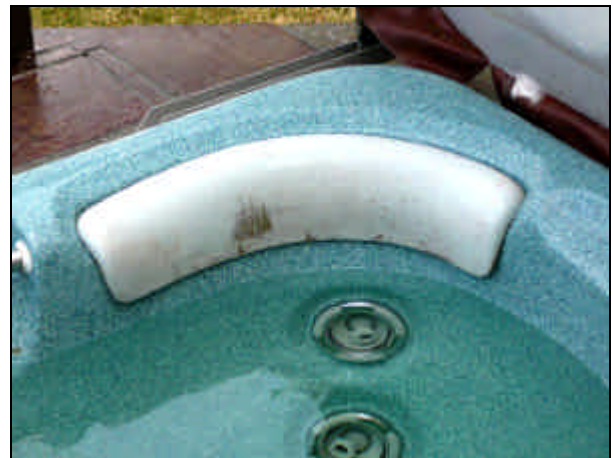
39. The four head cushions in the corners of the basin of the outdoor hot tub are suffering from the long-term exposure to chemicals used in the water. They may need to be replaced in the near future.
