**AAD Inspection Corp.**

# Home Inspection Report

**111 Round Cir  
My Town, ID 83000**

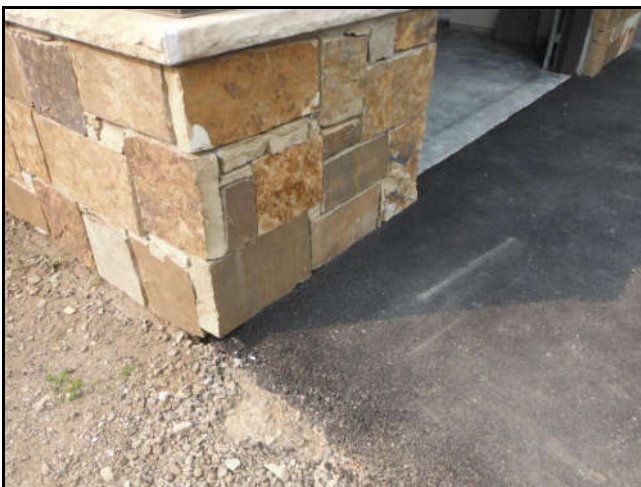
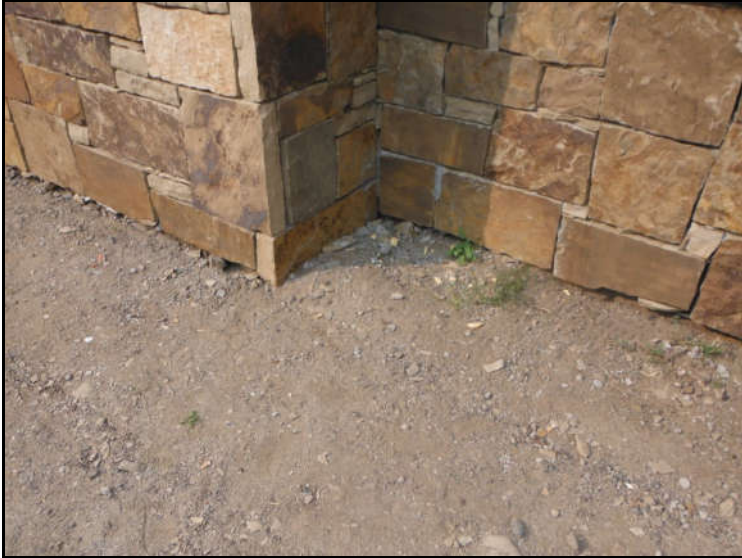
1. The masonry wainscot at the front and sides of the home is installed with contact of the adjacent asphalt and finish-grade soil surfaces, as exemplified in the following two photos.

This can encourage future potential moisture wicking and cracking in the masonry where it meets the asphalt at the front if any seasonal frost heaving or settling occurs. Siding manufacturers suggest maintaining several inches of ground clearance. Furthermore, landscaping has not yet been installed and will likely be installed over the level of the bottom edges of the siding surfaces.

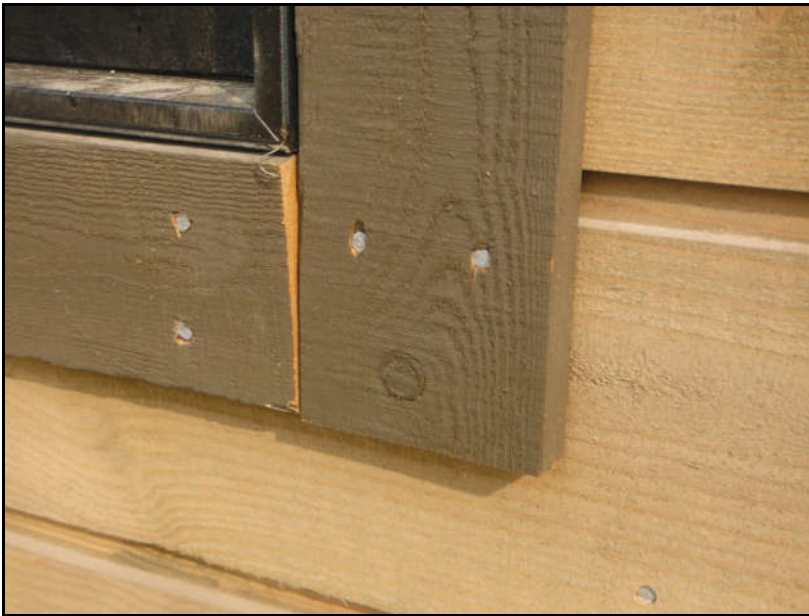
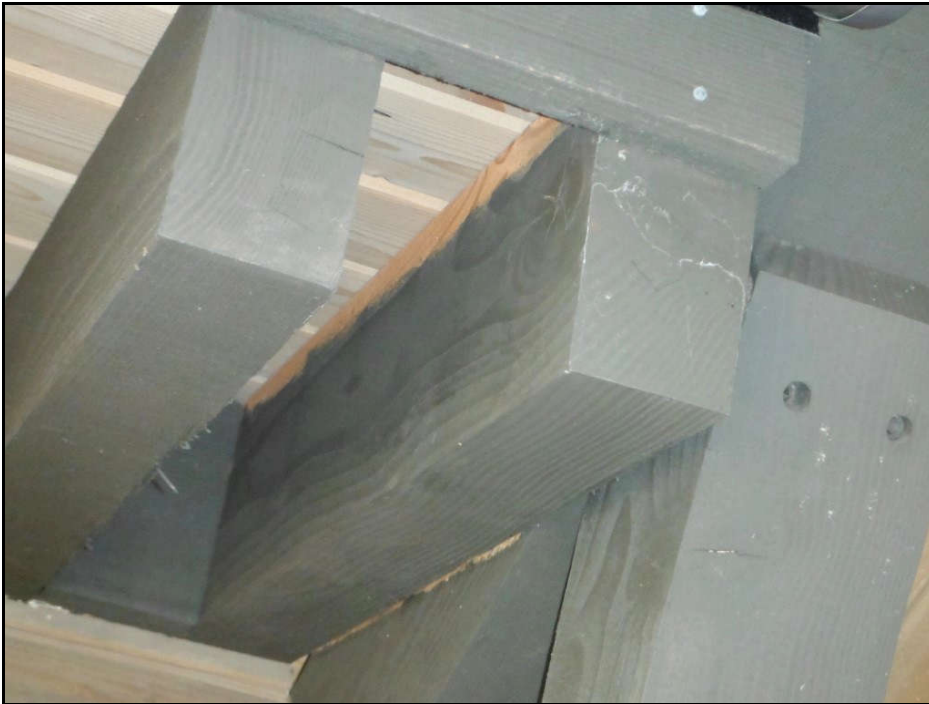
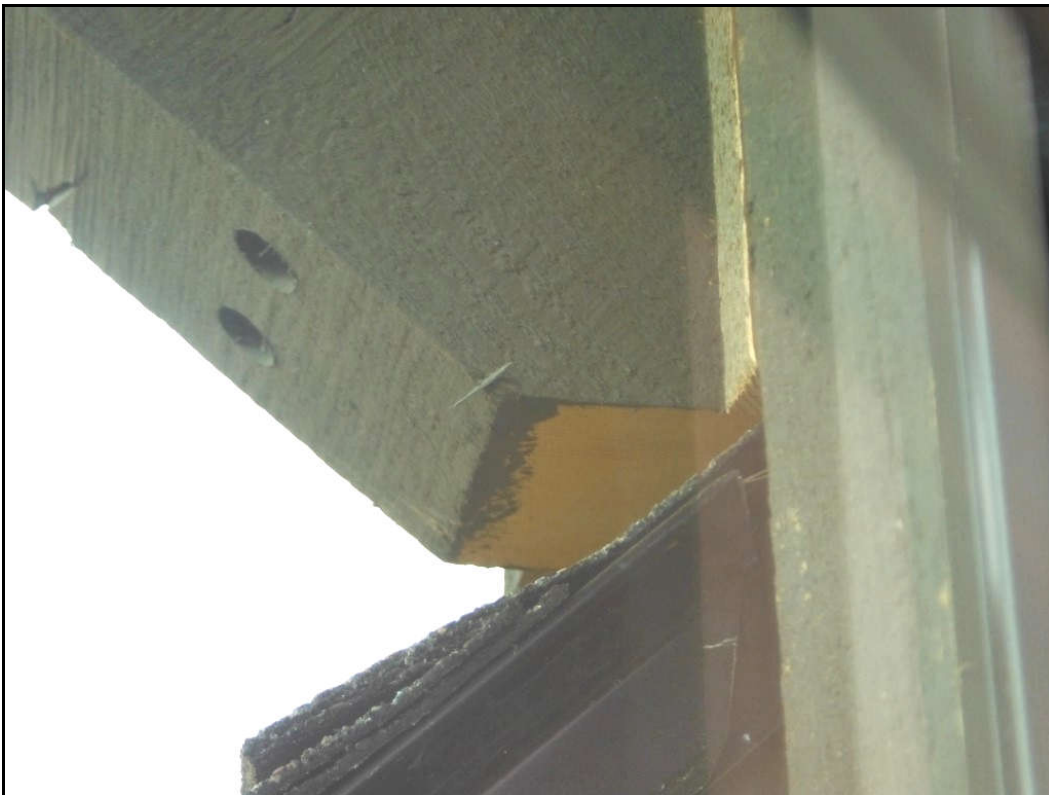
2. A number of siding trim surfaces are not fully finished with paint or stain, as exemplified in the following three photos.

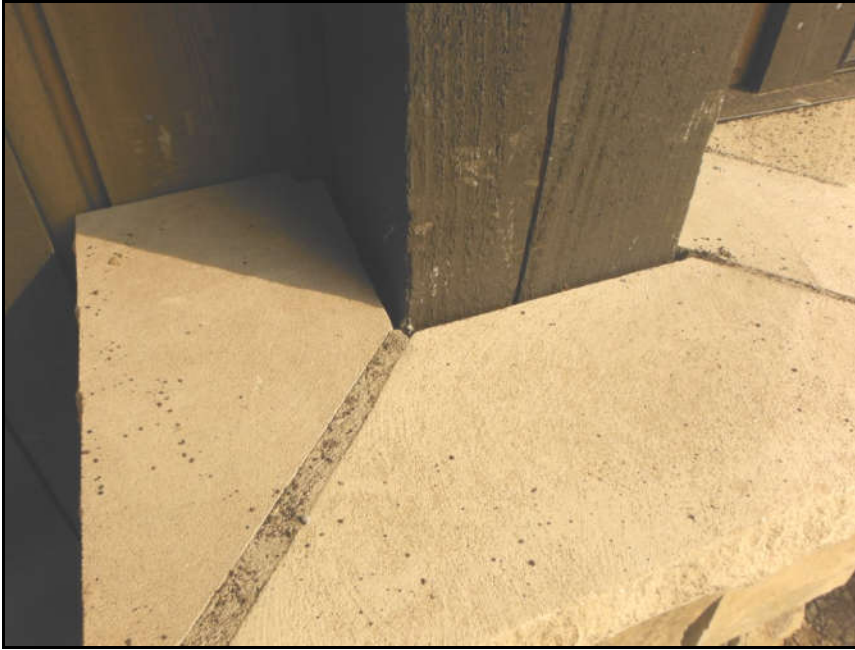
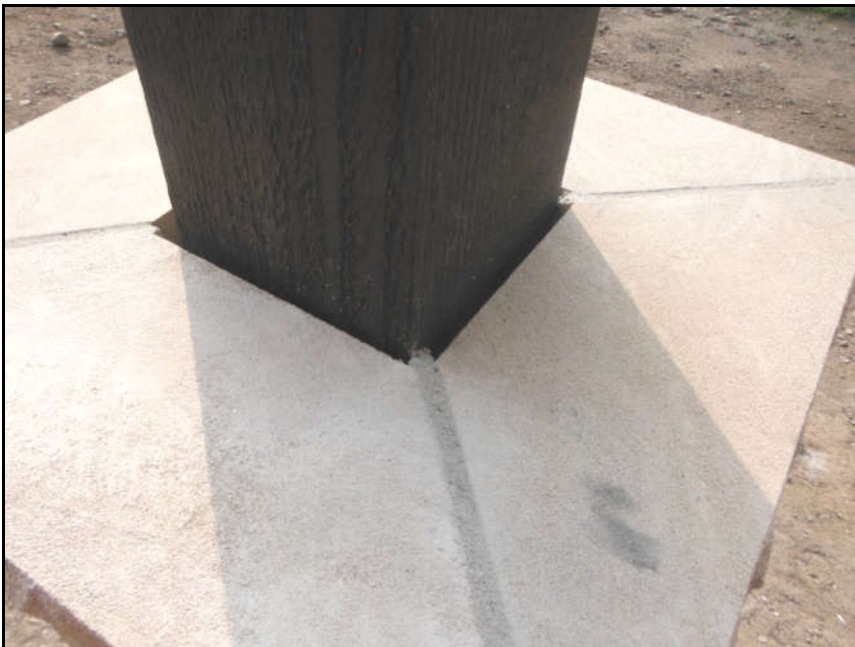
3. The rear patio support post surfaces are unsealed where they pass through the masonry caps, as exemplified in the following two photos. This can allow moisture behind these surfaces. (Similarly, the post bases where they pass through the masonry at the front have not yet been installed.)

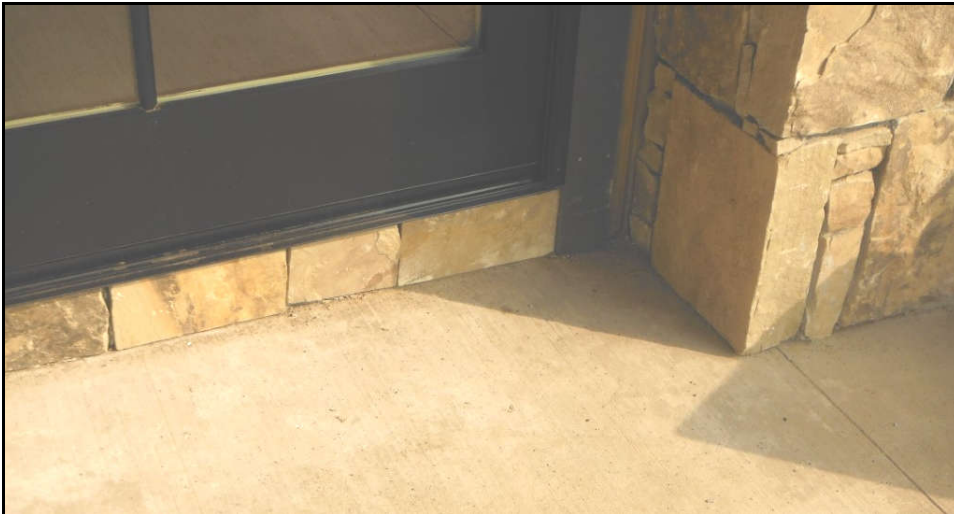
4. The siding and masonry at the rear patio is contacting the concrete slab below it, as exemplified in the following photo. This can encourage moisture to wick up into the siding, which can lead to possible deterioration. Siding should be held at least 1 inch above concrete to help prevent such issues. Furthermore, the materials behind and below the siding should be protected with flashing designed and installed to effectively prevent water entry behind the concrete.

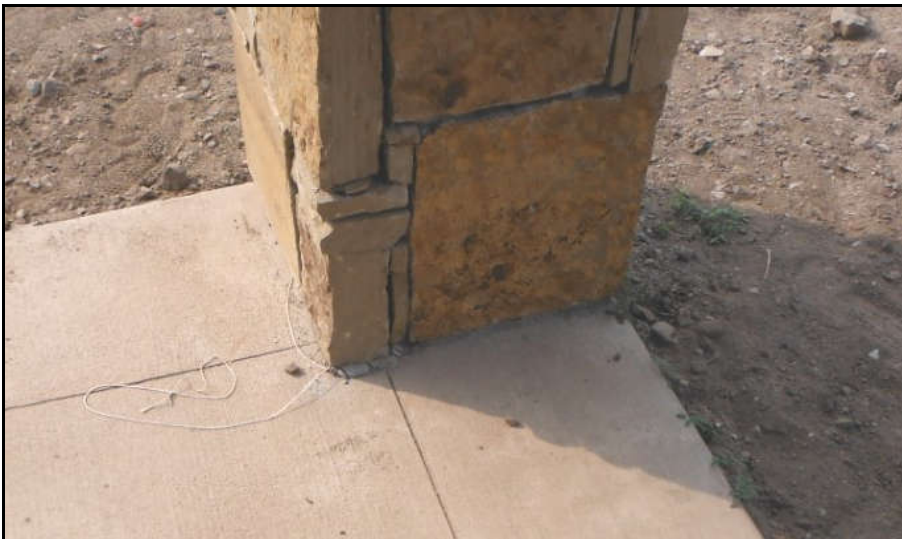
5. The masonry on the support posts at the rear exterior are in contact with the adjacent concrete, as exemplified in the following photo. This can encourage moisture wicking and potential cracking of the mortar or masonry during potential seasonal or intermittent frost heaving.

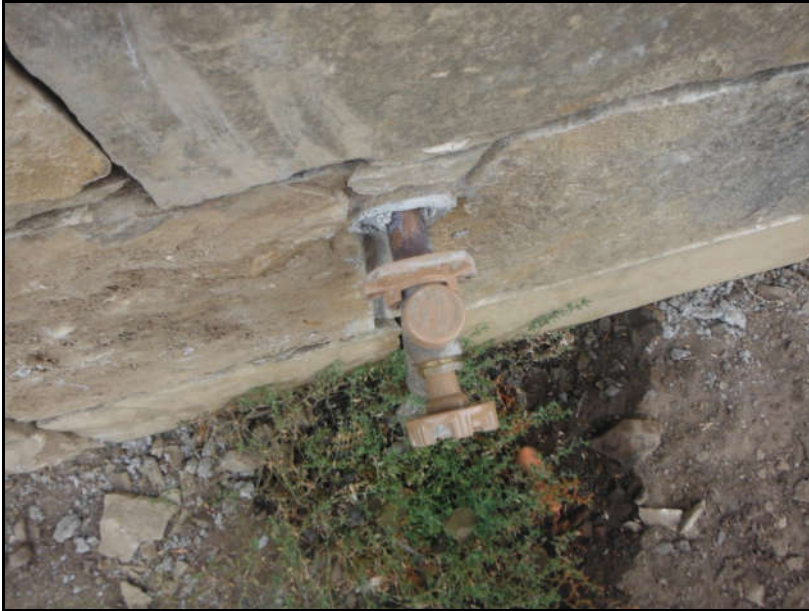
6. The freeze-proof sill cock (exterior garden hose valve) at the right exterior extends past the masonry, as shown in the following photo. It can be pulled or pushed somewhat. Furthermore, it twists during operation of the valve handle. This could cause damage to the flexible plastic piping inside the wall during normal operation.

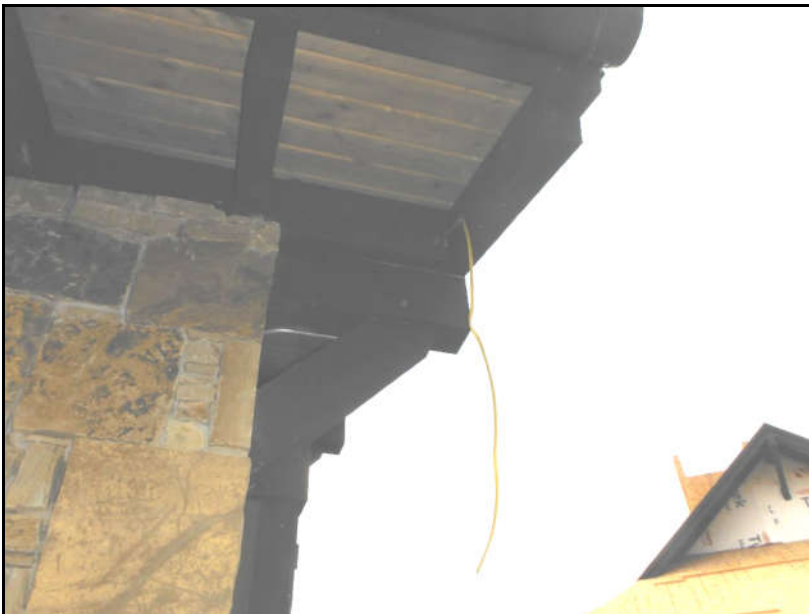
7. An electrical wire hangs from the soffit at the right front exterior, as shown in the following photo. This may be wiring for gutter heat cabling.

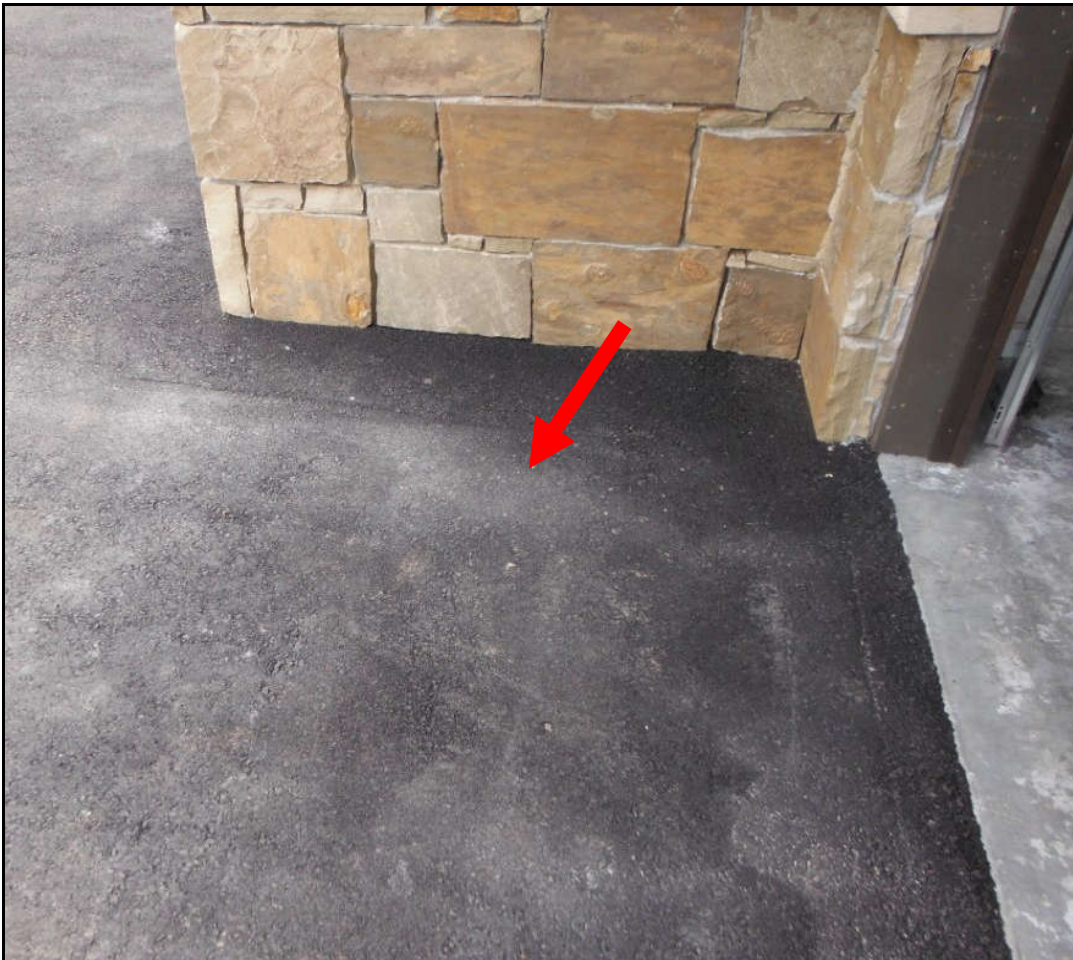
8. The metal gutters at the front of the structure do not have downspouts or leader chains. Perhaps they are intended for installation, but have not yet been installed.
9. The vehicle door jambs contact the adjacent concrete slabs at the front. This can encourage moisture wicking.
10. A depression is present in the asphaltic pavement in front of the right vehicle door, as shown in the following photo. This may trap or hold moisture during periods of inclement weathers.

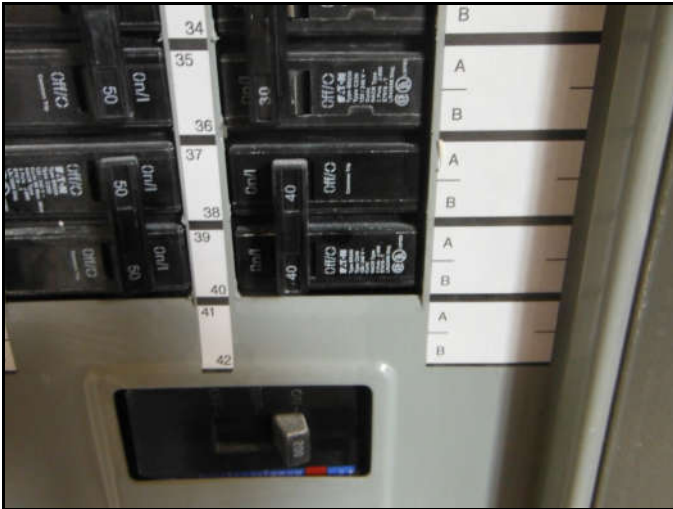
12. The hinge springs of the garage-house entry door are too weak or have been purposely relaxed. The door is intended to be able to self-close and self-latch if released from a fully open position.
13. When I approached the home, the breaker for the water heater was in a 'tripped' position. The water heater was not "on" or operating at this time. Therefore, I suggest involving a registered contractor.

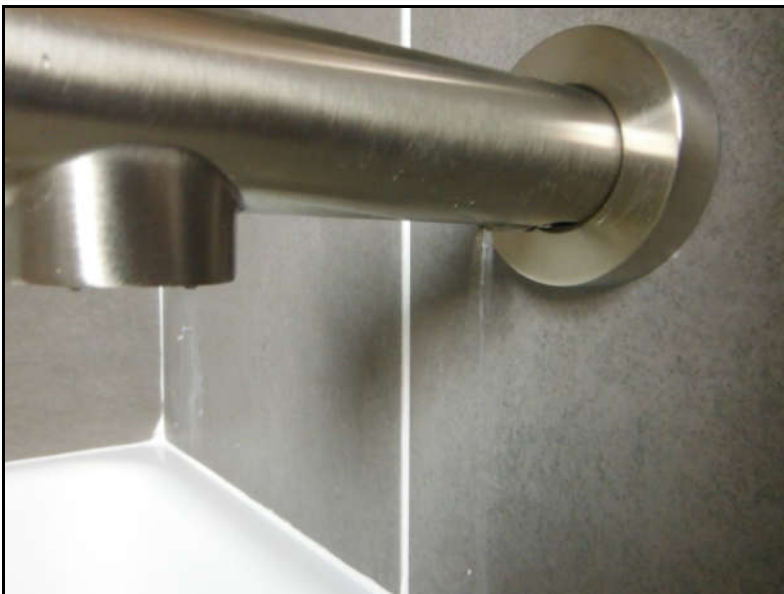
14. Water flows continuously from the upstairs bathroom tub spout while operating the shower, as shown in the following photo. I suggest involving a licensed plumber.

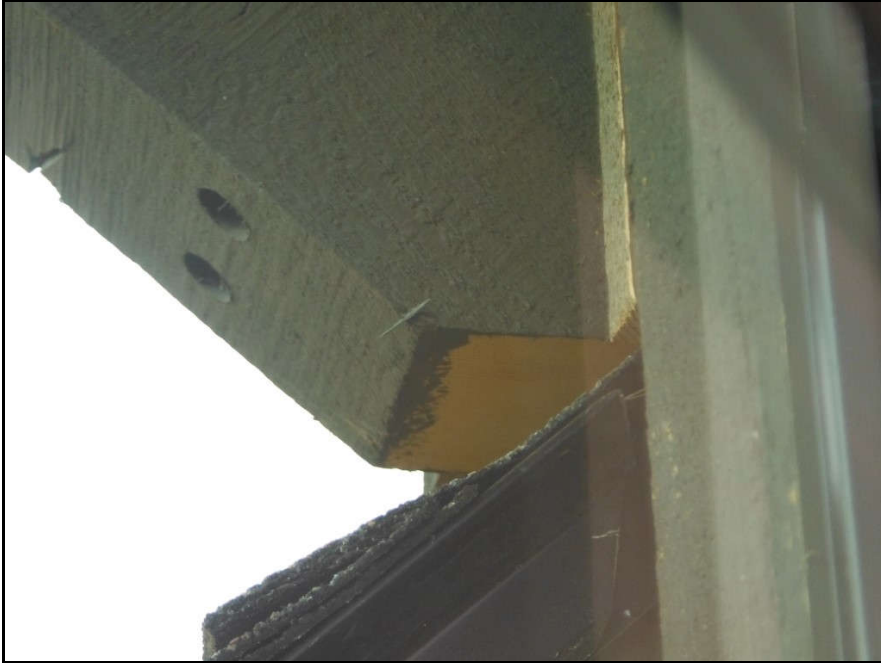
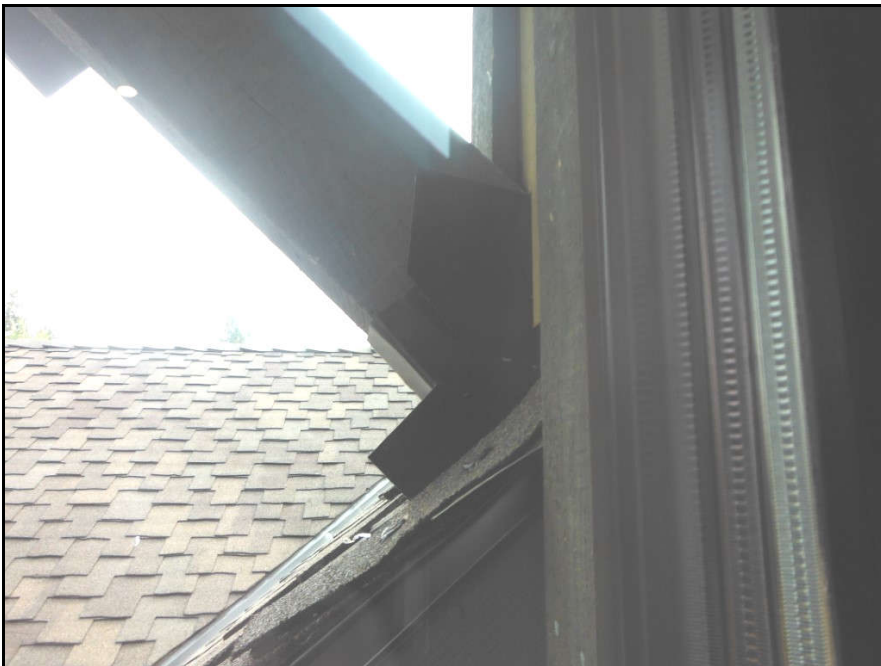
15. The brace-mounts for the overhang over the front window has been 'flushed', as exemplified in the following photo. However, the supports for the overhang of the rear windows have not been flashed, as exemplified in the following two photos.

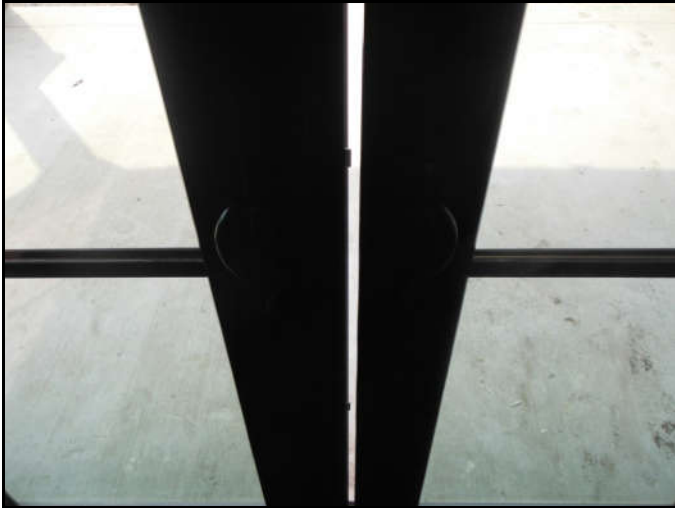
16. When I first approached the home, the rear entry sliding doors were open about an inch, as shown in the following photo. This could be a security risk and present an inadequate weather seal. I had some difficulty closing the door. However, I was able to successfully do so during the inspection.

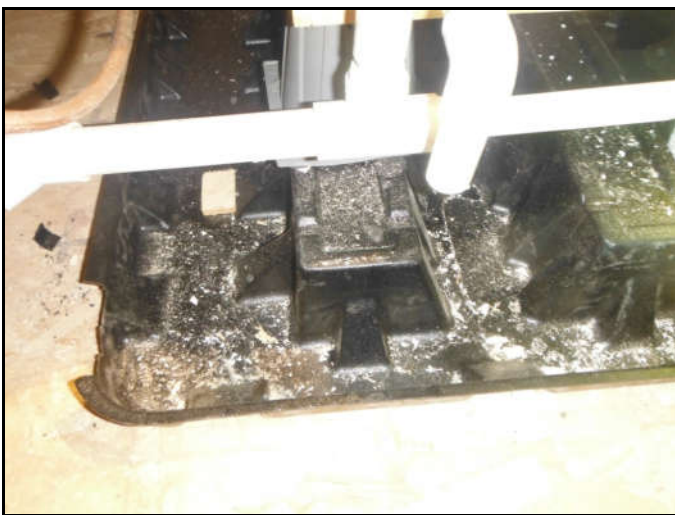
17. I ran the living room fireplace for about 25 minutes inside the home. After that amount of time, the smoke detectors in the home sounded and ran continuously. Perhaps the appliance should be run for a while to burn off any factory coatings, while airing out the home to help prevent these nuisance alarms in the future.
18. The catch tray beneath the HVAC system in the attic is filled with construction debris, as exemplified in the following photo. This debris can clog the primary drain or water sensor, if it were to fill with condensate. It should be cleaned.

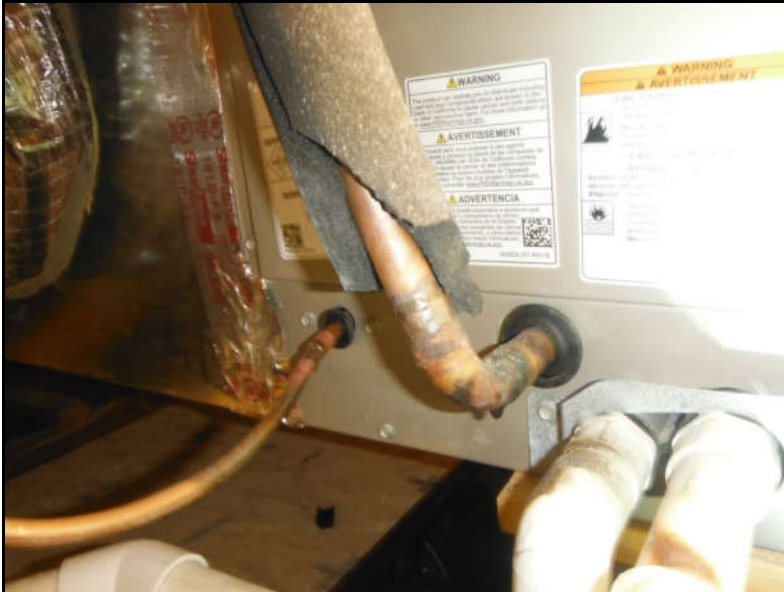
19. A small amount of insulation is missing from the refrigerant line where it enters into the evaporator coil cabinet to the left of the furnace in the attic, as shown in the following photo. Interior humidity can condense on this piping, leading to drips of water that can cause nearby moisture damage.

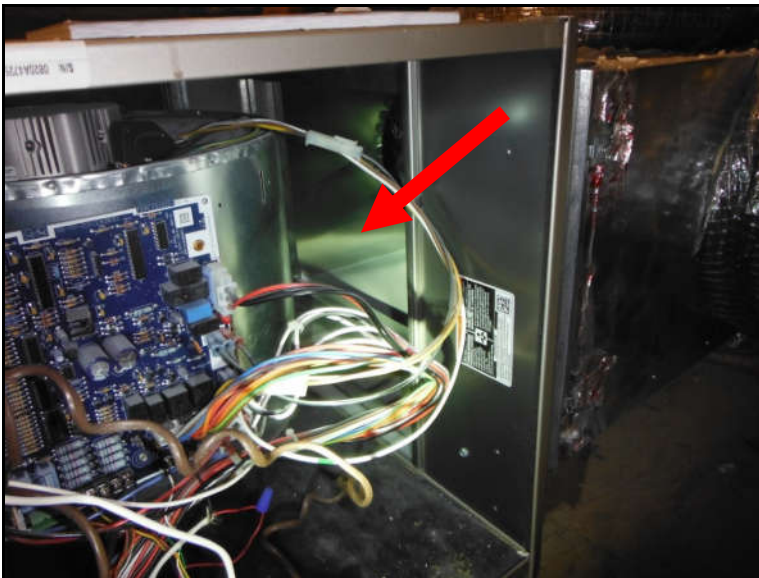
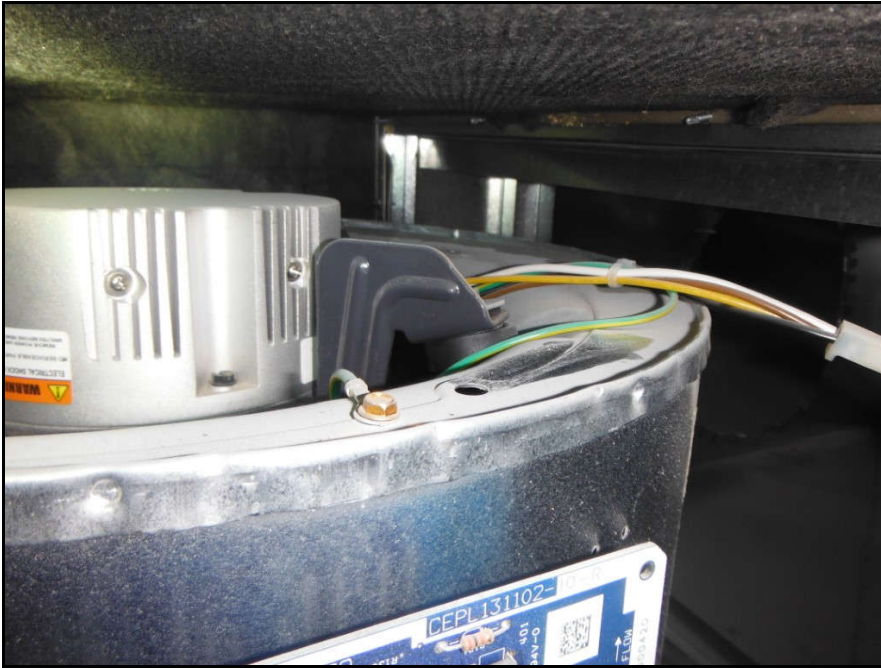
20. The HVAC equipment has been operating without a filter, as shown in the following photo. The blower compartment interior is dirty, as shown in the second photo. I suggest having a licensed HVAC contractor address this issue.

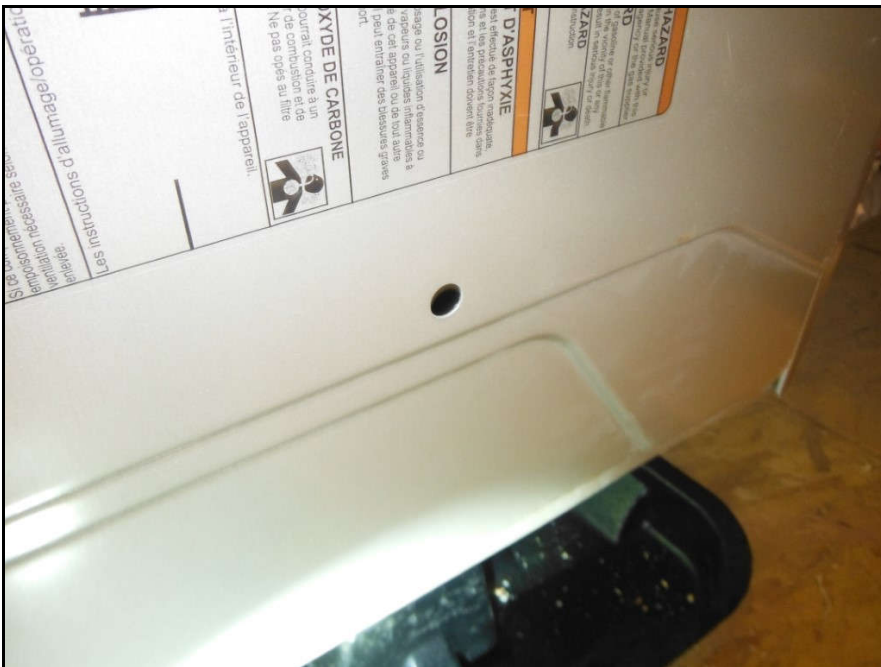
21. The viewing glass panel is missing through the blower compartment cover of the furnace in the attic, as shown in the following photo. This can allow attic interior air to be pulled through the blower during operation of the furnace.

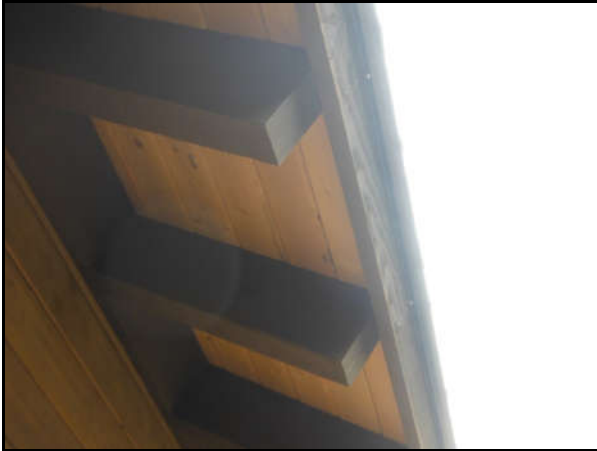
- a. Some fasteners are not fully driven through the fascia at the left exterior over the A/C compressor.

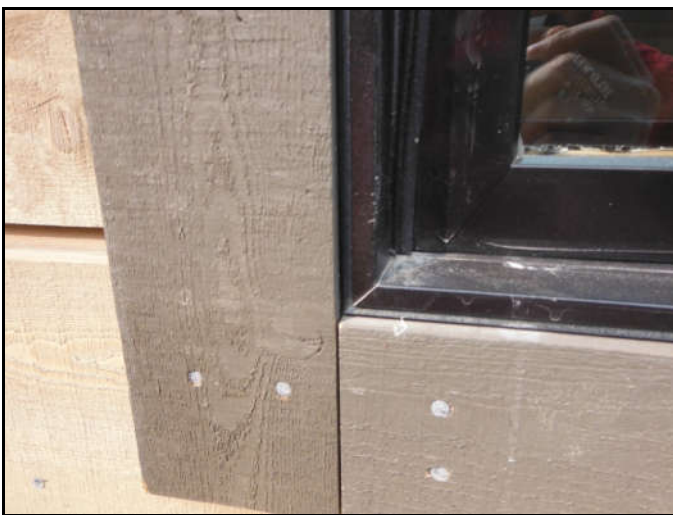
- b. One or more windows have little or no caulking around their frames at the exterior. However, if the windows are properly installed (with caulking behind their nail fins and with flashing tape applied around their frames before the siding was installed), the only remaining concern might be future swelling of trim boards. Therefore, periodic monitoring for swelling or other signs of water entry is a good idea.

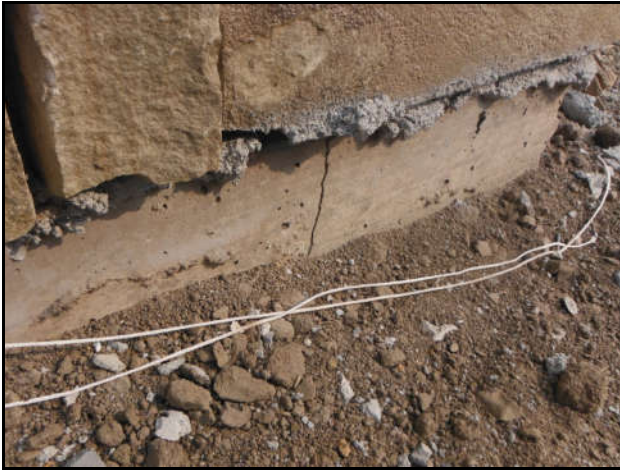
- c. A small crack is visible in the patio below the left rearmost post, as shown in the following photo.

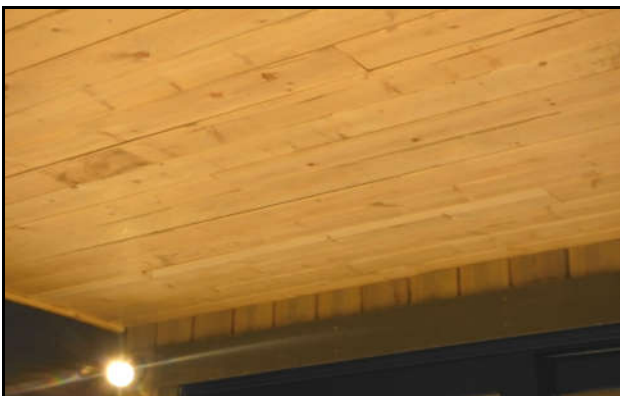
- d. Casement window screens and rear entry sliding glass door screens have not yet been installed. However, this is typical for construction at this stage. (Most builders will provide the promised screen panels at closing, as they prefer to keep them out of harm's way until then.)
- e. One or more hairline cracks have formed in the concrete flatwork of the rear patio. However, this type and extent of cracking is cosmetic, only. Please refer to further discussion regarding "Sealing Hairline Cracks in Concrete Flatwork", which I have included in the section titled "Ownership Tips for this Particular Property" near the end of this report.
- f. One or more small, but noticeable gaps are visible in the wood paneling in the rear patio soffits, as exemplified in the following photo.

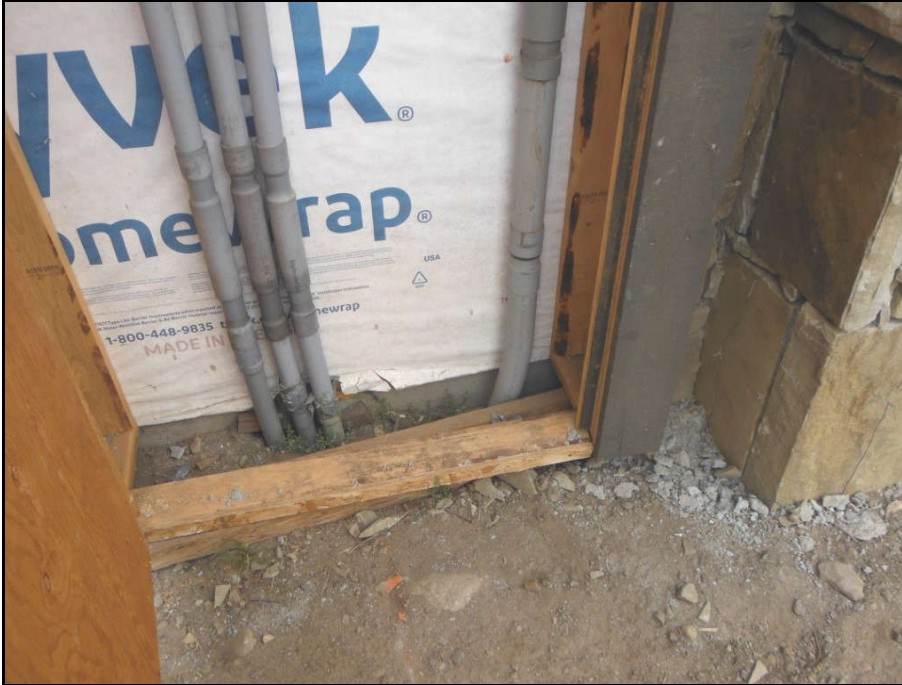
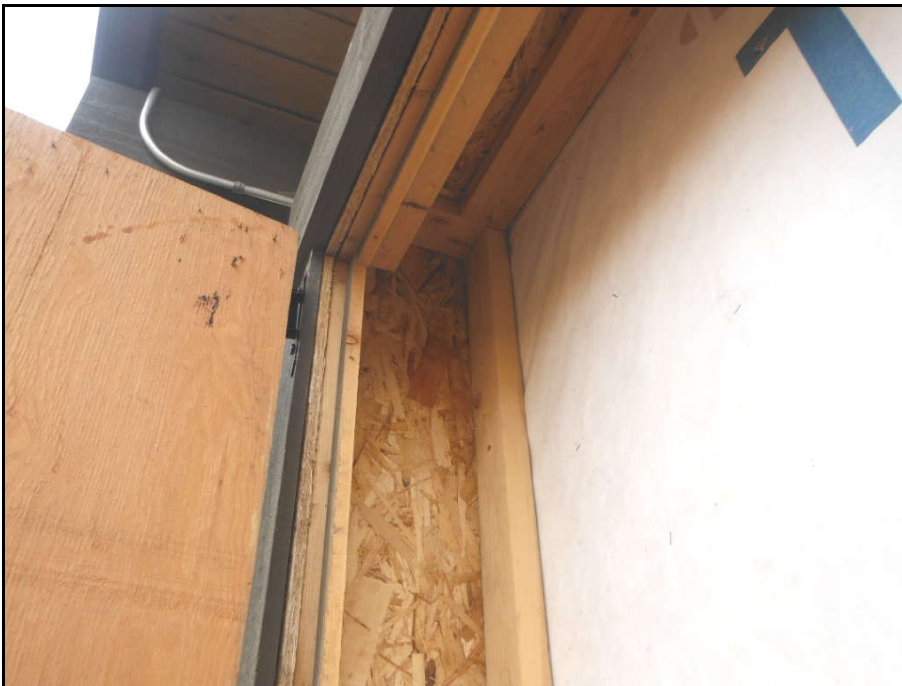
g. Aspects of the shed door and buildout for the meter at the right exterior are incomplete or unfinished, as exemplified in the following two photos.

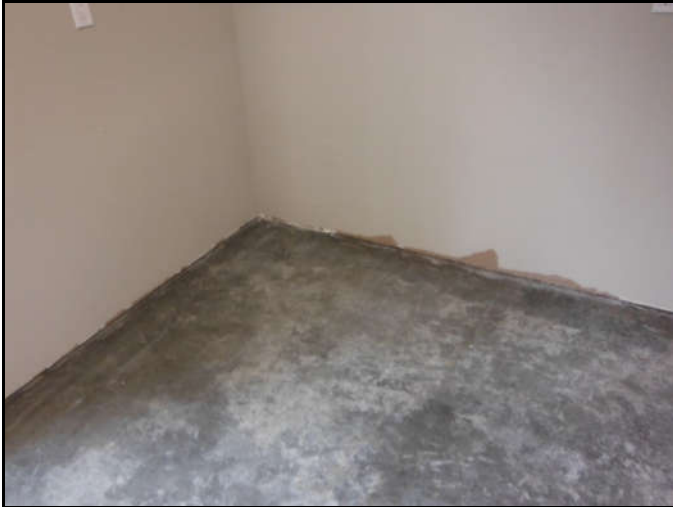
- h. The door for the front entry has a missing, damaged, or ineffectual doorstop. Other doors may have doorstop issues, as well. Doorstops can help prevent the damage to nearby surfaces that might otherwise occur because of doors swinging into them.
- i. The bottom edges of the sheetrock inside the finished garage have areas of exposed fasteners or torn paper facing, as exemplified in the following photo. I noticed one or more paint chips around the garage right-facing man door.

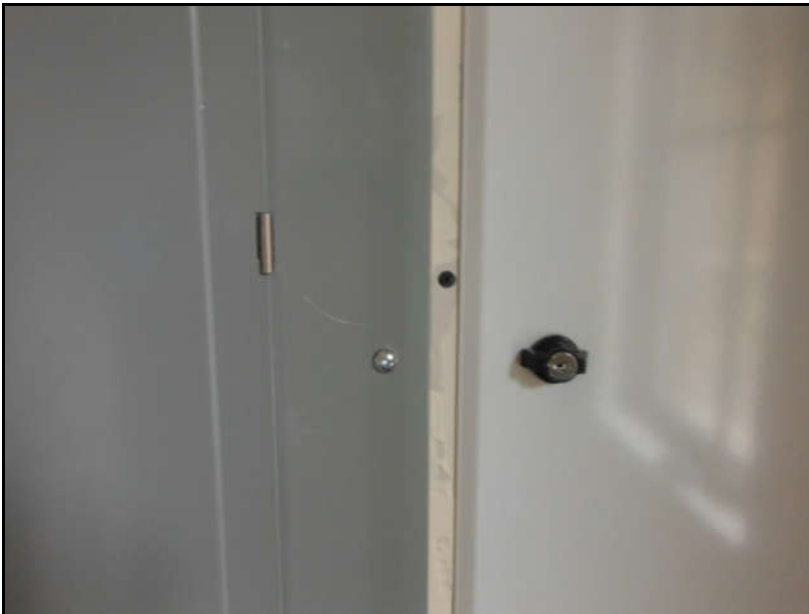
- j. The wall surfaces between the data communications panel and the circuit breaker panel are unfinished, as exemplified in the following photo.

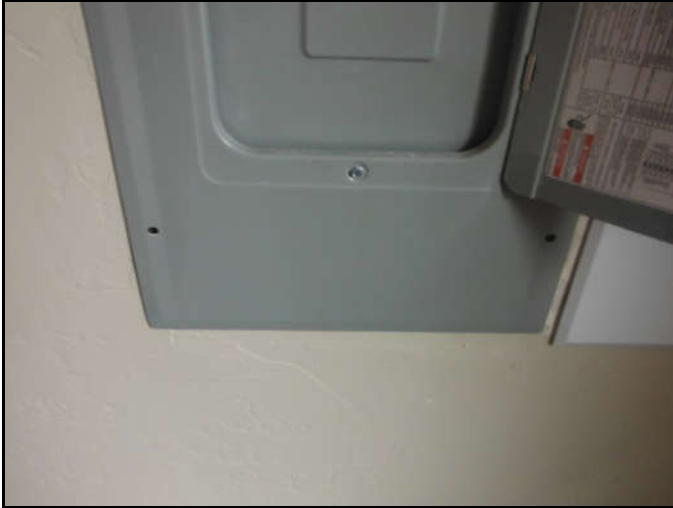
- k. The two lower corner fasteners are missing from the circuit breaker panel cover, as shown in the following photo.

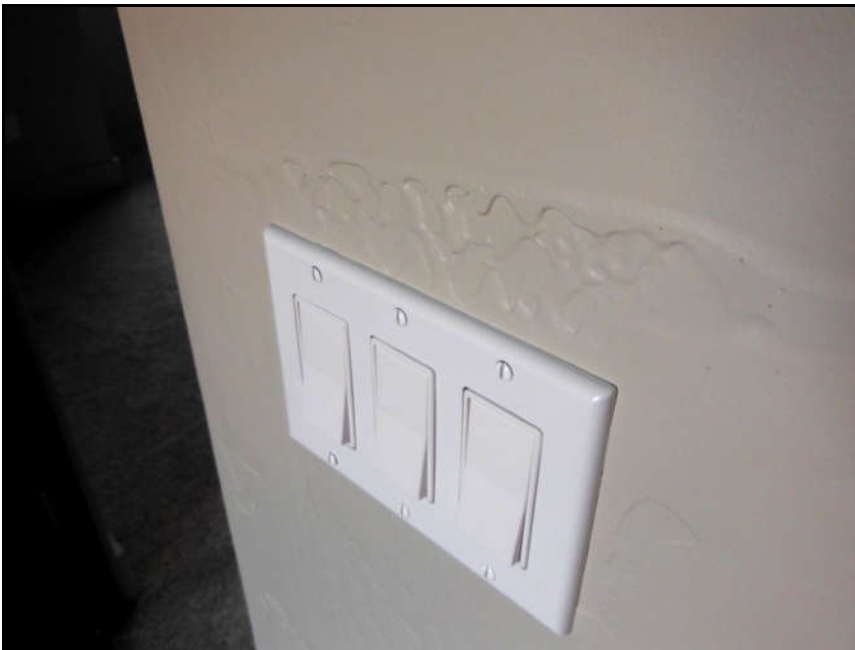
- l. The laundry closet door rubs against its hinge jamb weather stripping, intermittently, preventing it from latching.
- m. What appear to be some heavy texture drips are visible in the wall of the upstairs bathroom electrical triple-gang switch box, as shown in the following photo. Although cosmetic, it is quite noticeable.

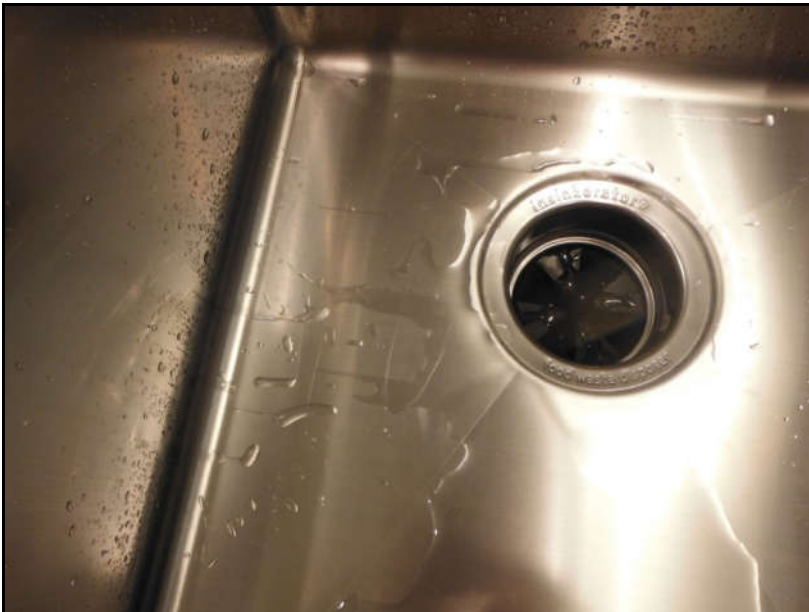
- o. The upstairs rear room entry door from the hallway impacts the strike plate when closing. This causes it to rub against the metal.
- p. Heavy scratches are visible in the basin of the stainless-steel kitchen sink, as exemplified in the following photo.

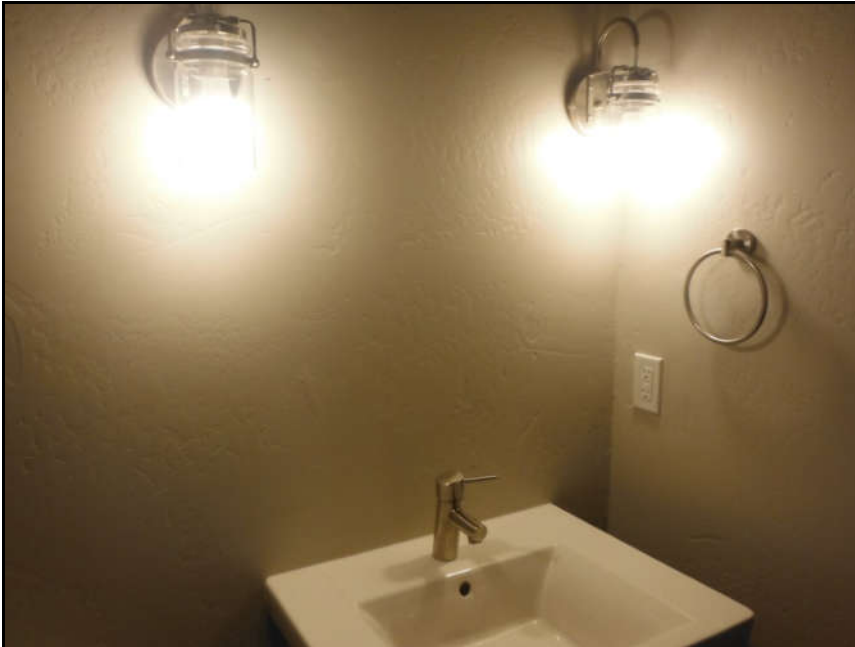
q. The half bathroom vanity mirror has not yet been installed, as shown in the following photo.

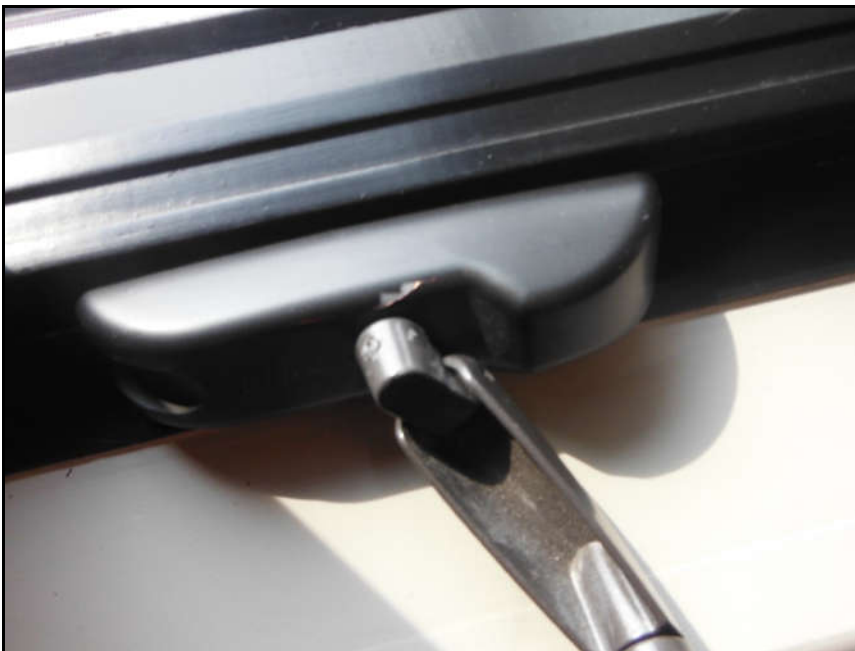
r. The veneer coating for the casement window crank outside the master bedroom door is scratched, as shown in the following photo.

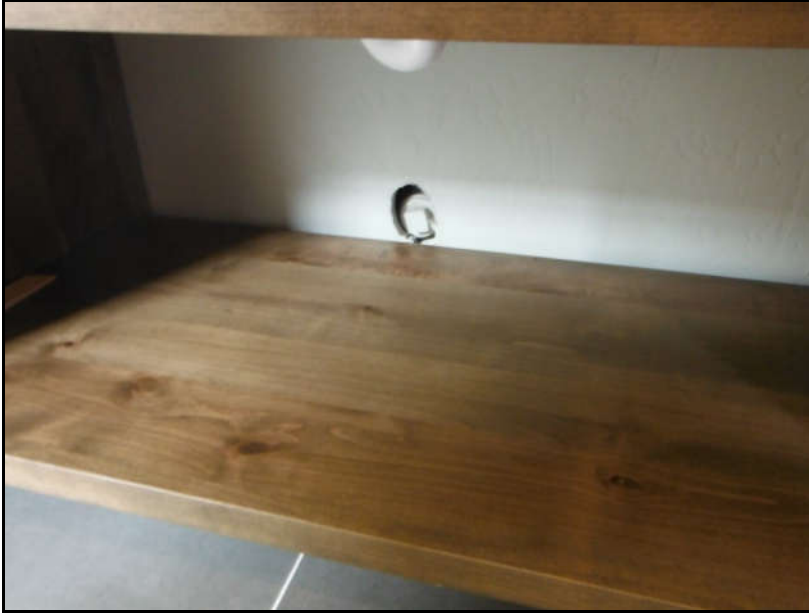
- s. Covers have not been placed over the plumbing cleanouts beneath the master bathroom vanity sinks, as exemplified in the following photo. While these are not required, many homeowners choose to cover them.

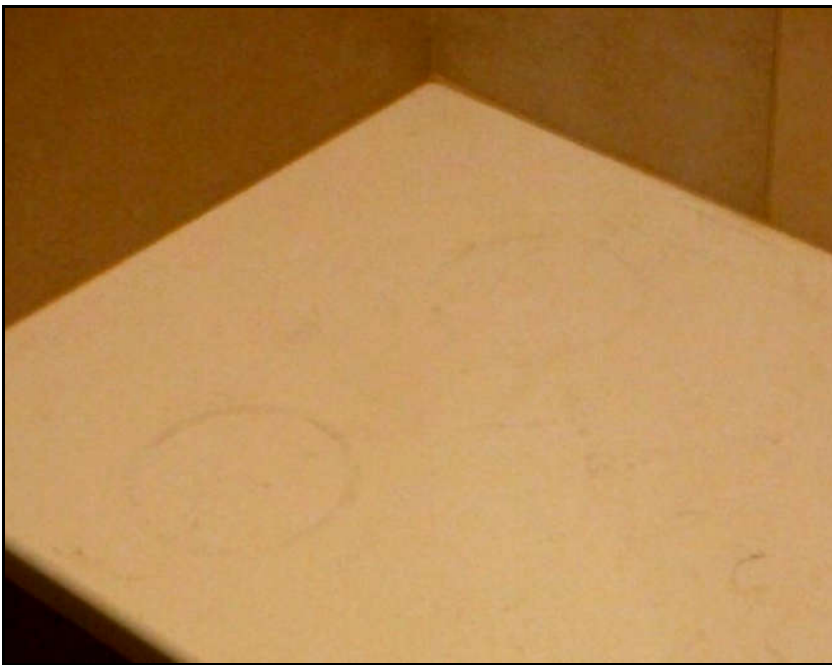
- t. Some circular stains are visible on the bench seat in the master shower, as exemplified in the following photo.

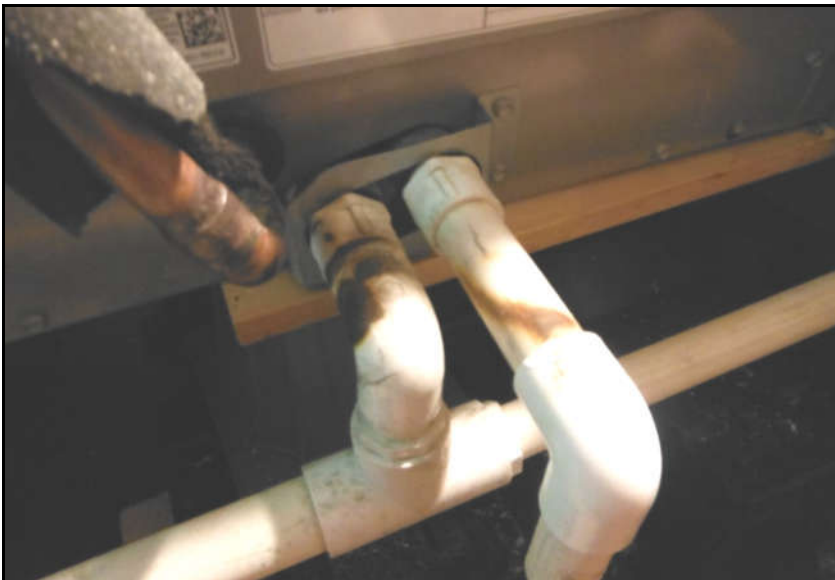
- v. Heat-caused discolorations from a soldering torch were noted on some of the white PVC plastic condensate drain piping adjacent to the evaporator coil cabinet of the HVAC equipment, as shown in the following photo. However, this is only a cosmetic concern.

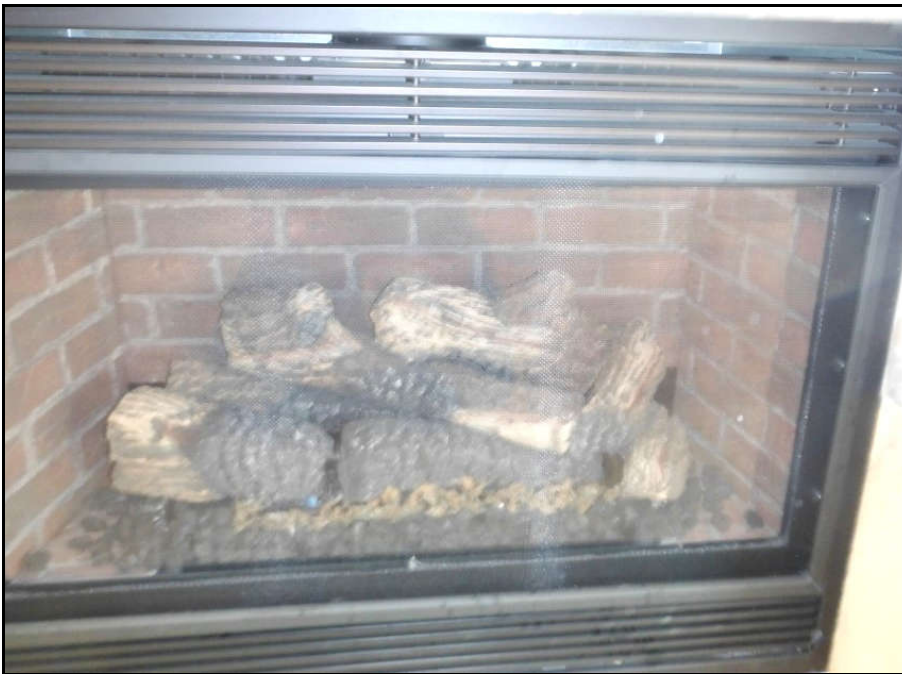
- x. The viewing panel is a little crooked at the top right corner of the fireplace, as shown in the following photo.

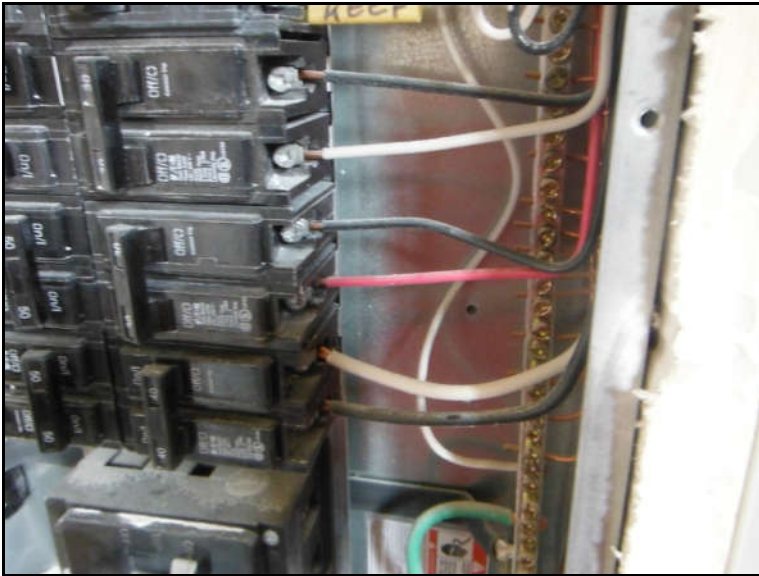
- White conductors have been used to carry current to the water heater and air conditioning circuit breakers in the main distribution panel, as shown in the following photo. It is my understanding of typical electrical practice that white conductor insulation is reserved for neutral conductors, only. (Additionally, a white conductor carries current to a 20-amp, single-pole breaker labeled, “heat tape” for the garage gutter.) I suggest involving a licensed electrician.
