AAD Inspection Corp.

Inspection Date: February 14, 2006

Re: COMMERCIAL INSPECTION
2720 W., IDAHO STREET, BOISE, ID

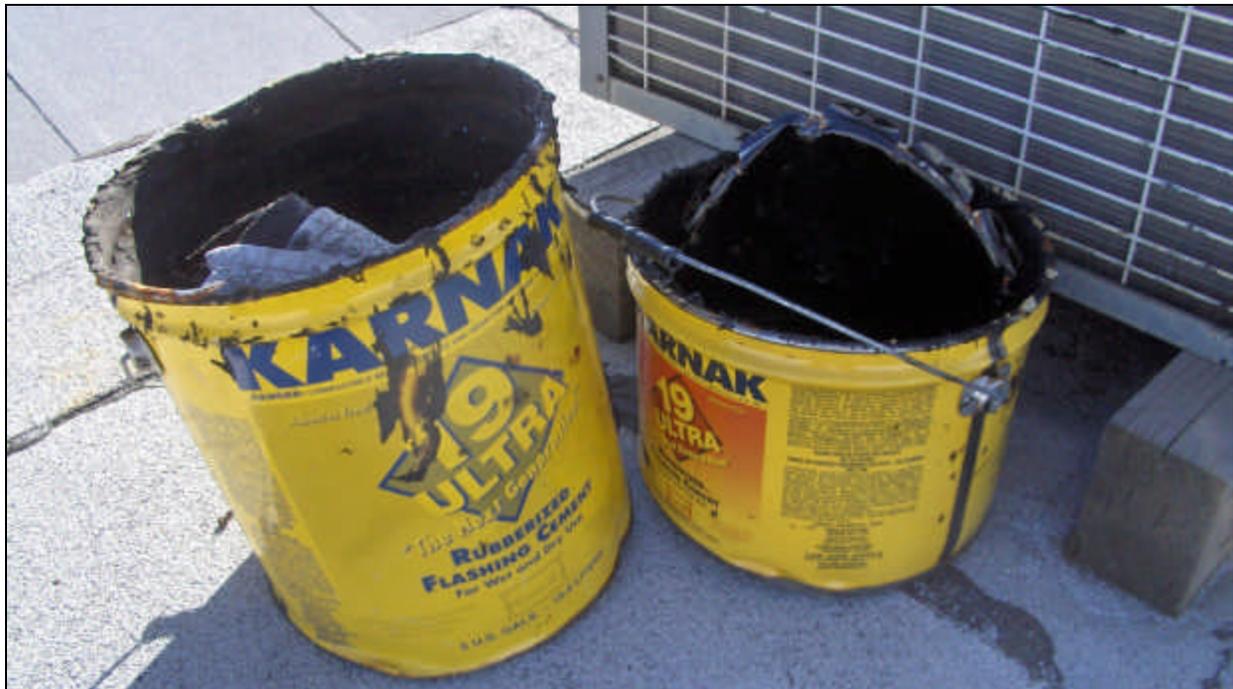
It appears that someone other than a qualified roofing contractor may have been applying roof patching compounds to the numerous places on all the rooftops. This type of application often reduces the effectiveness of subsequent roof maintenance and increases the costs for roofers to make more appropriate repairs, later. (The following photo shows the patching compounds that were likely used most recently.)

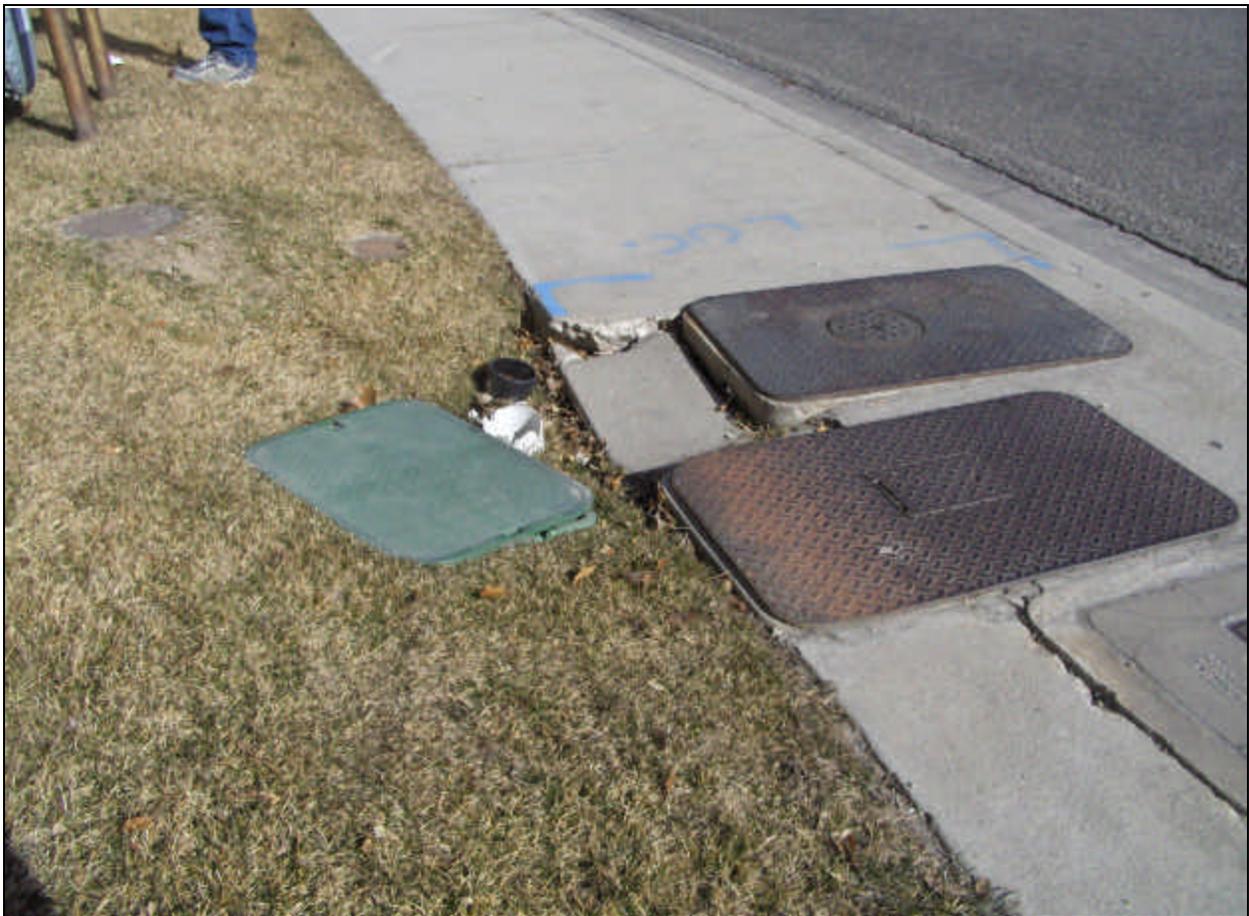
The sidewalk along the east side of the building has a sunken area near the sprinkler system's buried irrigation boxes. This area constitutes a tripping hazard for the general public. I strongly recommend removing this hazard as soon as practical.
