Home Inspection Report

**123 Any St.
Any Town, ID 86753**

Inspection Date: 07/21/2025

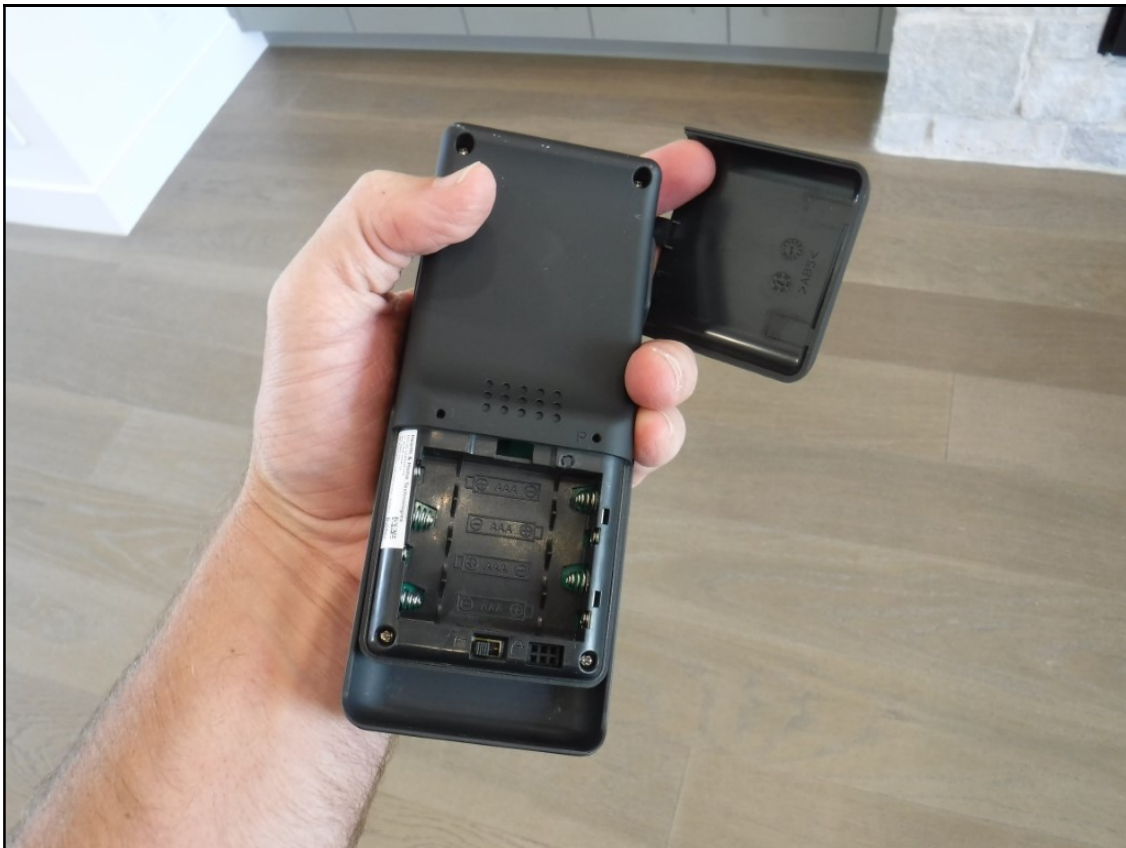
1. The batteries are missing from the remote control for the fireplace, as shown in the following photo.

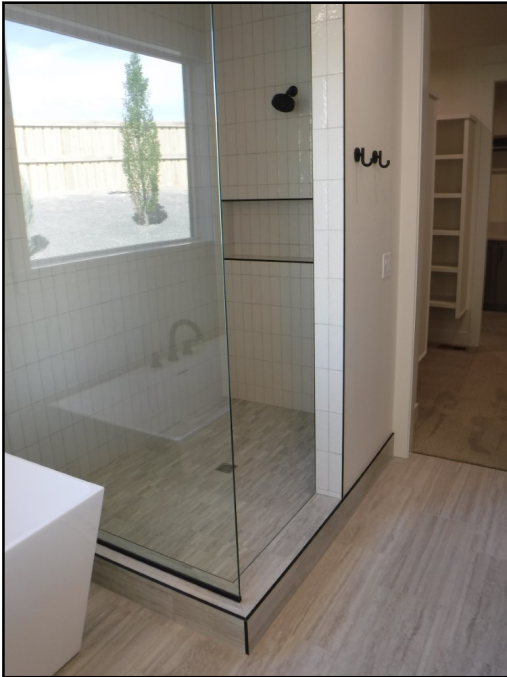
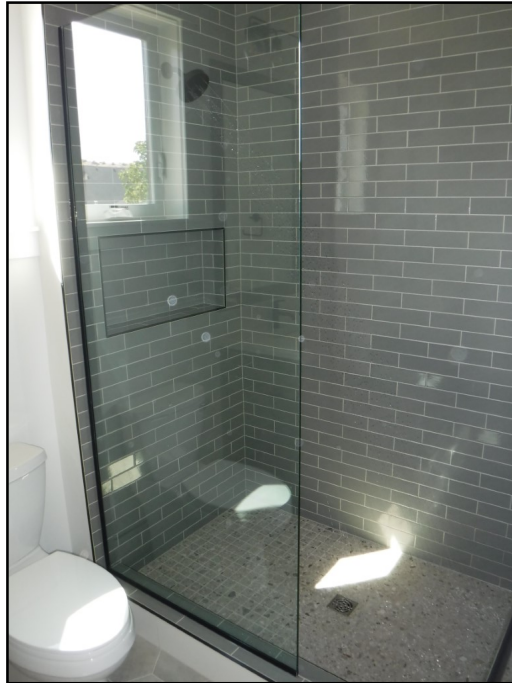
2. Doors have not been installed for the walk-in showers in the master bathroom and front left guest bathroom, as shown in the following photos.

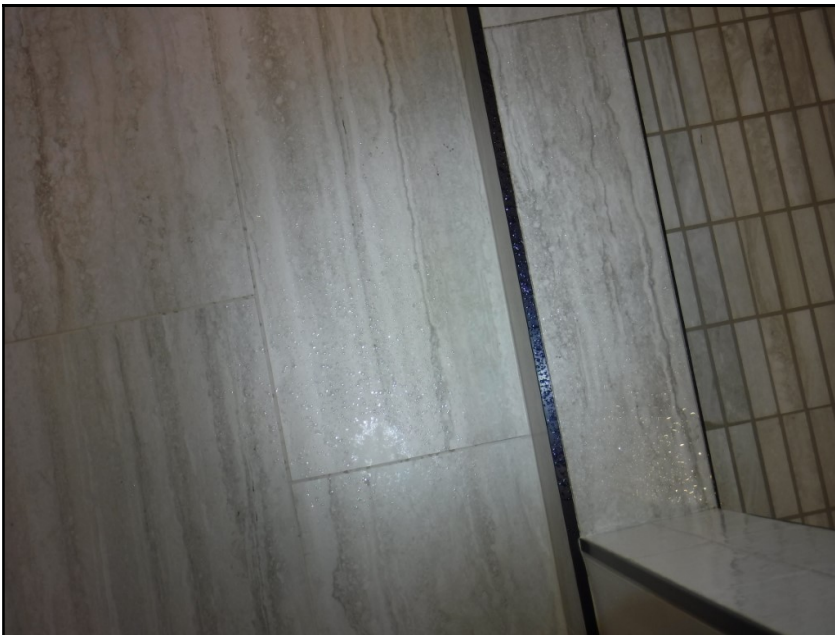
This causes water to easily splash onto the adjacent thresholds and floor surfaces, as exemplified in the following photo.

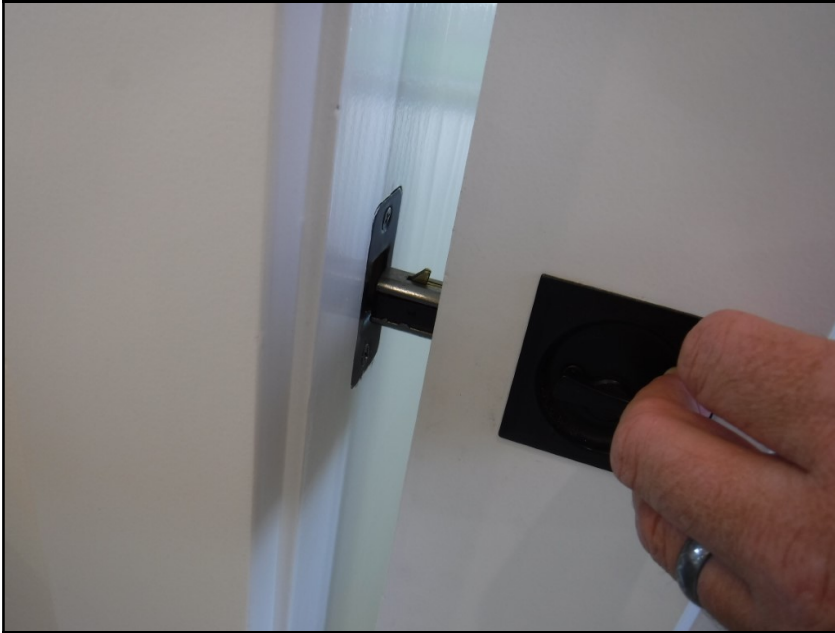
3. The pocket door between the master bedroom and master bathroom is stiff to fully close. Perhaps adjustments could be made. Additionally, the latch bolt does not catch on the strike plate while in the locked position, as shown in the following photo.

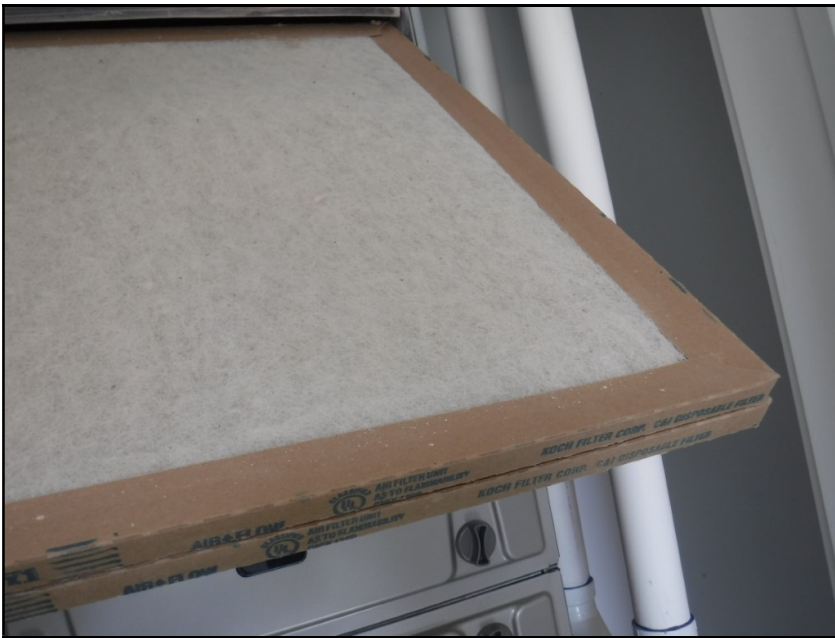
4. The air filters were dirty, as shown in the following photo.

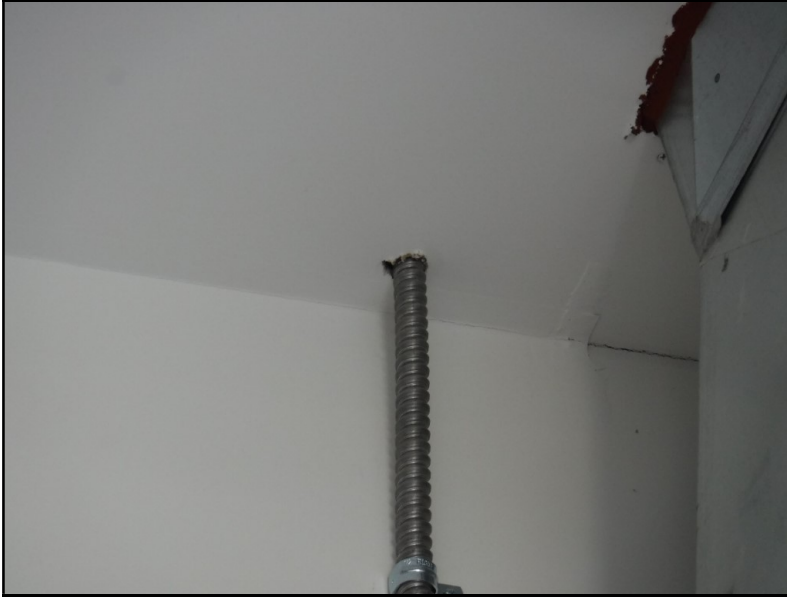
5. Fire-rated caulking has not been applied around a sheetrock penetration for conduit near the furnace in the garage, as shown in the following photo.

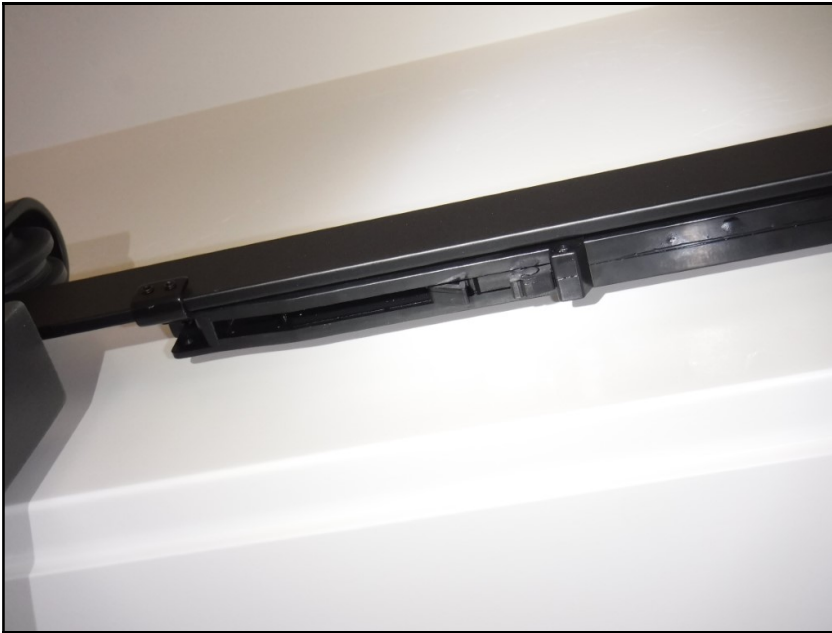
6. The barn-style sliding door at the entry to the front office includes soft-close hardware, as shown in the following photo. However, this hardware does not reset when the door is closed. Therefore, the door does not get caught by the hardware when it is opened (which can knock the stopper loose).

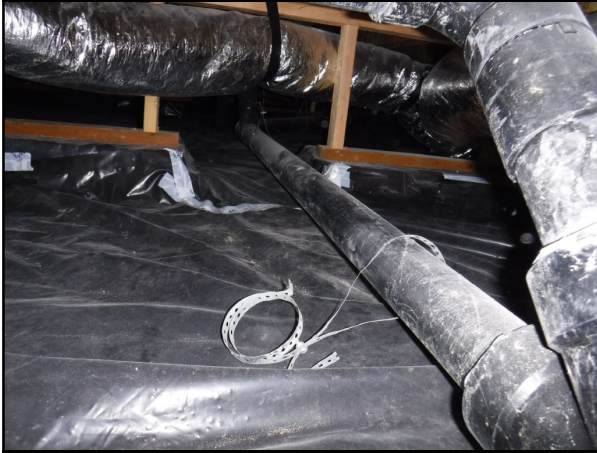
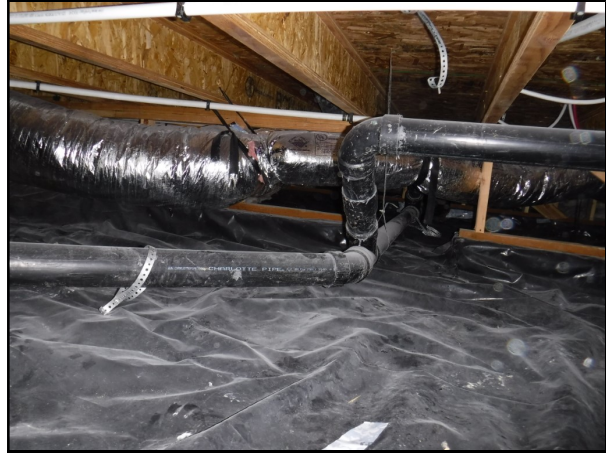
7. One or more steel drain plumbing straps are disconnected in the crawl spaces under the home, as exemplified in the following photos.

These straps should be securely in place at least every 4 feet to adequately support the horizontal runs of the drain piping in order to help eliminate sags that could eventually trap solids and cause blockages. (The horizontal runs of drain piping should always slope between $\frac{1}{4}$ and $\frac{1}{2}$ inch per foot towards the collection system.)

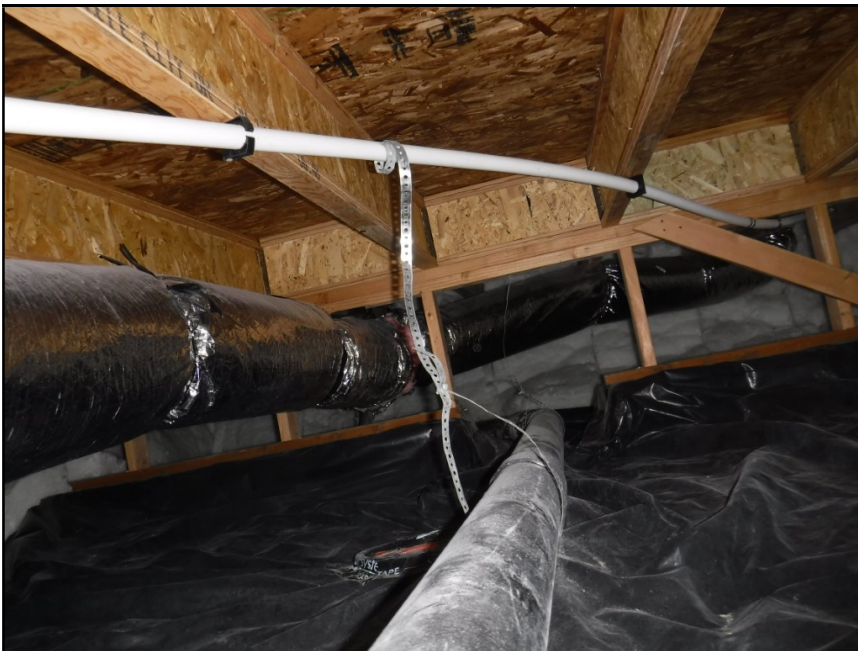
Additionally, at least one of the plumbing straps has been attached to a water supply line, as shown in the following photo. This can strain the supply line.

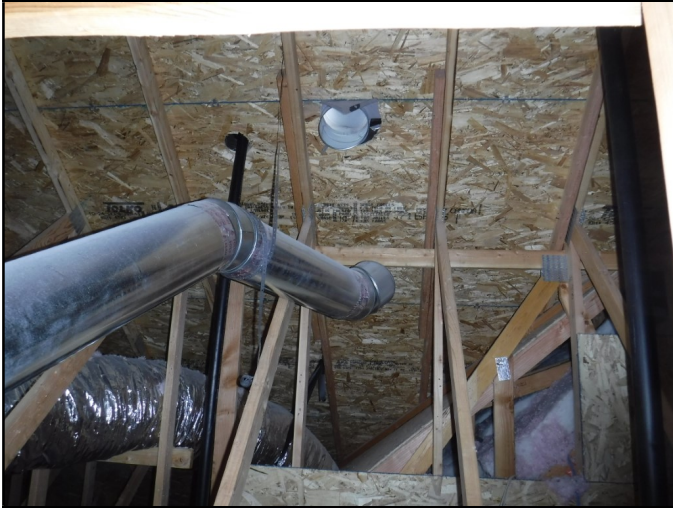
8. The kitchen exhaust duct has come loose from its roof penetration, as shown in the following photo.

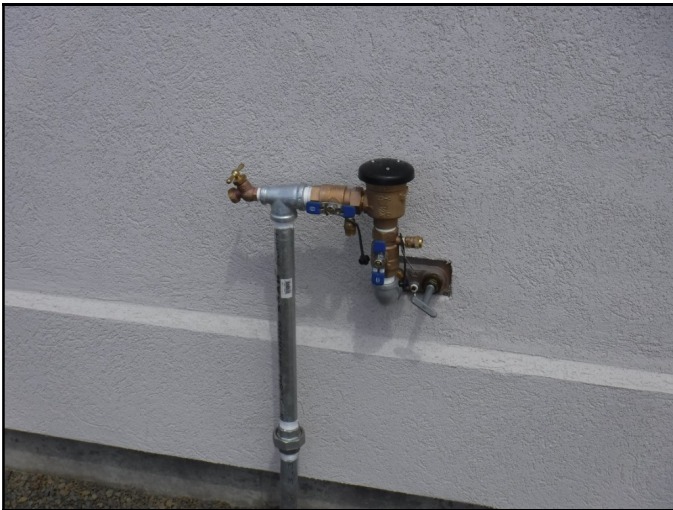
9. The backflow prevention assembly at the left exterior (shown in the following photo) has no current inspection tag on it.

The purpose of this valve assembly is to protect public drinking water systems (including aquifers) from possible cross contamination that could seriously threaten public health. Please understand that there is no “grandfathering” of older valves where public safety is at risk. (NOTE: Although state code requires annual reinspection of these valves by certified backflow prevention inspectors, many property owners are still unaware of this law and have water systems out of compliance.)

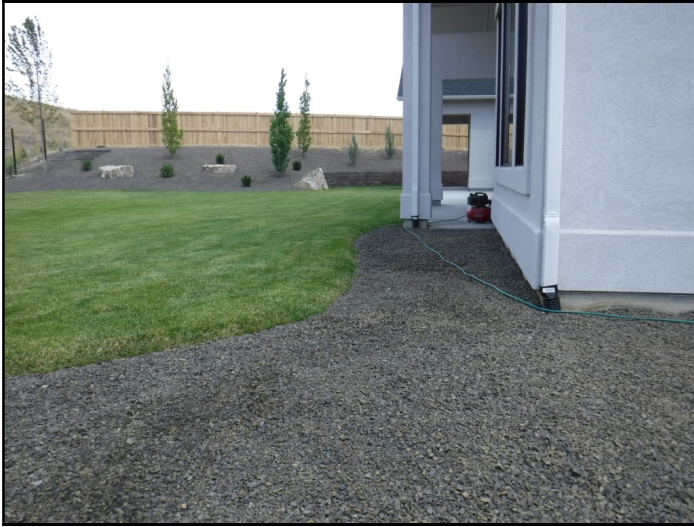
10. The overhead garage door opener for the RV bay initially failed to open when I pressed the button near the interior-to-garage door. The digital display indicated an "Excessive Force" error. Every subsequent testing of the door and the button was successful.
11. The grading in a few areas is insufficiently sloped to ensure that roof runoff, direct precipitation, or irrigation water will be able to flow successfully away from the foundation quickly enough to avoid infiltration into adjacent below-grade spaces, as exemplified in the following photo.

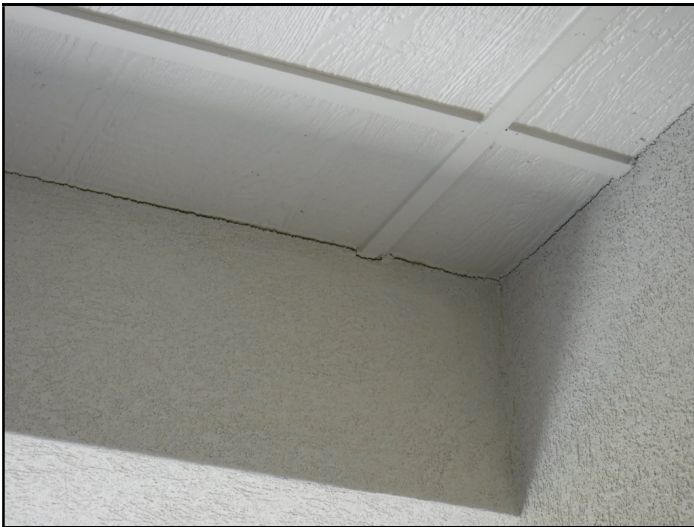
12. I noted a small gap where the stucco meets the ceiling of the rear patio, as exemplified in the following photo.

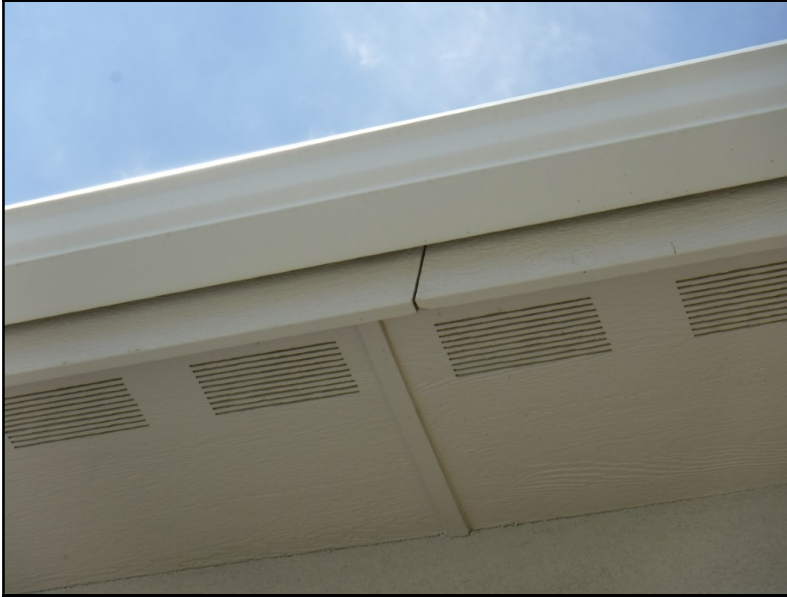
13. Caulking and paint has not been applied to some of the fascia seams around the home, as exemplified in the following photo.

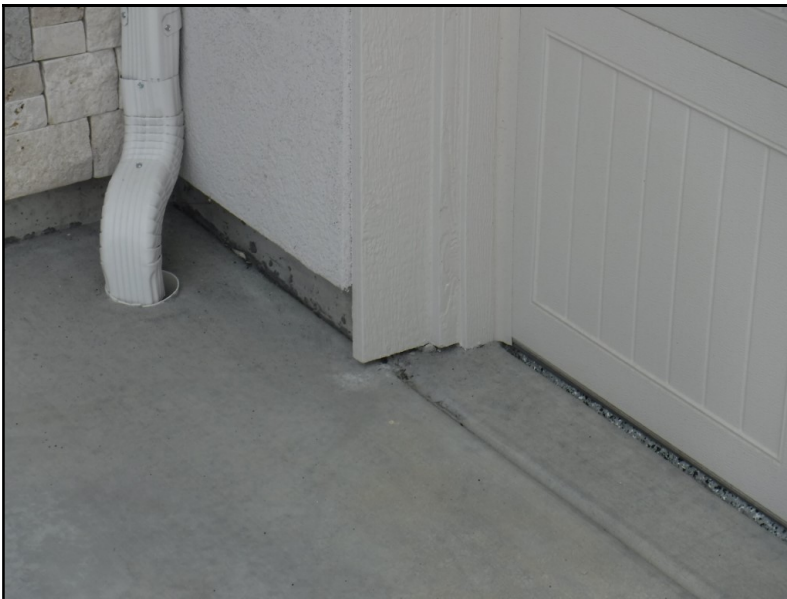
14. One or more wooden overhead vehicle doorjambs, as exemplified in the following photo, are contacting or nearly touching the concrete driveway slab. This can encourage moisture to wick up into the wood and/or be subject to damage due to frost upheaval of the driveway. All decayable building materials should be held at least 1 inch above concrete to help prevent such issues.

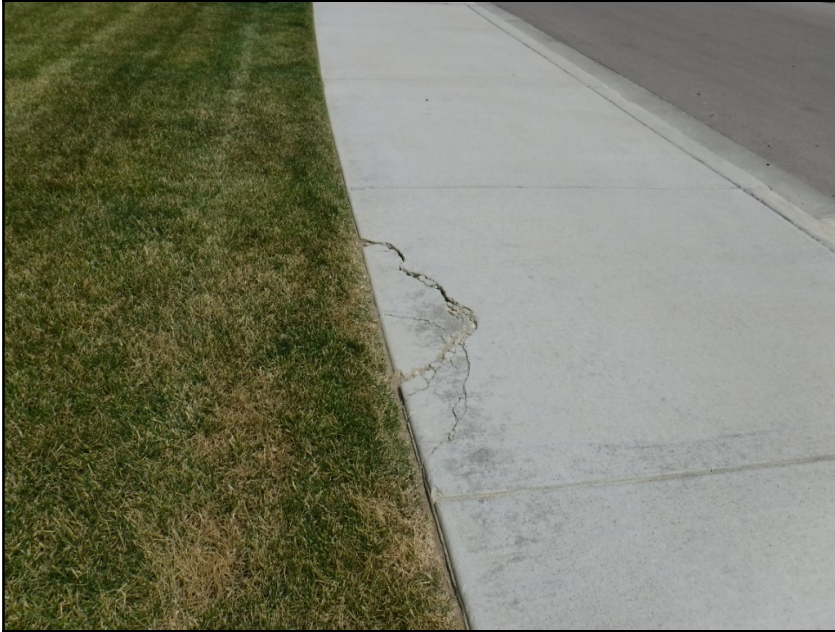
15. I found a cracked and settled area of the concrete slabs for the sidewalk at the front right of the property, as shown in the following photo. This can be a tripping hazard.

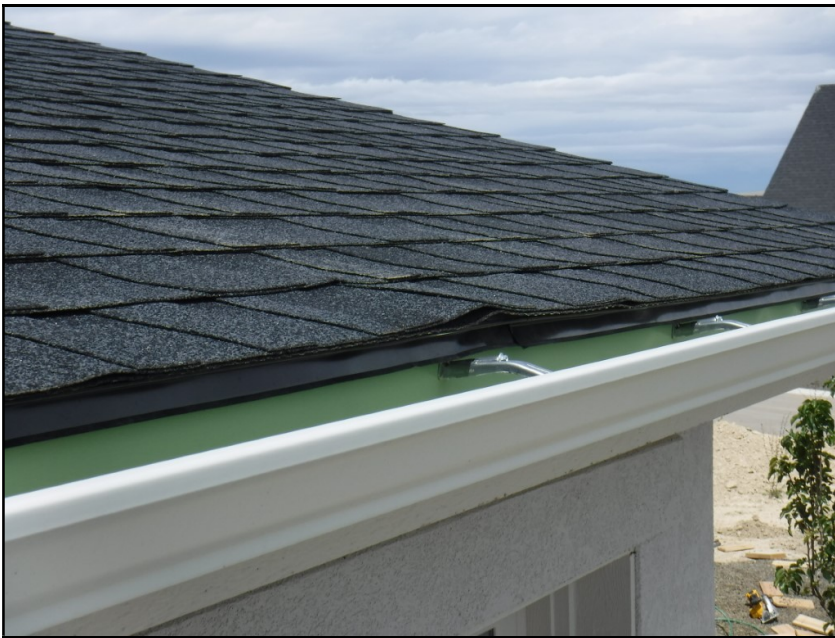
16. A few of the shingles are slightly buckled along the front edges of the roof at the front right of the home, as shown in the following photo.

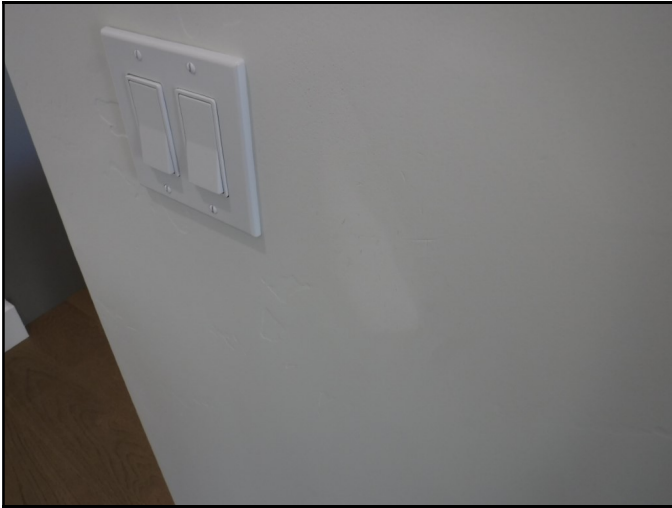
- a. Several interior sheetrock and trim surfaces have already been patched and/or applied with touch-up paint, as exemplified in the following photo. These areas will be more visible at varying times of the day, as light catches them from different angles.

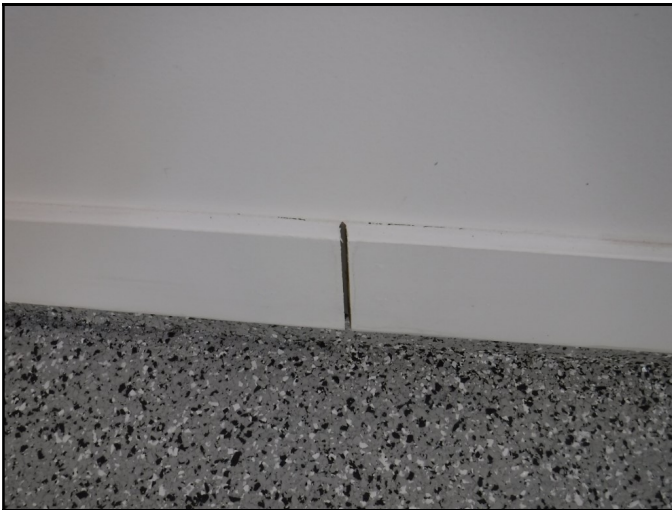
- b. I found a 1/4-inch gap in the baseboard molding at the right interior of the garage, as shown in the following photo.

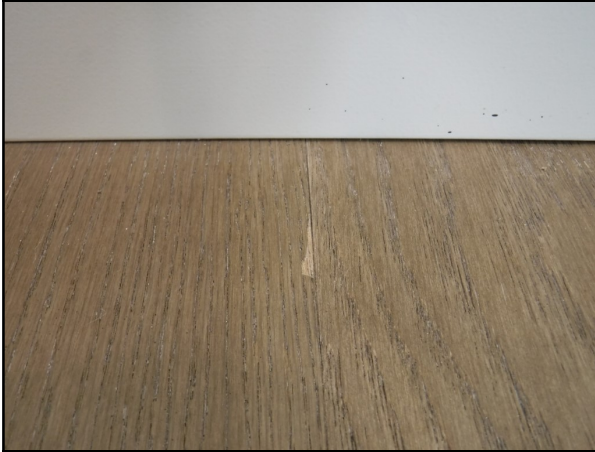
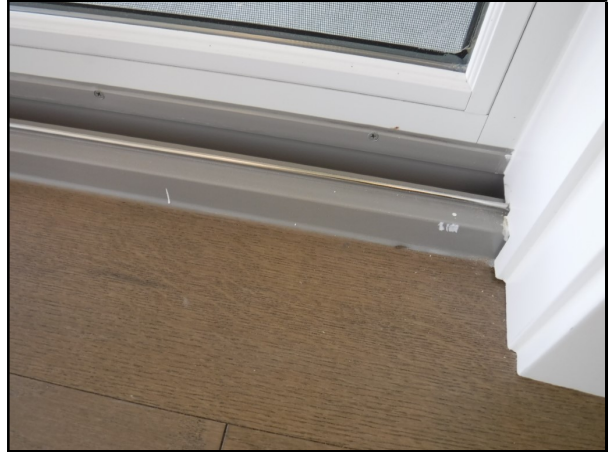
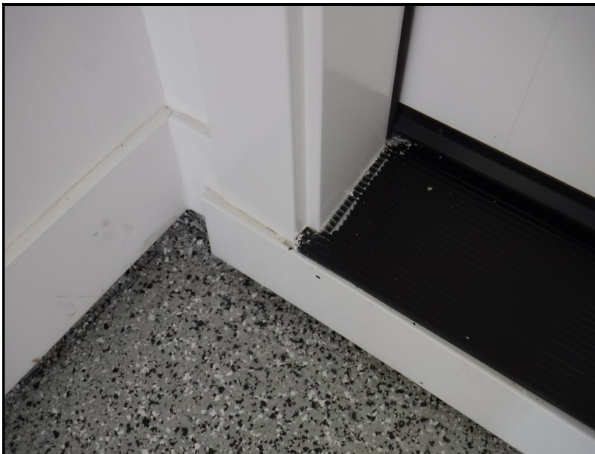
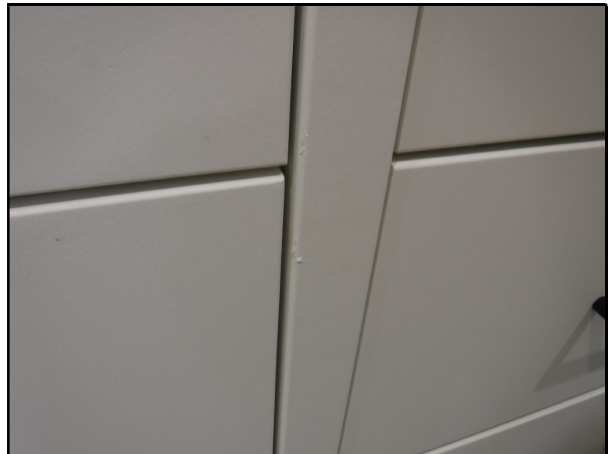
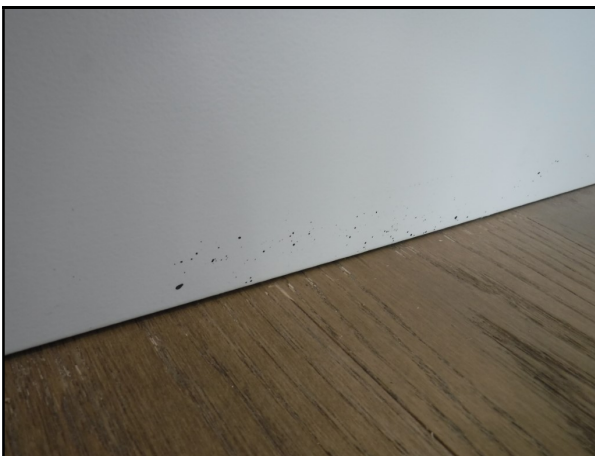
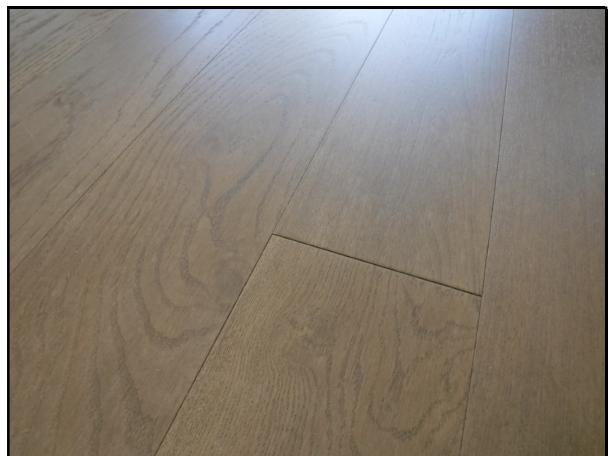
- c. The interior surfaces of this property have less than the typical amount of blemishes, scratches, dents, scuffs, or dings that may require repair in order to present the best possible visual appearance, as exemplified in the following photos.

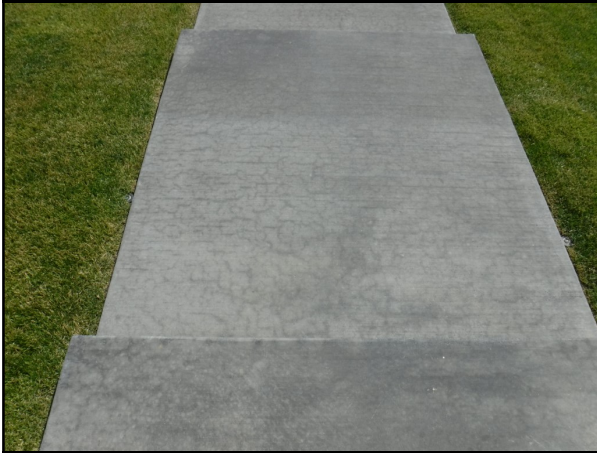
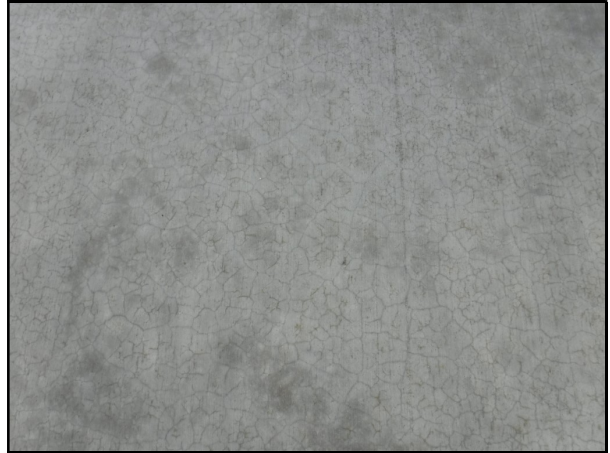
- d. The concrete slabs of the driveway and front entry sidewalk have already started to develop spalling and crazing patterns, as exemplified in the following photos. Additionally, the coloration of the concrete is inconsistent. However, this is only a cosmetic concern.

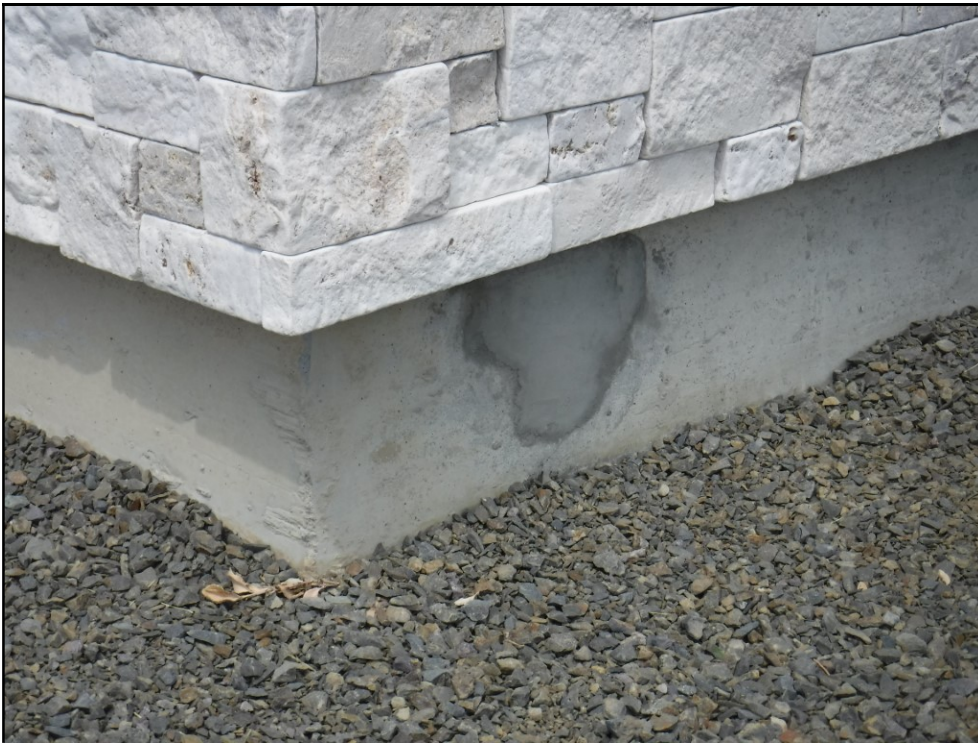
- e. The exterior side of the foundation has been patched in a few areas, as exemplified in the following photo. This is typically done where the hold-down straps are installed.

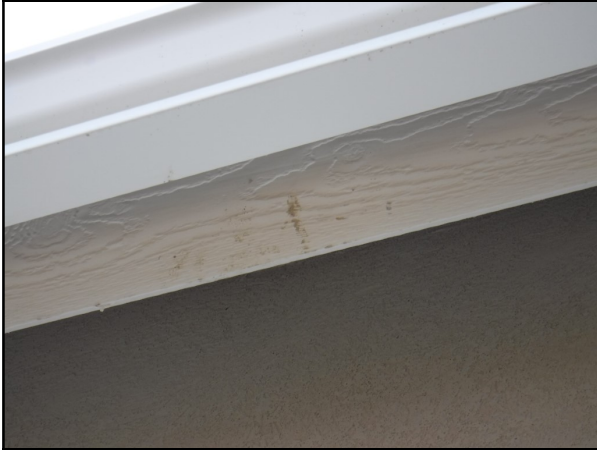
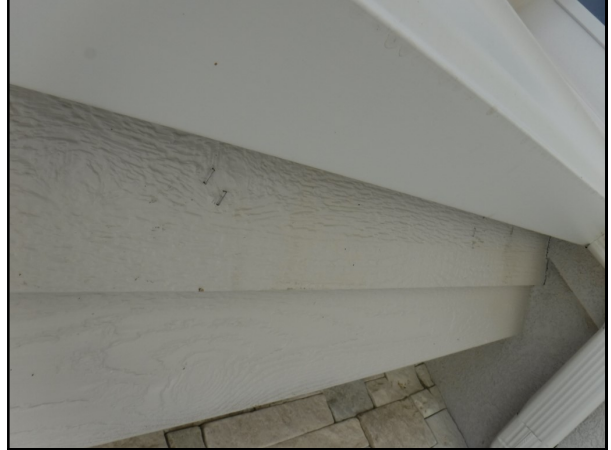
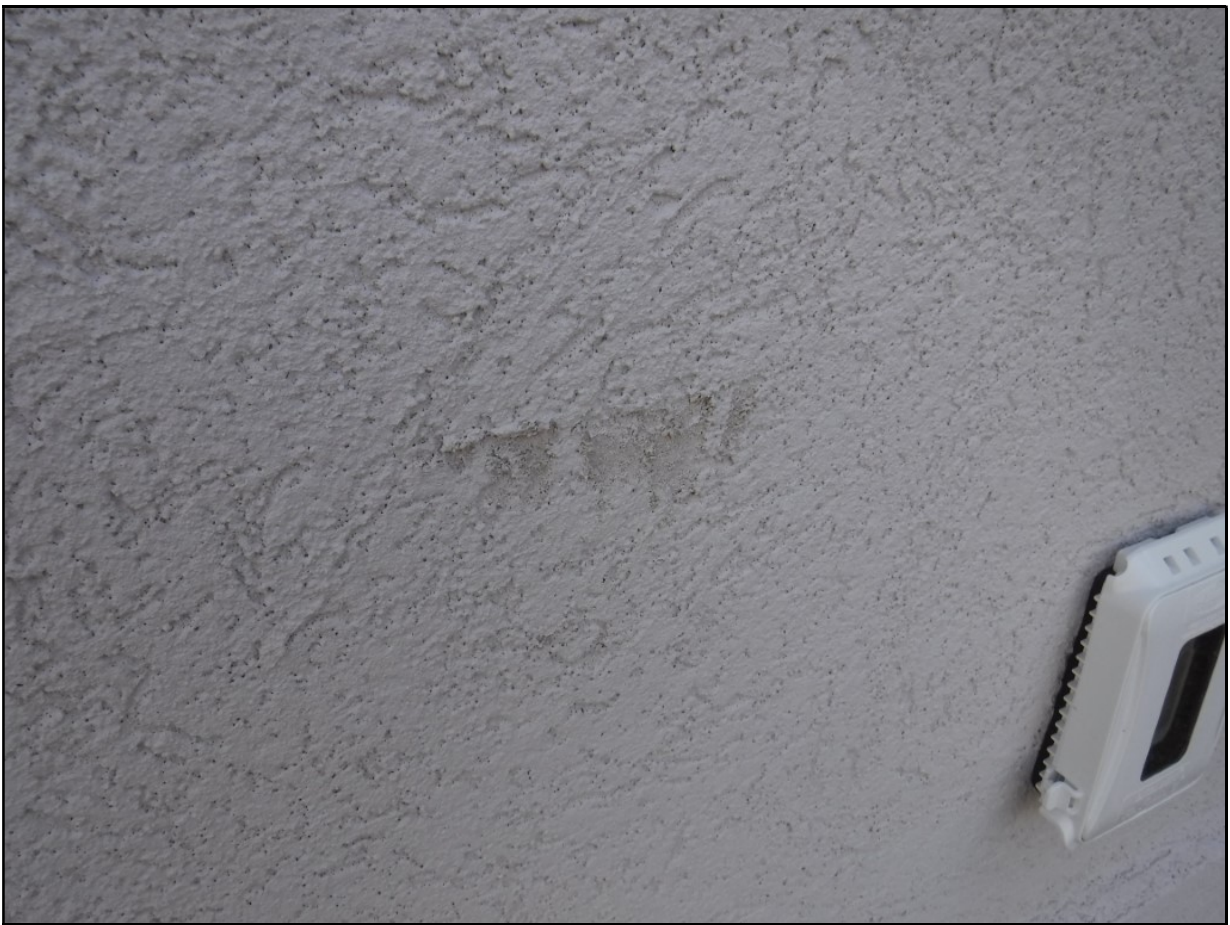
- f. The exterior surfaces of this property have less than the typical amount of blemishes, scratches, dents, scuffs, or dings that may require repair in order to present the best possible visual appearance, as exemplified in the following photos.

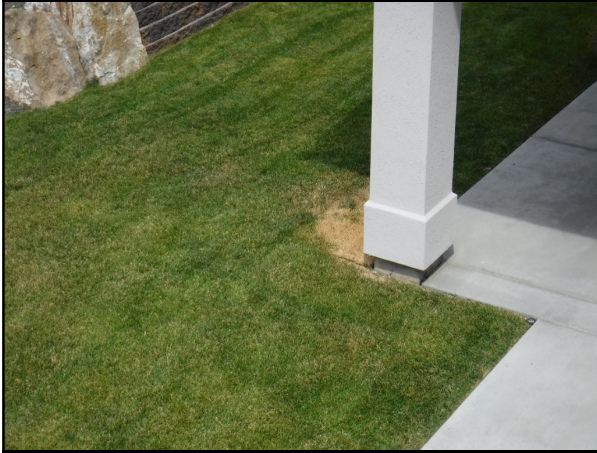
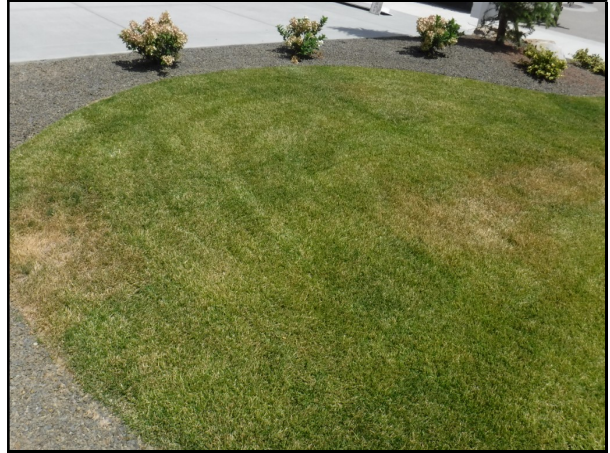
- g. I found a few patches of dead or dying grass near the back patio and in the front yard, as shown in the following photos. However, this is only a cosmetic concern.

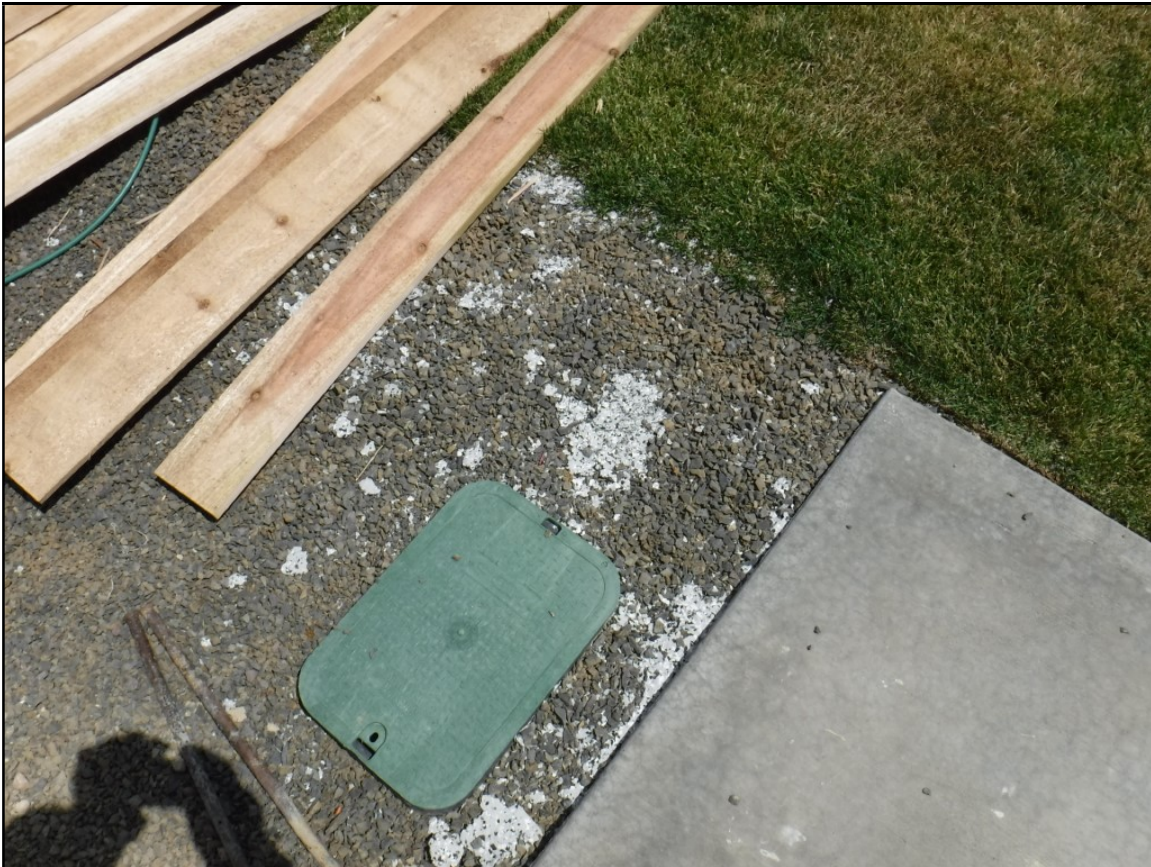
- h. I found multiple epoxy flakes on the landscaping rock to the right of the garage, as exemplified in the following photo.

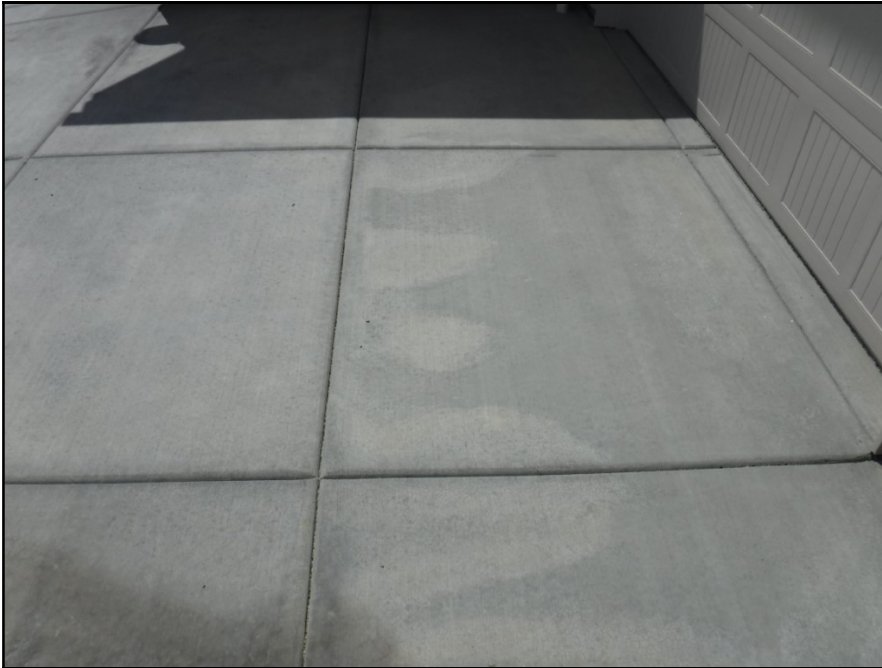
- i. I found a few stain patterns on the concrete slabs at the rear right of the driveway, as exemplified in the following photo.

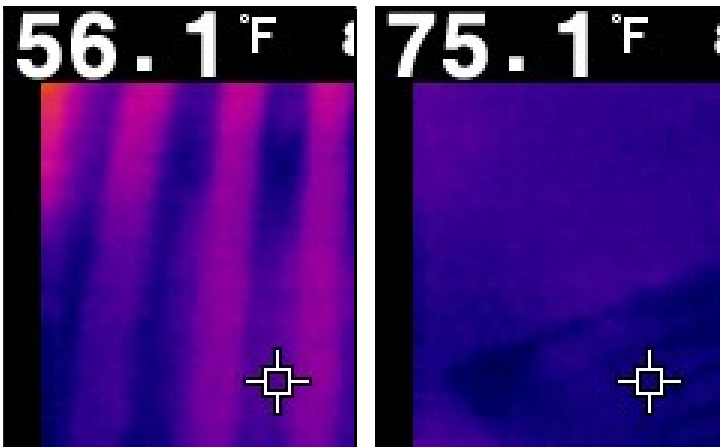
- After running the air conditioner for more than 10 minutes, I measured a cooling effect differential of 19 F° between feed-air and return-air registers close to the air handler, as shown in the following photos. (*Cooling effects outside the range of 17 to 22 degrees are usually considered “problematic” and warrant the attention of a licensed HVAC contractor.*)

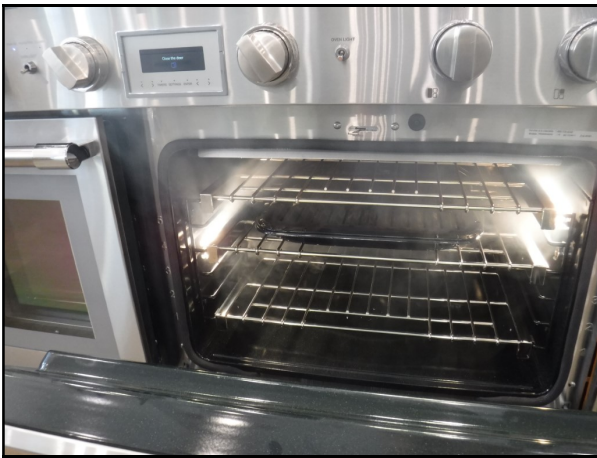
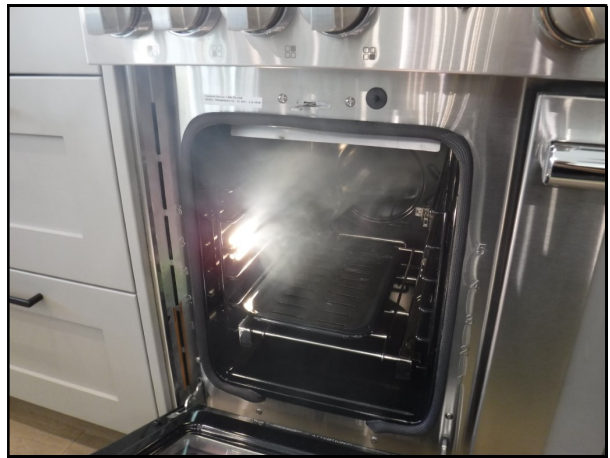
- Smoke emitted from the kitchen range during normal use of bake and broil, as shown in the following photos. This is typically from the protective coating on the interior, which burns away after the first few uses.

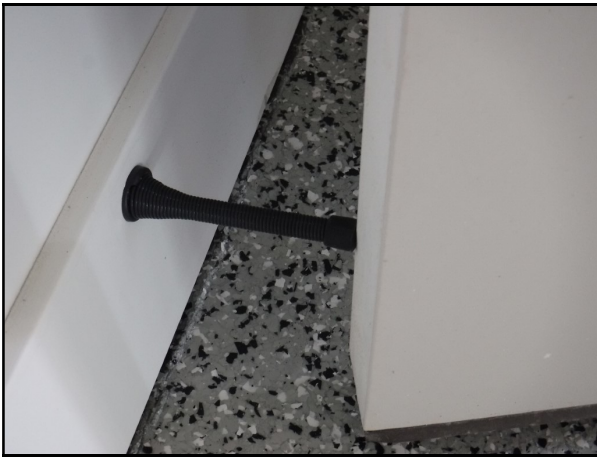
- The precaution of applying matching silicone caulking in all bathrooms and laundry rooms or kitchens not only along the joints where floor coverings meet the fronts of tubs or showers, but also around their entire floor perimeters can help prevent future water damage. When water gets on floors, it doesn't always stay next to the water sources. This additional precaution is not "required" or "expected" of builders or sellers, but tends to offer extended protection against the possibilities that escaping waters can get under the floor coverings to cause eventual swelling of particleboard underlayments, or cause discolorations of the floor coverings.
- The doorstop for the right garage door barely catches the door, as shown in the following photo.

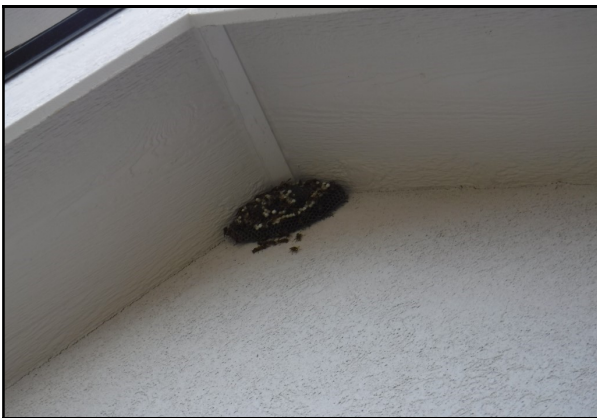
- I found wasps around the exterior of the home, as exemplified in the following photo. Although this is rather typical, the services of a professional pest control contractor could be obtained, if desired.

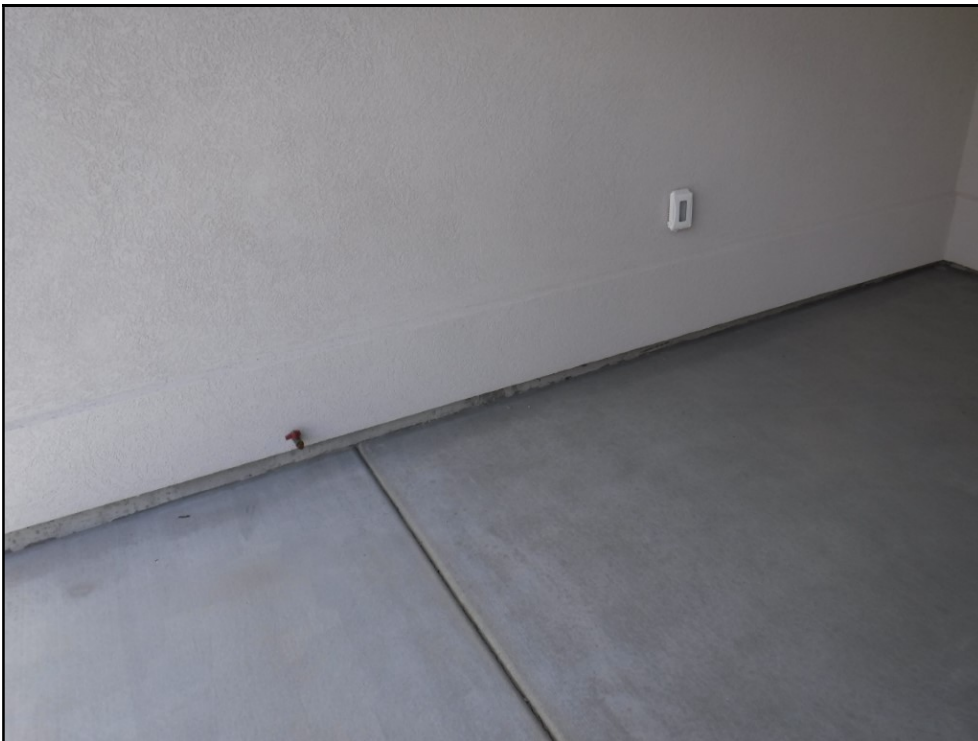
- Gas piping has been stubbed out at the back patio for a possible future barbeque or other outdoor cooking appliances, as shown in the following photo. However, I suggest always keeping a plug or cap in place over the end of the piping (in addition to any other valves or quick disconnects) whenever appliance hoses are not connected.
