AAD Inspection Corp.

Home Inspection Report

**123 Any St
Any Town, ID. 86753**

Inspection Date: 07/15/2025

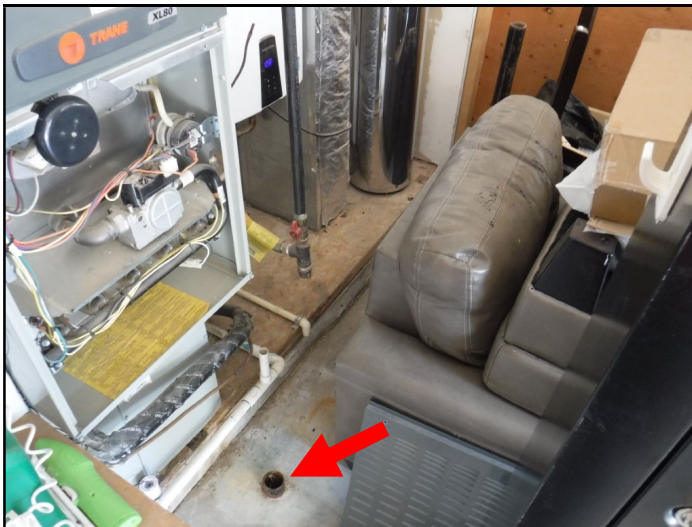
1. The hinge springs of the garage-to-interior door are too weak or have been purposely relaxed. They are no longer effective at maintaining the original degree of fire barrier between the garage and the rest of the structure. The door should be able to self-close and self-latch if released from a fully open position.
2. The bulb failed to illuminate in a ceiling-mounted light fixture at the center of the garage. Perhaps the bulb is burnt out.
3. One of the bollard posts has been removed from the rear interior of the garage (near the furnace), as shown in the following photo. This can increase the likelihood of damage to the furnace from parking vehicles.

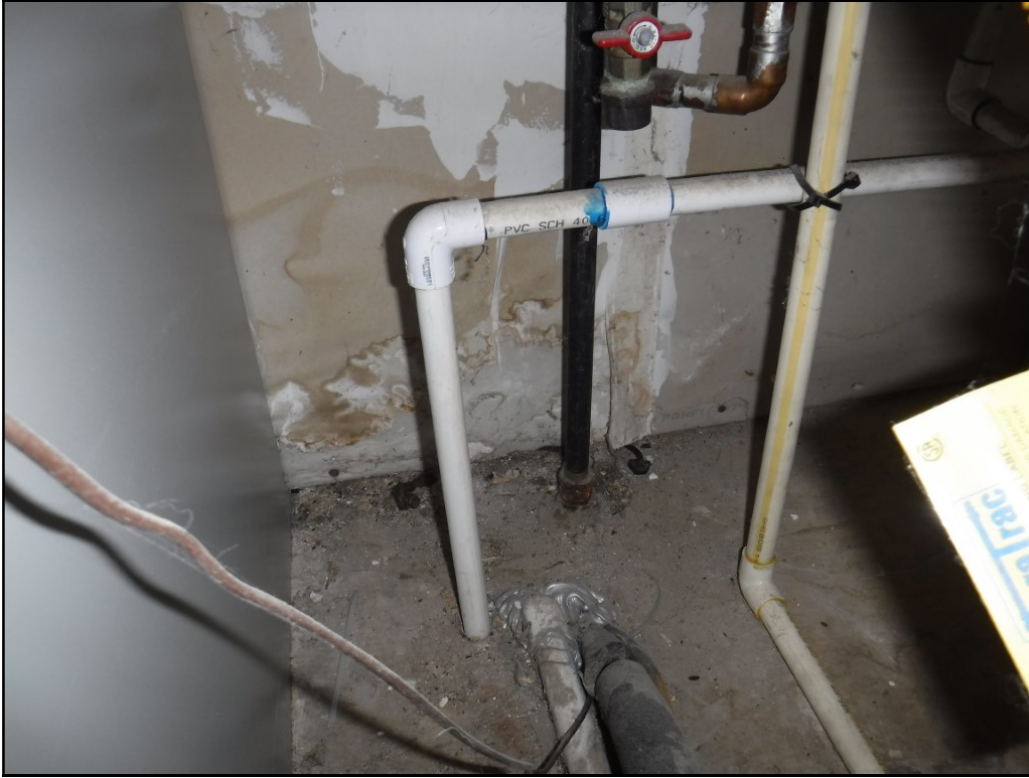
4. I found staining on the sheetrock surfaces under the water heater in the garage, as shown in the following photo. This is likely from past leaking from the previous appliance. I did not find any active leaking at this time.

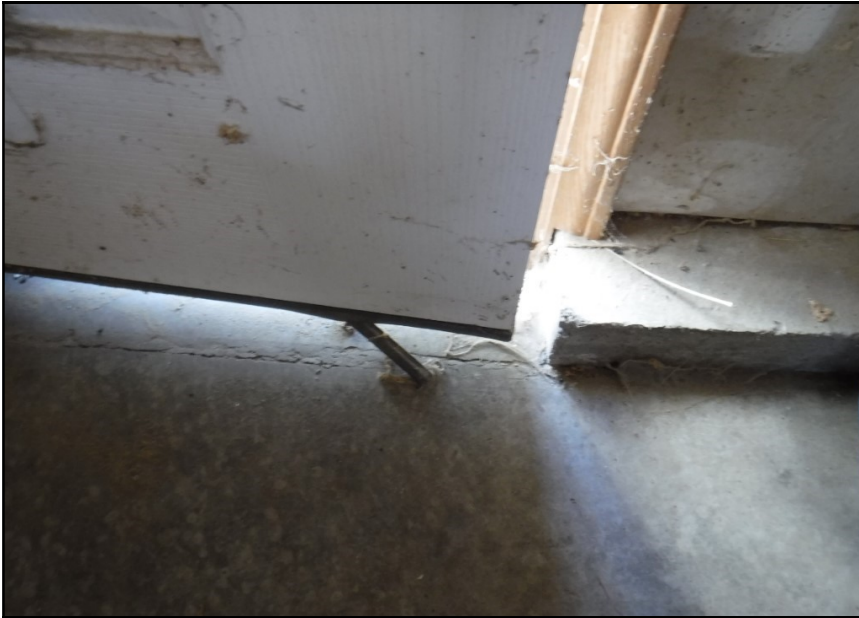
6. The door sweep on the rear garage door is a little tattered, as shown in the following photo.

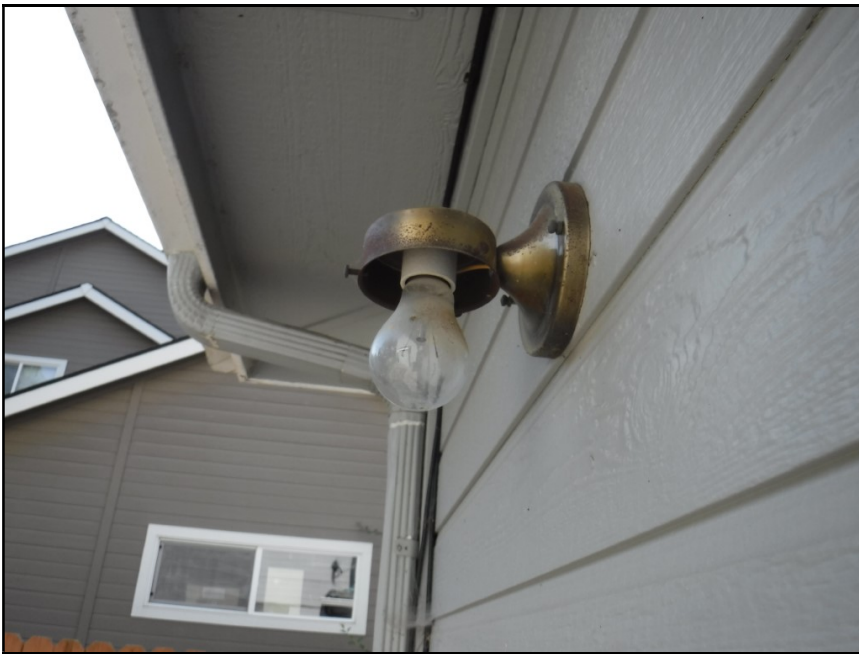
7. The weatherproof cover is missing from the exterior-mounted light fixture at the rear of the garage, as shown in the following photo. Additionally, the bulb for this light fixture appears to be burnt out.

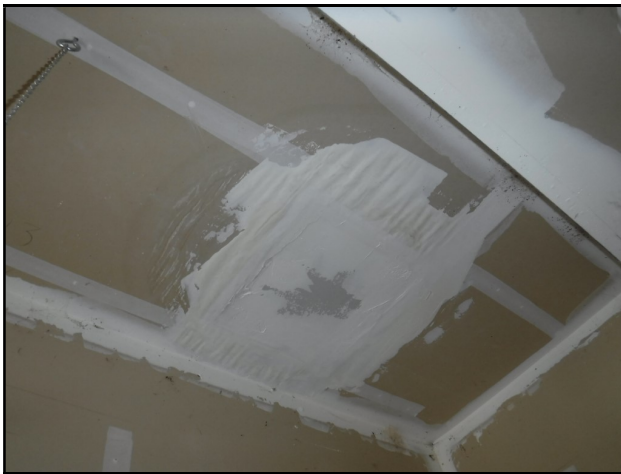
8. The ceiling sheetrock surfaces at the rear right interior of the garage have been patched recently, as shown in the following photos. I could see temperature variations along the seams of the patch, where joint compound is drying. It is my understanding that this area of the garage is underneath the master bathroom. Moreover, the stain patterns around the patched area likely indicate a recent leak repair. I suggest obtaining copies of any applicable receipts from licensed plumbers, for the work performed in this area. It is my understanding that the Buyer's Agent and Buyers were able to see into the unpatched hole prior to this inspection, and by their account, there may be potential microbial growth within the subfloor of this area.

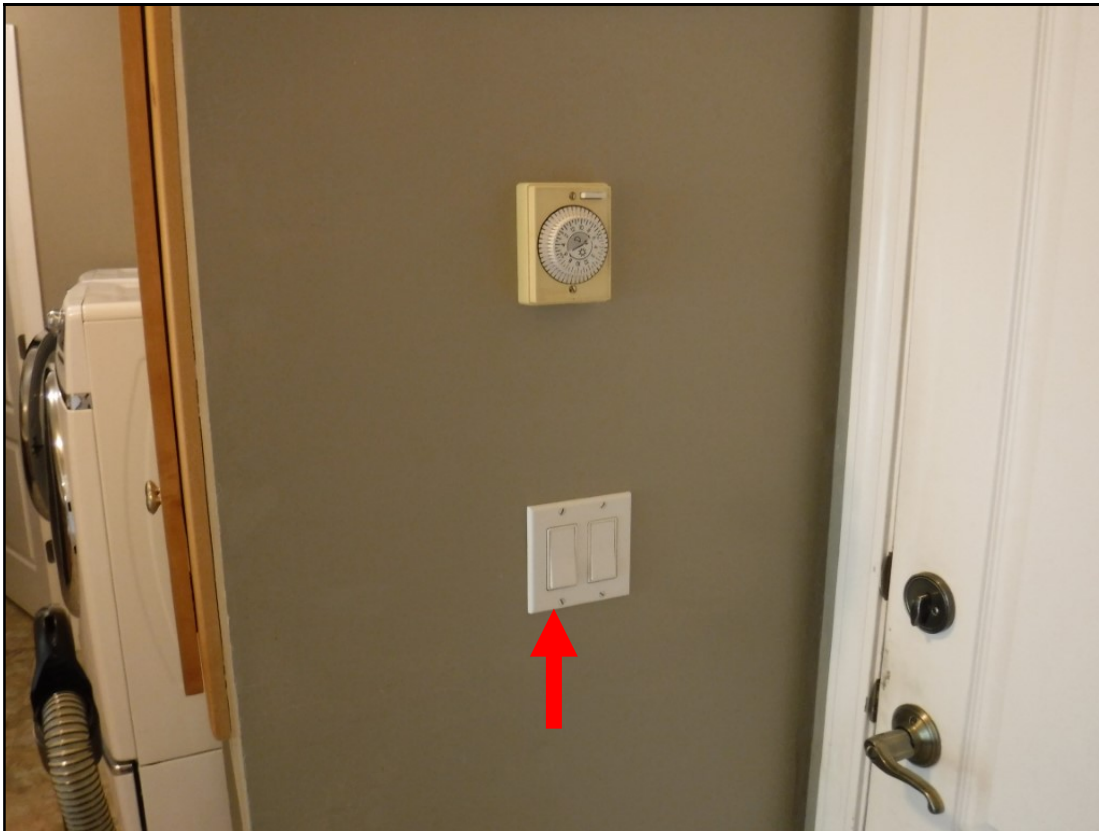
9. The exhaust fan in the laundry room failed to operate during the inspection. The exhaust fan appears to be controlled by a timer, in addition to a light switch near the interior-to-garage door (shown in the following photo).

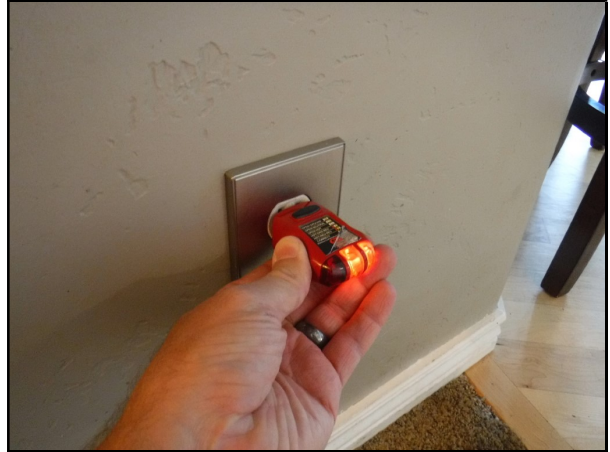
10. The grippers are loose within the duplex outlet receptacles throughout the home, as shown in the following photos. This makes it easier for plugs to back out, and more difficult for prongs to make a solid connection.

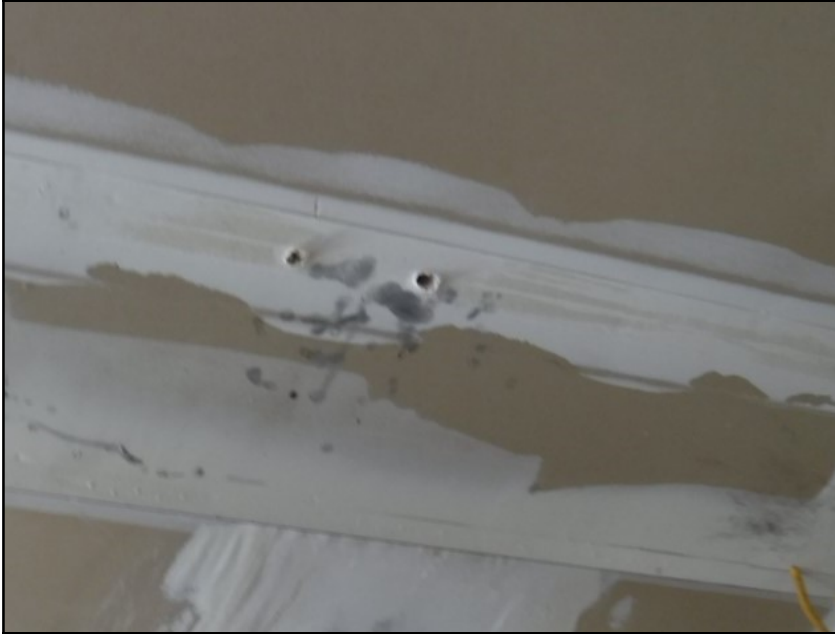
14. I found a few unsealed sheetrock penetrations in the garage, as exemplified in the following photo. This can weaken the fire barrier between the garage and the rest of the home.

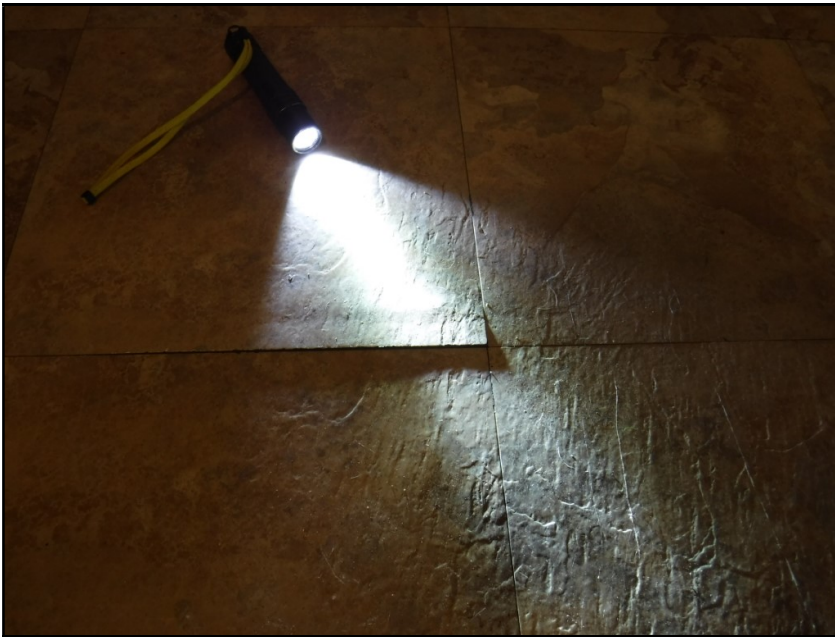
15. One or more floor tiles are loose along their seams in the laundry room, as exemplified in the following photo. These can catch on toes and feet.

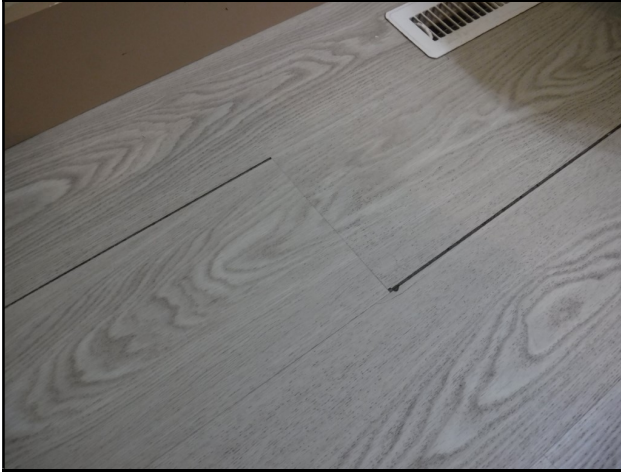
16. I found a couple of subtle gaps along the seams of the floor coverings in the main-floor bathroom, as shown in the following photo.

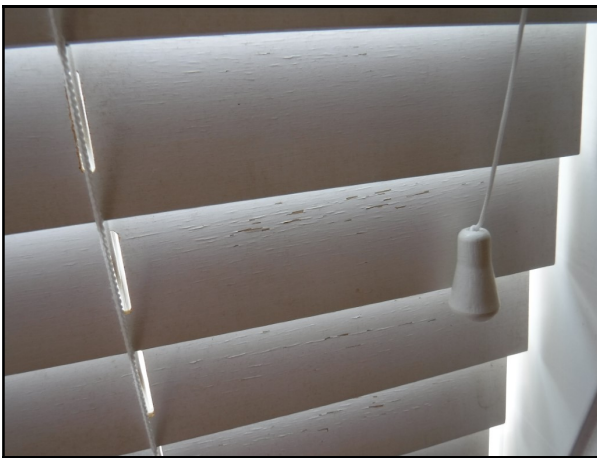
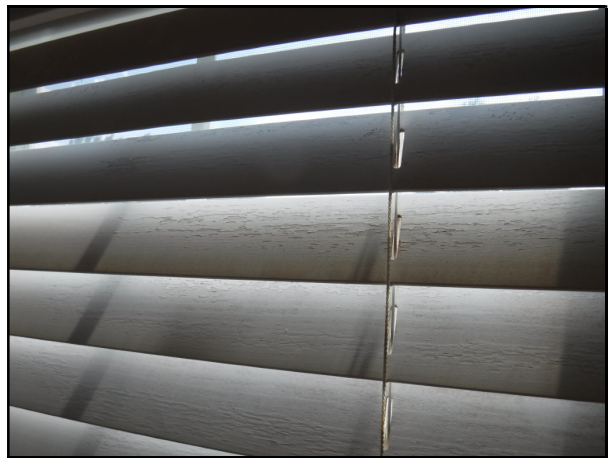
17. The freestanding range/oven appliance has no anti-tip bracket installed. (These brackets are installed at one of the rear feet and intended to prevent the appliance from tipping forward if a child happens to open the oven door and climbs onto it.)
18. The fan/light fixture combo in the upstairs front left bedroom makes a repetitive clicking/brushing noise during normal operation of the fan function. Perhaps adjustments could be made.
19. Paint is peeling from the majority of the blinds slats throughout the home, as exemplified in the following photos.

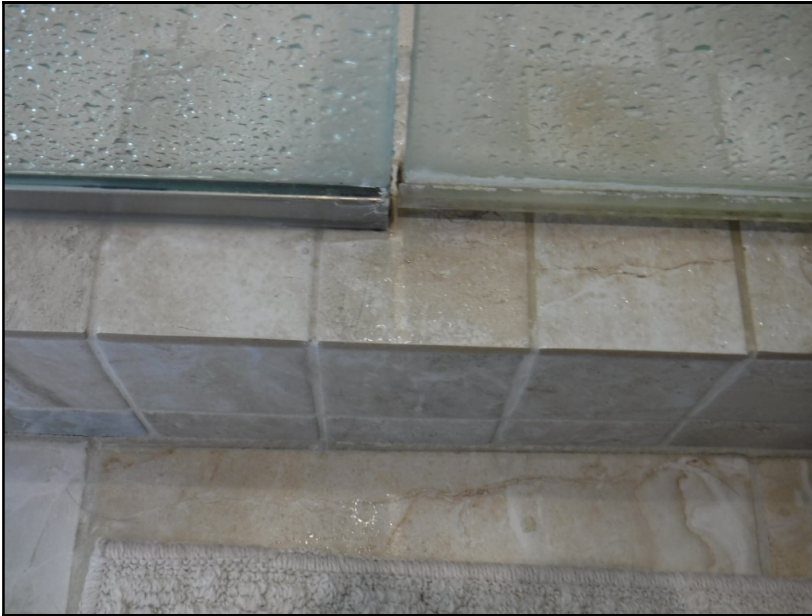
21. Water is spraying past the seams of the shower door in the master bathroom, as shown in the following photo.

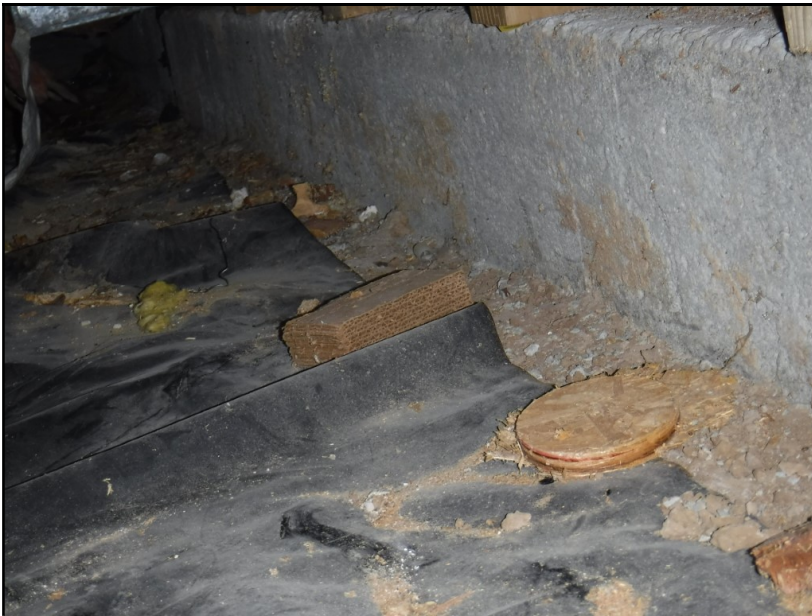
22. Construction scraps containing cellulose (wood or paper products) have been left in the crawl spaces under the structure, as exemplified in the following photo. Since these scraps can eventually attract various wood destroying organisms, I recommend that they be removed.

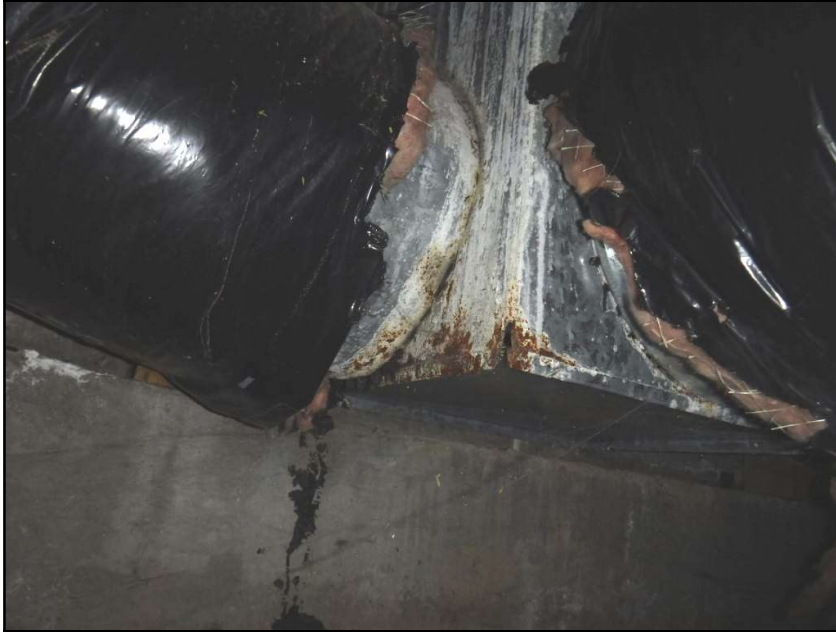
23. I found condensate staining on the sheetmetal plenum in the crawl spaces under the furnace, as shown in the following photo. This likely indicates past condensate leaks. However, I did not find any active leaking at this time.

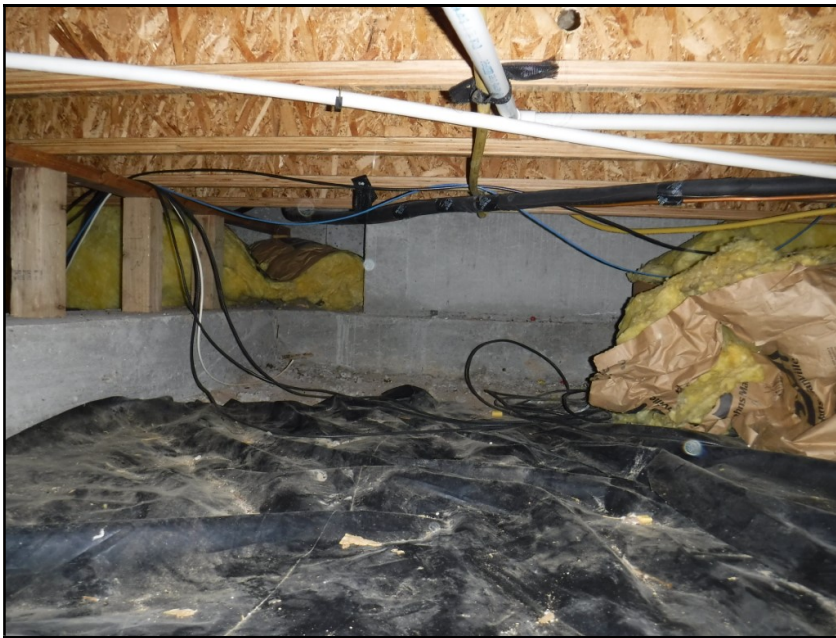
24. Sections of the insulation have been removed from the foundation walls in the crawl spaces, as exemplified in the following photo.

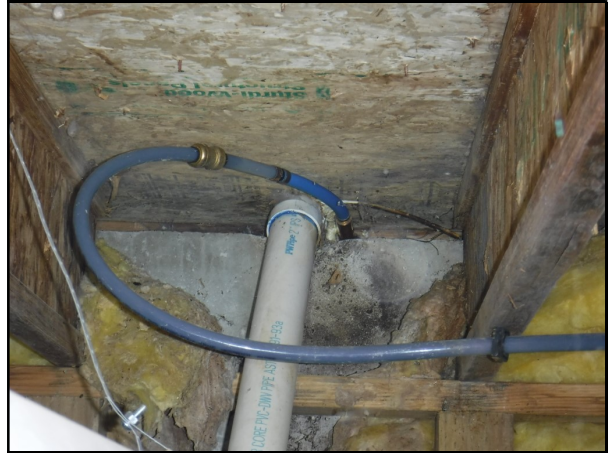
25. I found staining on the concrete foundation, the insulation, and on the subfloor surfaces in the crawl spaces under the kitchen sink, as shown in the following photos. I also found potential microbial growth in this area. This is likely the result of a past leak.

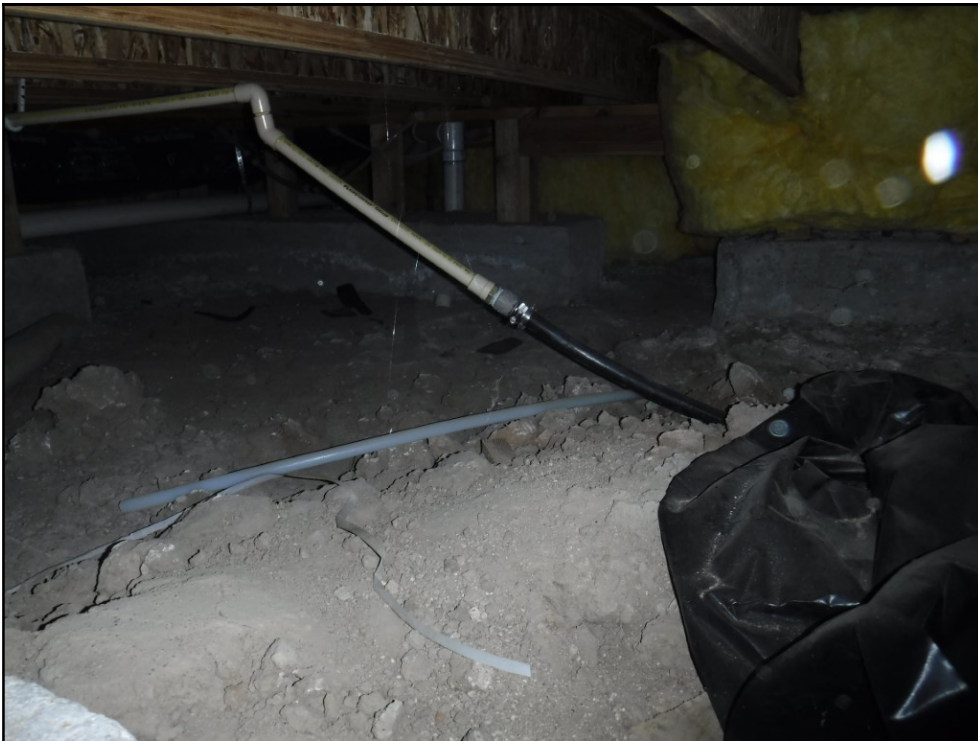
26. I noted gaps in the vapor barrier coverage throughout the crawl spaces, as exemplified in the following photo. This exposes the soil and can increase humidity.

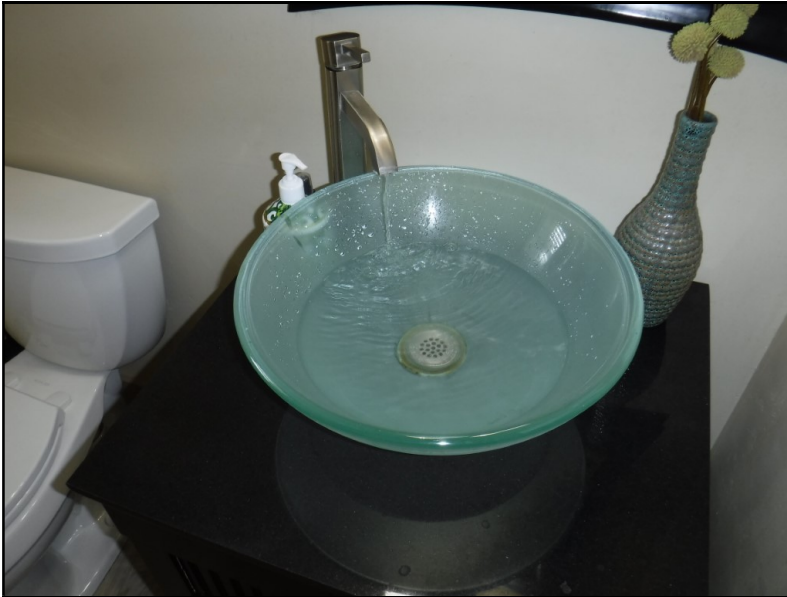
27. The sink in the main-floor bathroom has a slow drain, as shown in the following photo.

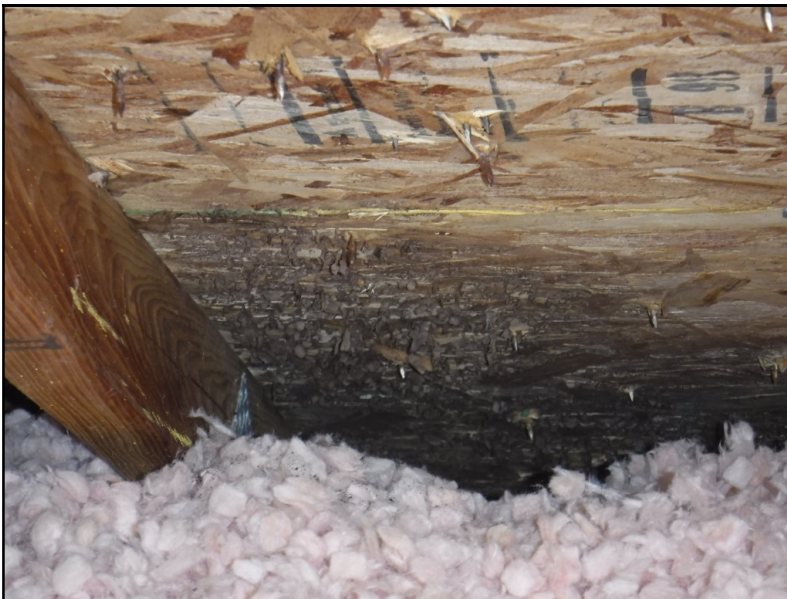
28. I found potential microbial growth on the OSB roof decking in the attic above the rear right corner of the master bedroom, as shown in the following photo. I did not find any visual indication of leaking in the surrounding areas. Humidity can accumulate on the north sides of the attic spaces and in areas that do not get as much direct sunlight.

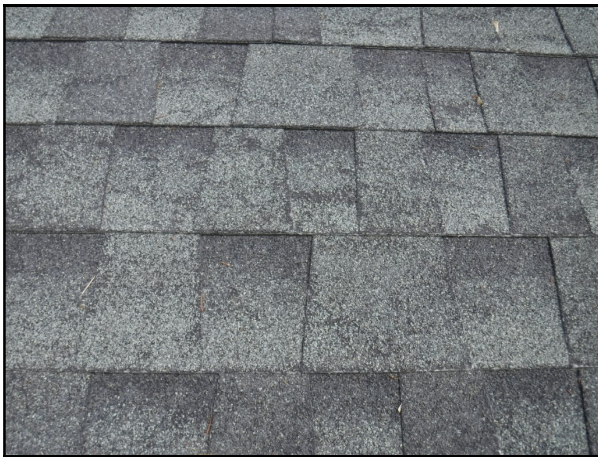
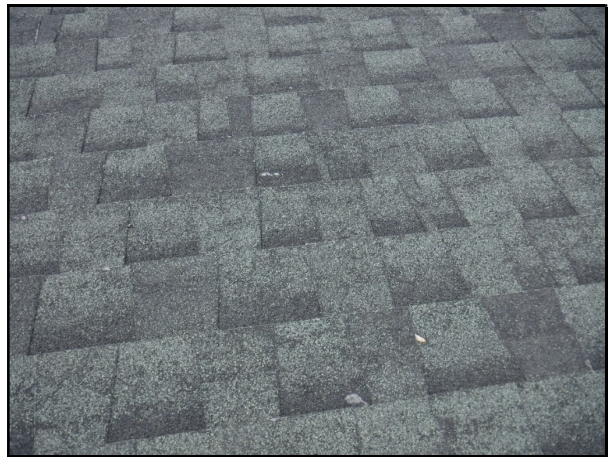
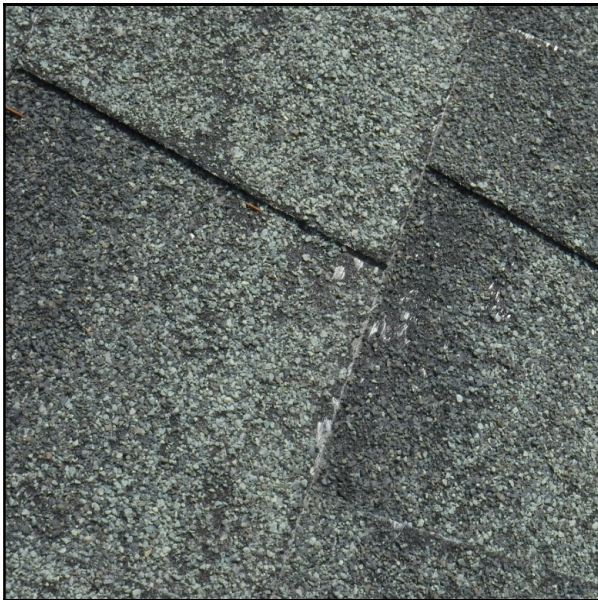
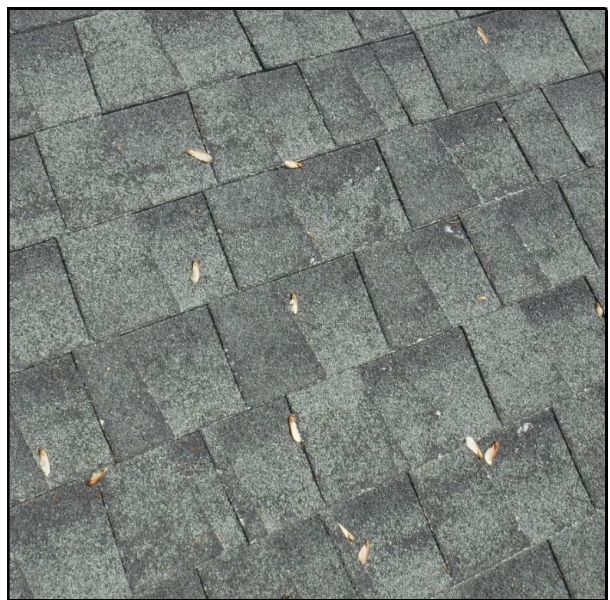
29. The current roof coverings are now about 13 years old, according to my best guesses using deductive logic and/or visual clues. This type of roof covering typically lasts from 25 to 30 years. However, I've seen such roof coverings fail sooner and last longer. I suggest taking the roof covering's age into account when budgeting for upcoming maintenance and/or replacement costs. Often, the opinions of qualified professional roofing contractors can lend more credibility to these considerations.

Additionally, I noted more than the typical amount of mineral loss, fraying, abrasions, and general "wear & tear" on the shingles for their age, as exemplified in the following photos.

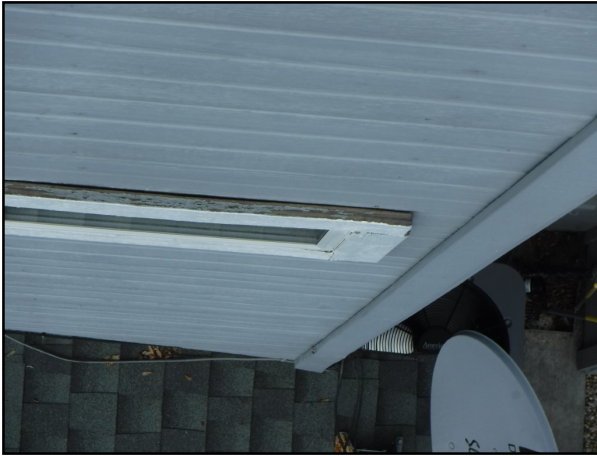
Additionally, paint is peeling from the top edges of the horizontal trim boards around the exterior, as exemplified in the following photos.

Moreover, the exterior paint is appearing “chalky” (due to oxidation with age and long-term exposure to the sun). For this reason, alone, the prospective buyer may wish to budget for a repaint within the next few years. Local painting contractors should be able to better diagnose the present condition and likely remaining longevity, together with meaningful estimates for eventual repainting.

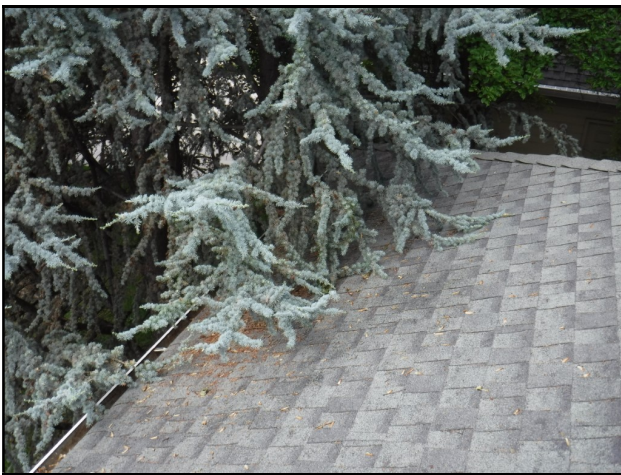
32. Tree branches are touching the roof and/or building, as exemplified in the following photo. Cutting all branches back and away from the building at this time (and seasonally, hereafter) would help avoid long-term wind-action abrasion damage.

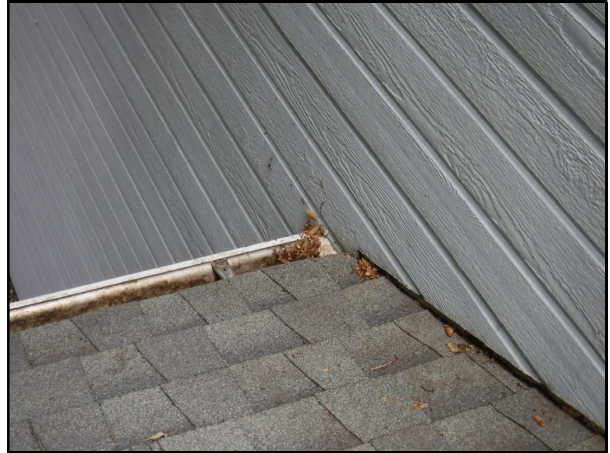
33. The lower ends of the sloped roof-to-wall flashing runs at the front left of the upper eaves and at the rear left of the lower eaves have missing, damaged, or ineffectual diverter flashing ("kicker flashing"), as shown in the following photos. This can allow water to enter the siding where it can cause damage.

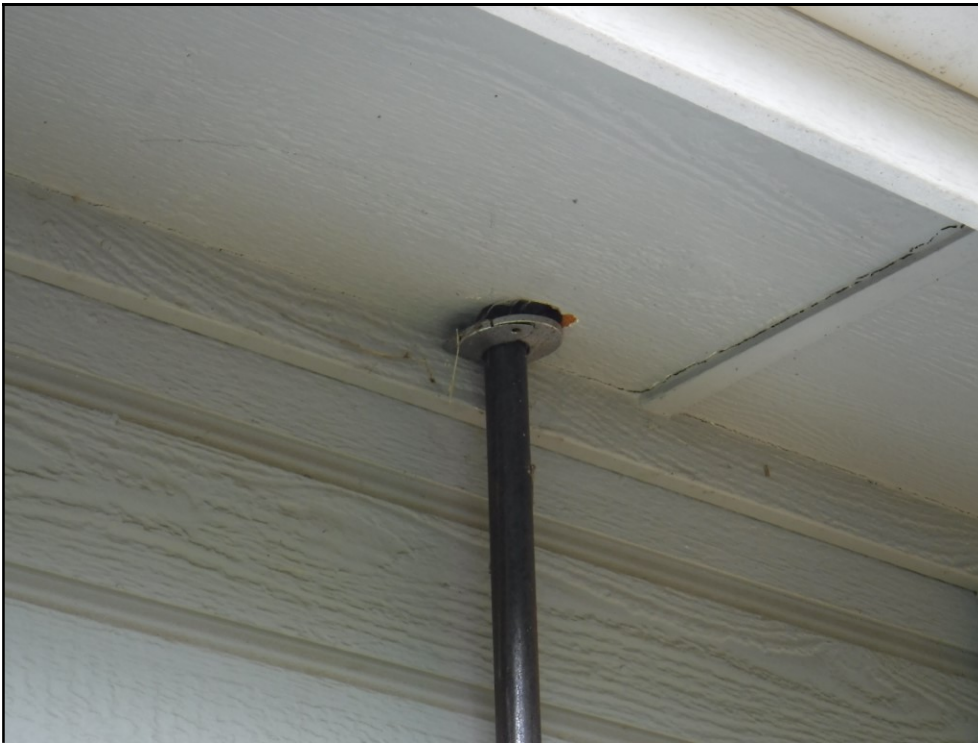
34. The flange is loose where the gas supply line enters the eaves at the right exterior of the garage, as shown in the following photo. This can be a pathway for pests into the attic.

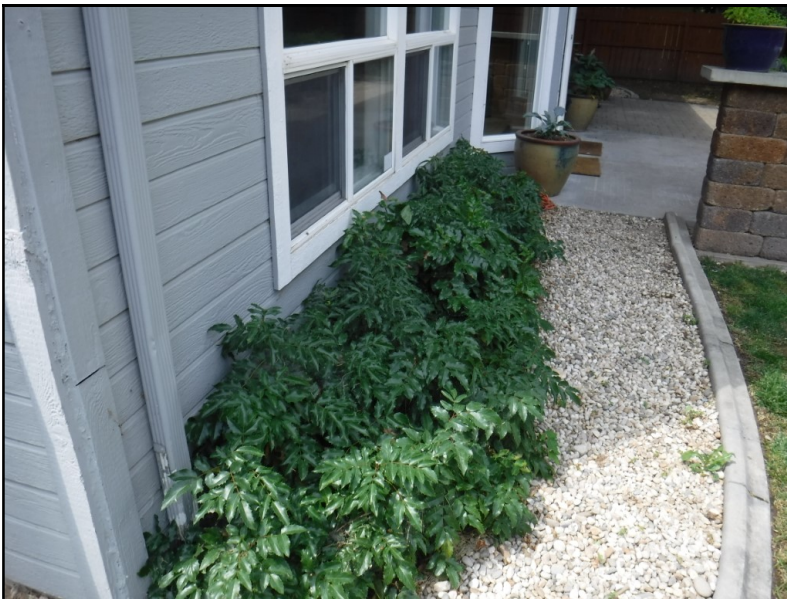
40. Some exterior plantings, as exemplified in the following photo, have been allowed to grow into contact with the siding. These should be kept pruned back and away enough to avoid direct contact and to allow the siding to dry out between rains or irrigation cycles. (At least one foot of clearance is recommended.)

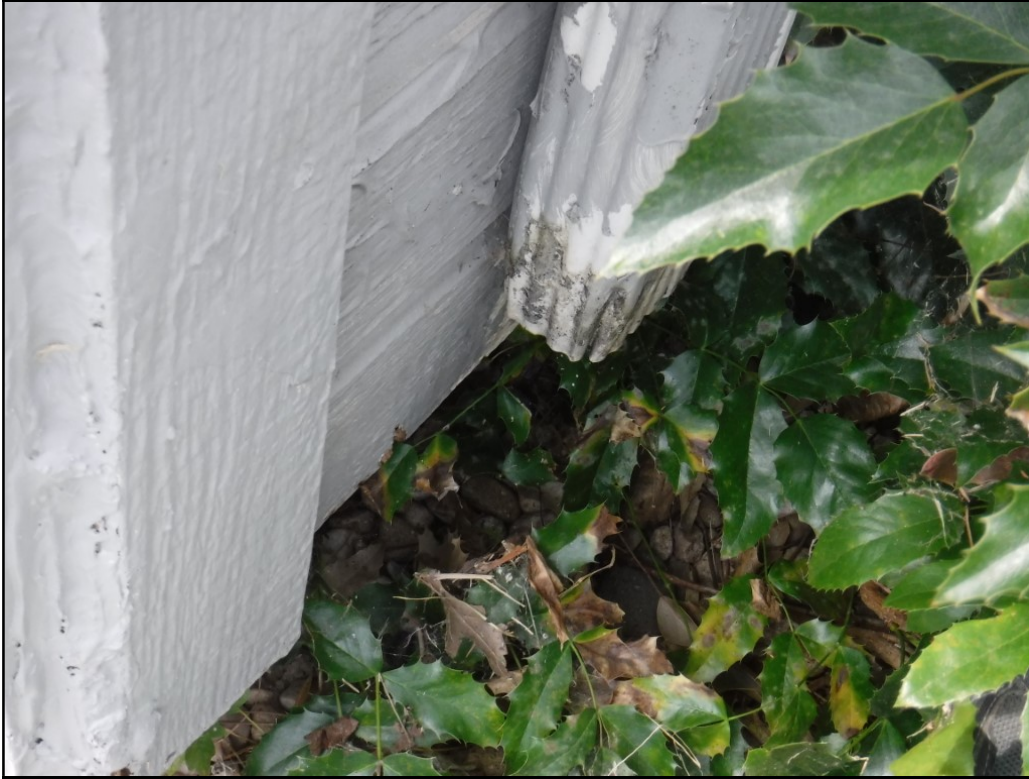
41. The elbows are missing from a couple of gutters at the rear of the home, as exemplified in the following photo.

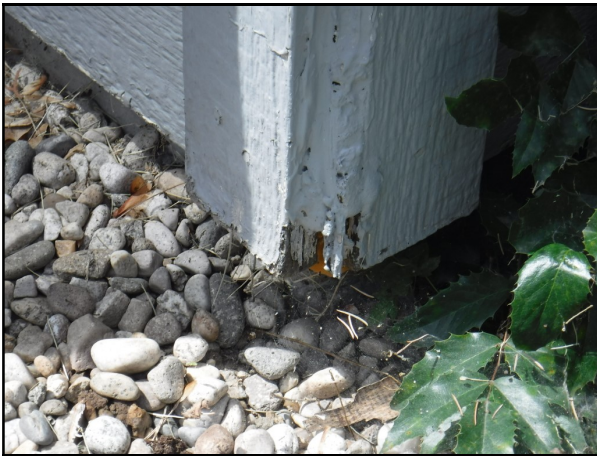
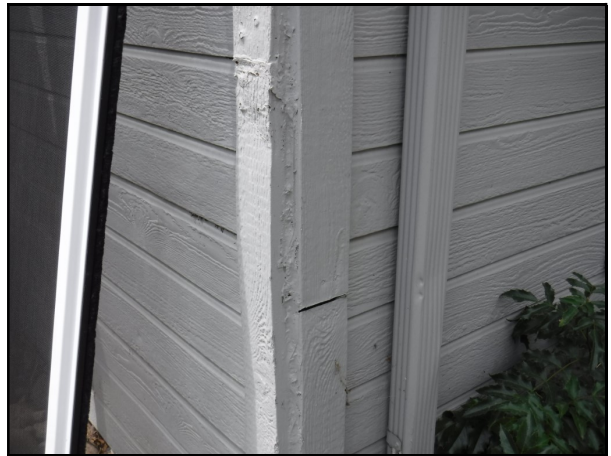
42. The exterior vertical trim boards have swelling and possible deterioration near their bottoms, as exemplified in the following photos. These surfaces could be sealed with primer, caulk, and matching color coatings, if desired, to help prevent this condition from worsening.

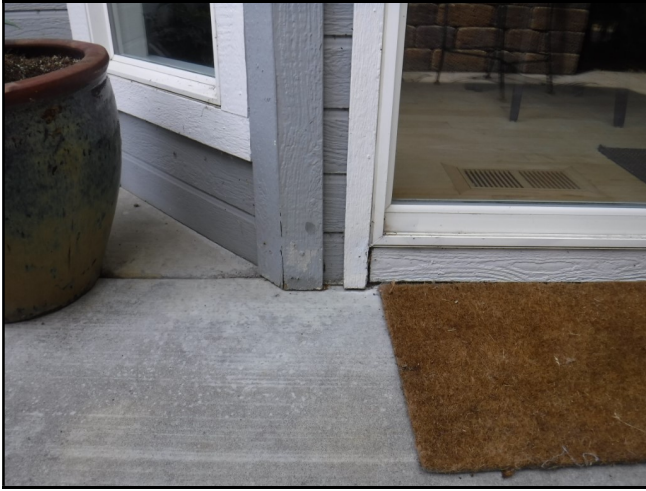
43. The siding at the rear patio, as exemplified in the following photo, is contacting the concrete slab below it. This can encourage moisture to wick up into the siding, which can lead to possible deterioration. Siding should be held at least 1 inch above concrete to help prevent such issues. Furthermore, the materials behind and below the siding should be protected with flashing designed and installed to effectively prevent water entry behind the concrete.

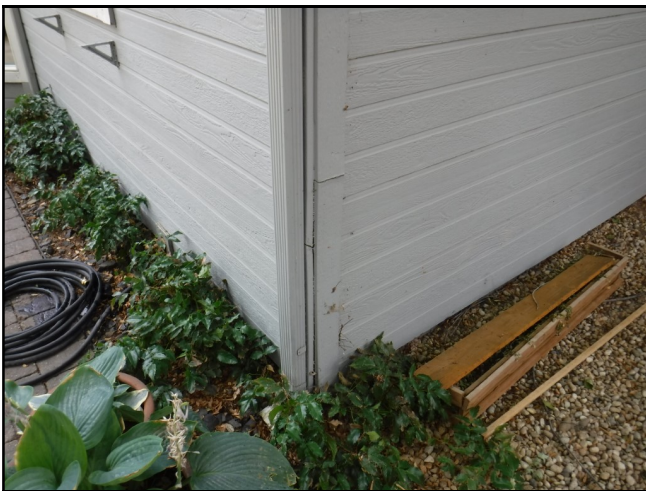
44. One or more gutter downspouts discharge where their water cannot continue to flow adequately away from the foundation, as exemplified in the following photo. I suggest modifying the downspouts or the grading to help keep water from ponding against the house. I also suggest monitoring any adjacent below grade spaces for evidence of exterior surface water infiltration after periods of heavy rains or intense irrigation.

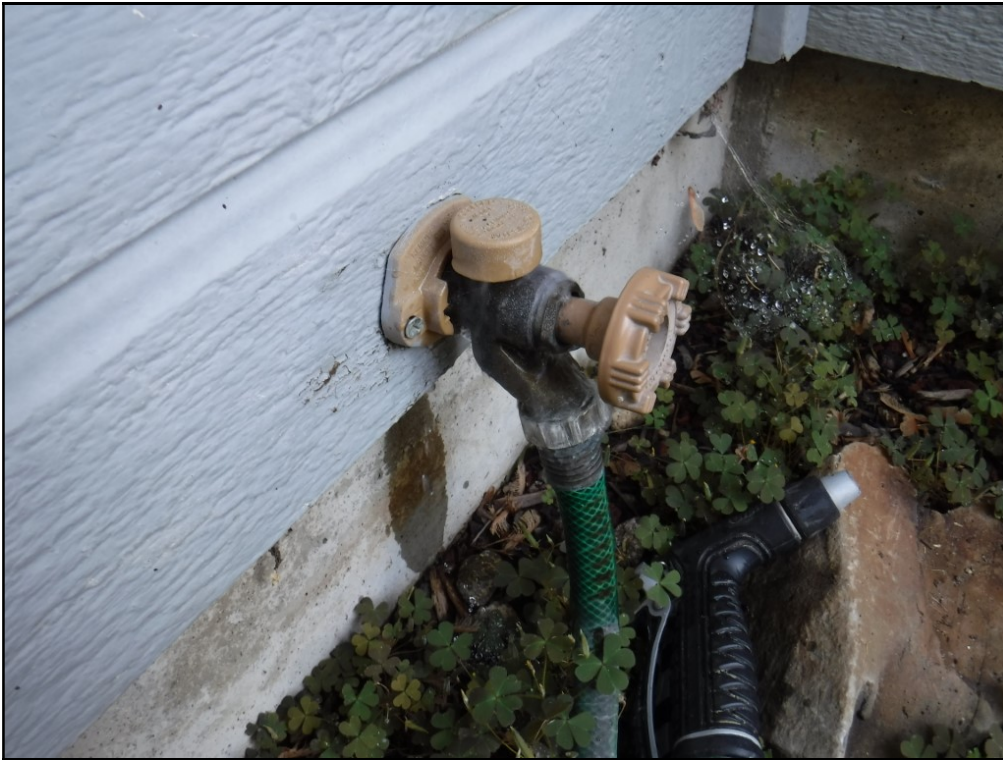
49. The freeze-proof sill cock (exterior garden hose valve) to the right of the front entry leaked through its vacuum-breaker (anti-siphon feature) when I placed a cap over the hose threads and turned the valve open, as shown in the following photo. Cleaning, repair, or replacement of the valve will likely be required to return it to its original ability to prevent dirty water from getting back into the house's water system.

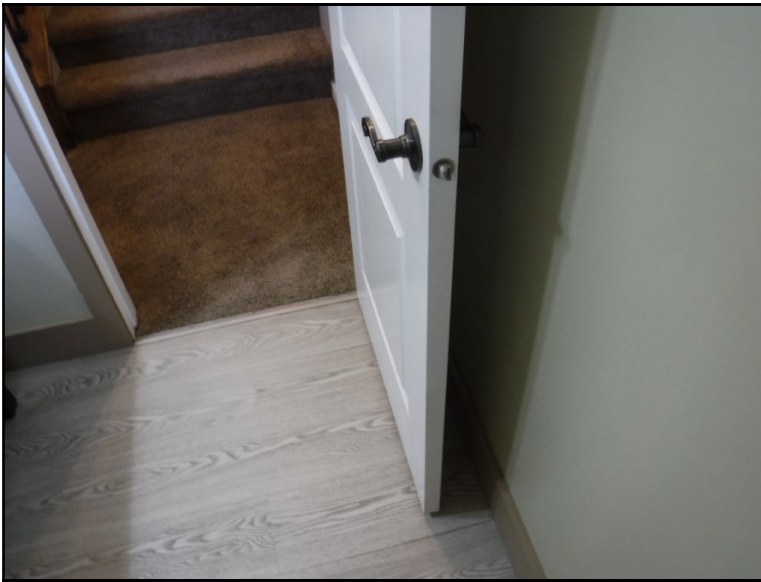
- a. The door to the main-floor bathroom has a missing, damaged, or ineffectual doorstop, as shown in the following photo. Other doors may have doorstop issues, as well. Doorstops can help prevent the damage to nearby surfaces that might otherwise be done because of doors swinging into them.

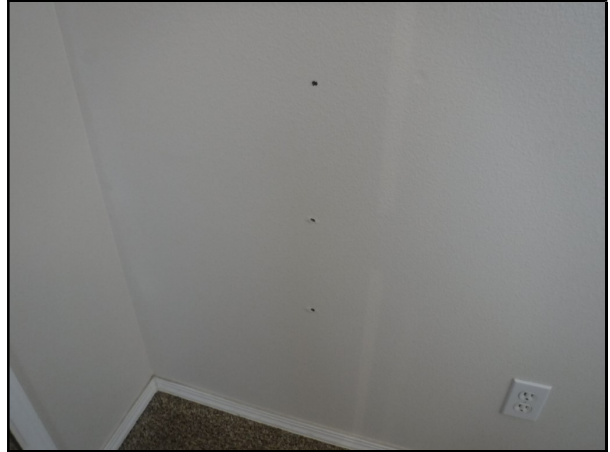
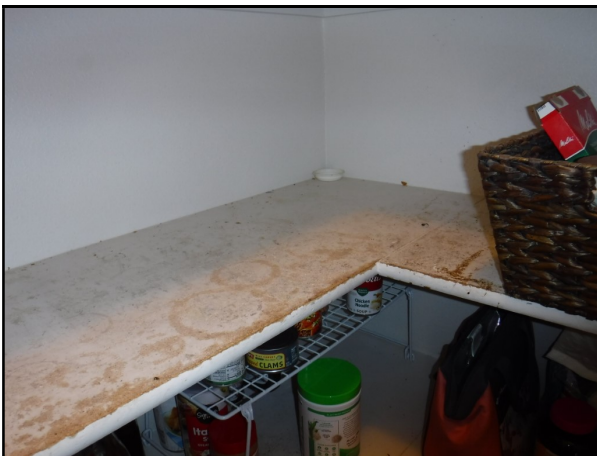
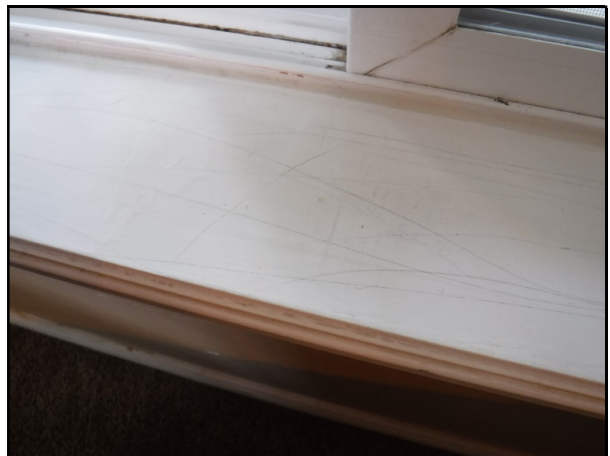
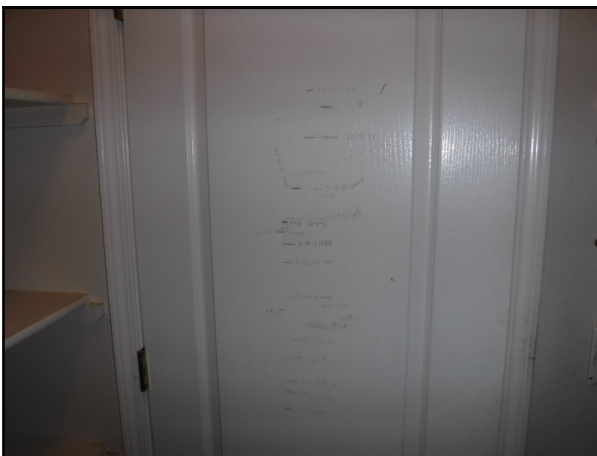
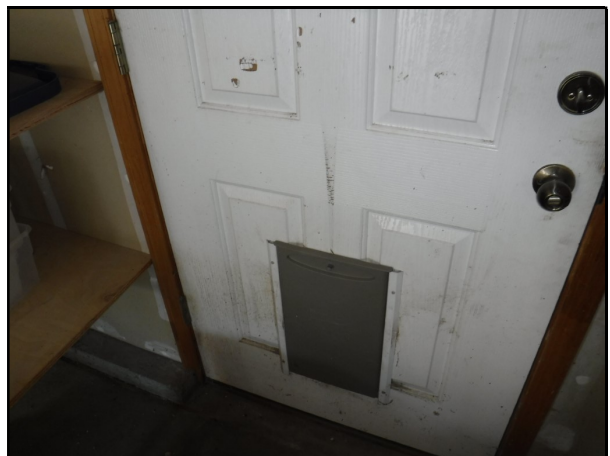
- d. The interior surfaces of this property have the typical amount of blemishes, scratches, dents, scuffs, or dings that may require repair in order to present the best possible visual appearance, as exemplified in the following photos.

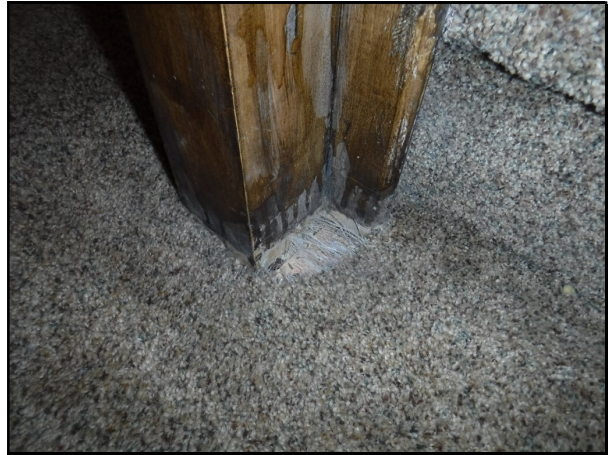
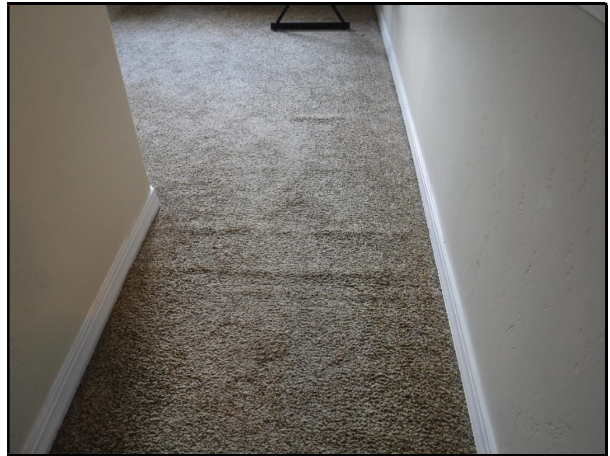
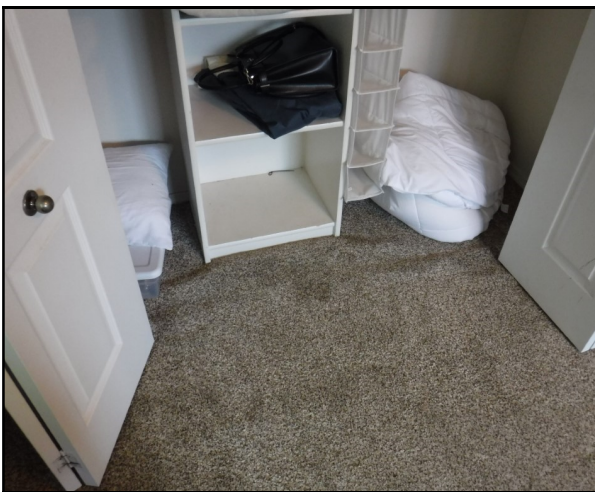
- e. The carpeting throughout the home is worn, loose, damaged, and stained in areas of higher traffic, as exemplified in the following photos.

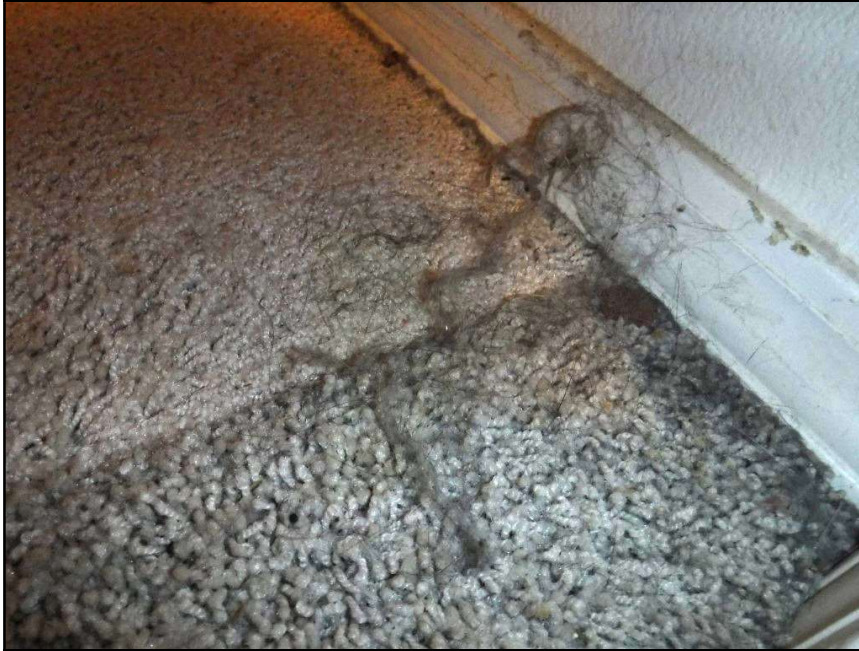
Additionally, the current homeowners have at least one pet in the house. Therefore, I found pet hair and dander on multiple carpeted surfaces, as exemplified in the following photos.

Once any stain is identified as being from animal excrement, I strongly suggest spraying the stain with Nature's Miracle Pet Stain Remover. (The enzymes in this liquid product essentially digest any remaining urine or fecal matter upon contact, leaving the floor covering stain-free and odor-free ☺.)

However, if it is discovered that urine has soaked beyond carpet backing and into carpet padding, I strongly suggest temporarily removing the carpeting in the affected areas so the pad can be replaced. (Otherwise, stains and odors will continue to leach back up and through the professionally cleaned and sanitized carpets.

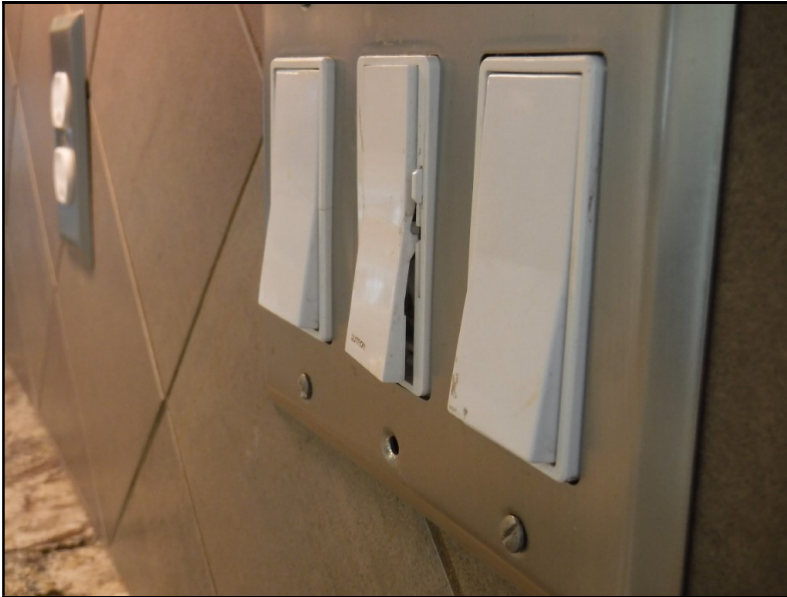
- f. The plastic is damaged on one or more light switches in the kitchen, as exemplified in the following photo.

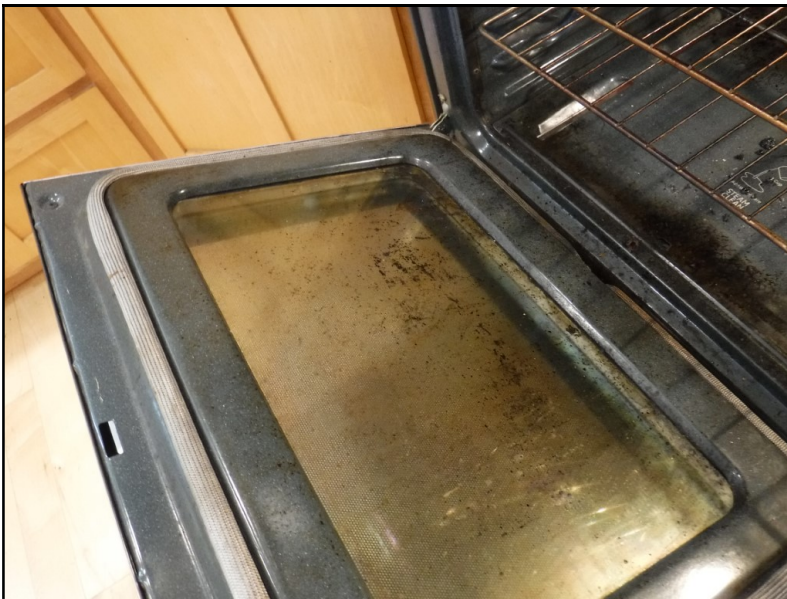
- g. Food soils are noted between the glass panels of the oven door, as shown in the following photo. (This can require disassembly of the door to access the soiled surfaces if cleaning is desired). Also, please refer to further discussion regarding avoiding food soils in oven doors, which I have included in the section titled "Ownership Tips for this Particular Property" near the end of this report.
