AAD Inspection Corp.

Home Inspection Report

**123 Any St
Any Town, ID. 86753**

Inspection Date: 07/15/2025

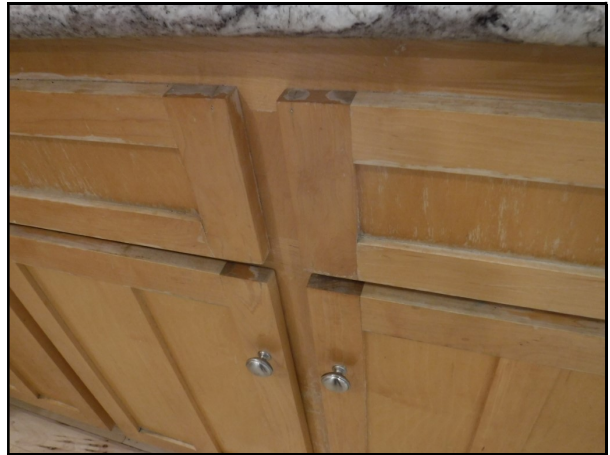
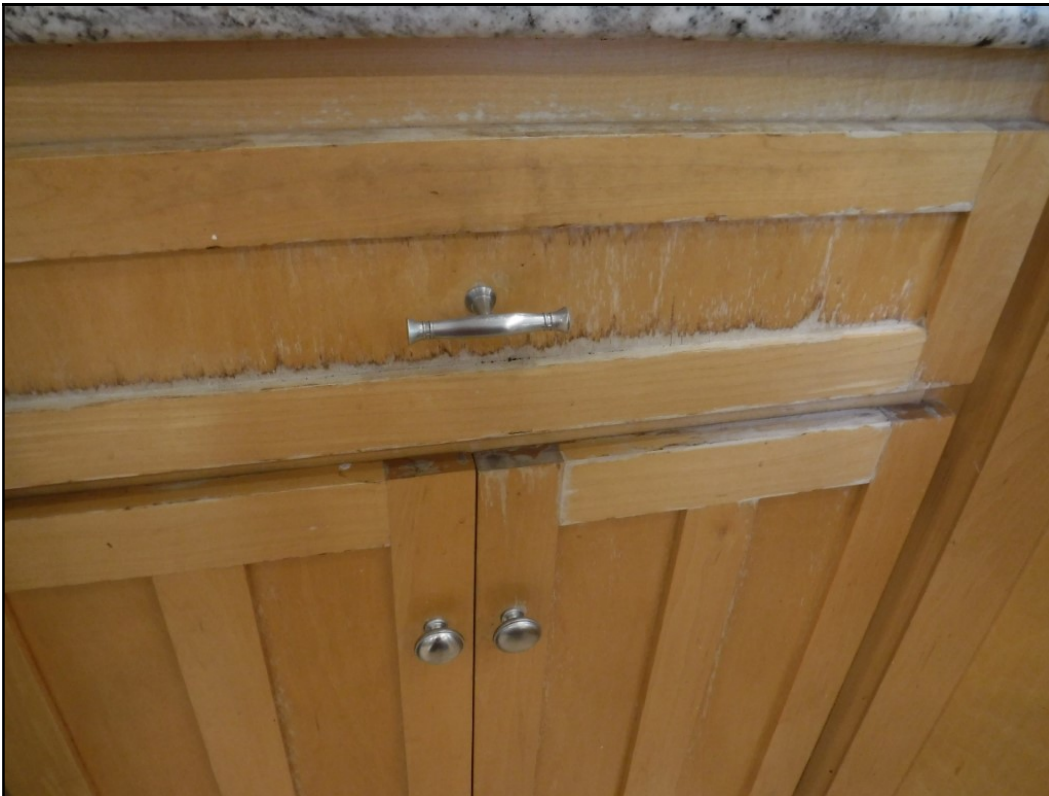
- h. The cabinets and drawers throughout the home are a little worn, as exemplified in the following photos. You may wish to consider rejuvenating these surfaces by rubbing fresh matching stain and/or clear coatings into them with #0000 steel wool pads. (The steel wool pads will scrape away any unsound finish coatings, along with any unwanted oils or dirt, while simultaneously presenting the fresh coating to the wood.)

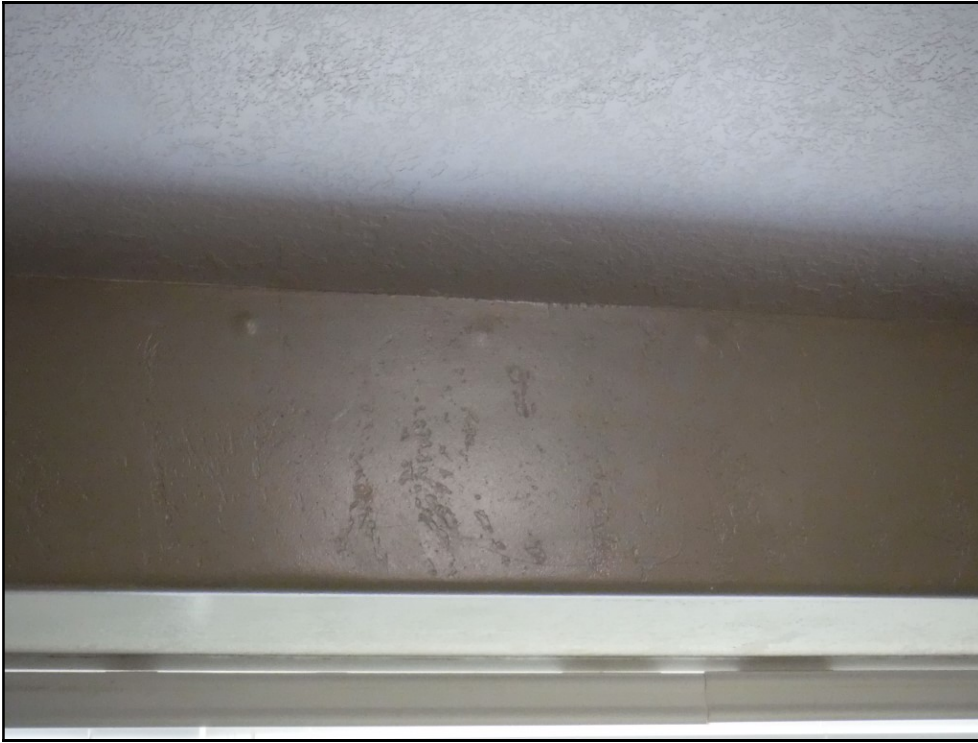
- i. One or more nail bumps (or nail pops) were noted throughout the home, as exemplified in the following photo.

Nail bumps (or nail pops) in the otherwise smooth, flat surfaces of sheetrocked ceilings or walls are caused by nail heads appearing to back out of the surfaces through the thin layer of drywall mud and texture that is applied over them.

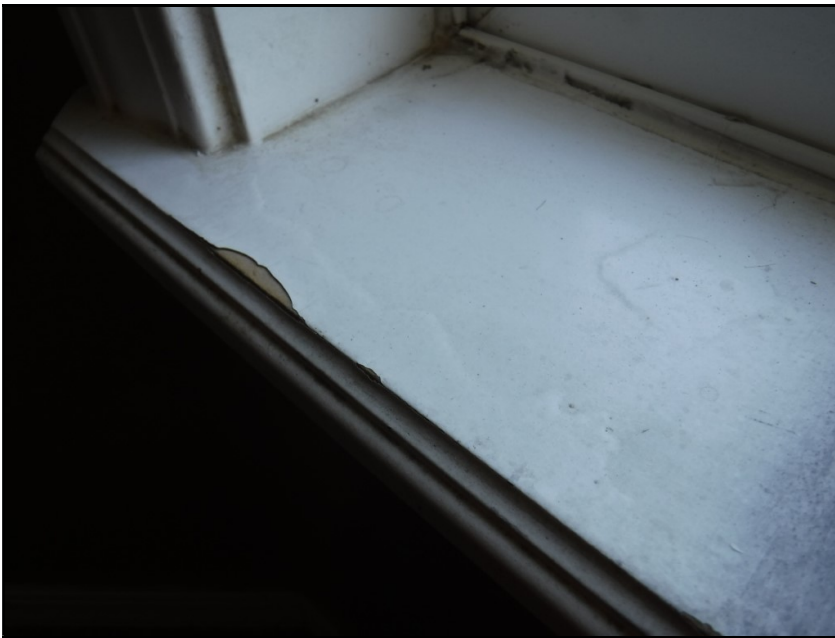
- k. I found a few areas of swelling on the interior windowsill trim in the master bedroom, as exemplified in the following photo. This is likely from leaving the window ajar during rainy weather. However, this is only a cosmetic concern.

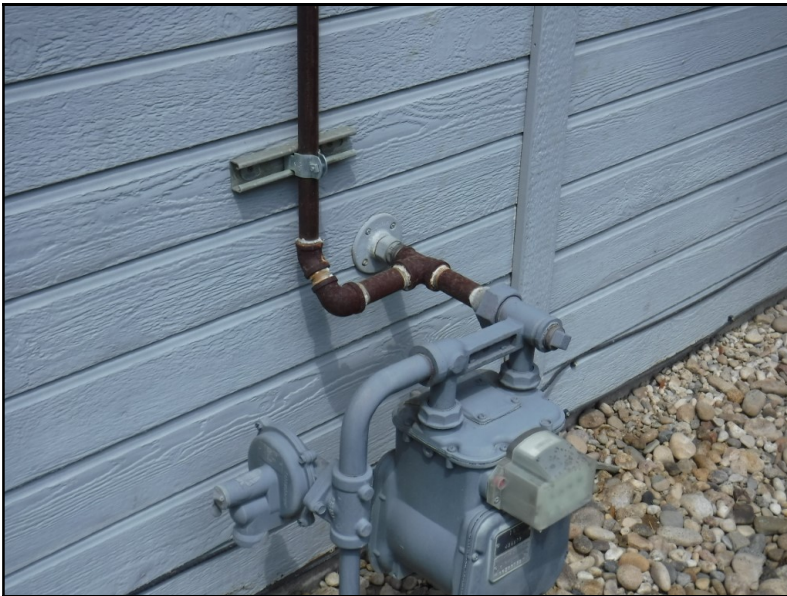
- m. The iron piping at the natural gas meter has developed a noticeable amount of rust, as exemplified in the following photo.

I don't perceive the current amount of corrosion to be a threatening issue. However, the gas company and/or local gas plumbing contractors may have differing opinions. Nonetheless, I suggest simply wire brushing the rusted surfaces, then coating them with Rust-Oleum® or a similar paint to help prevent or reduce further corrosion.

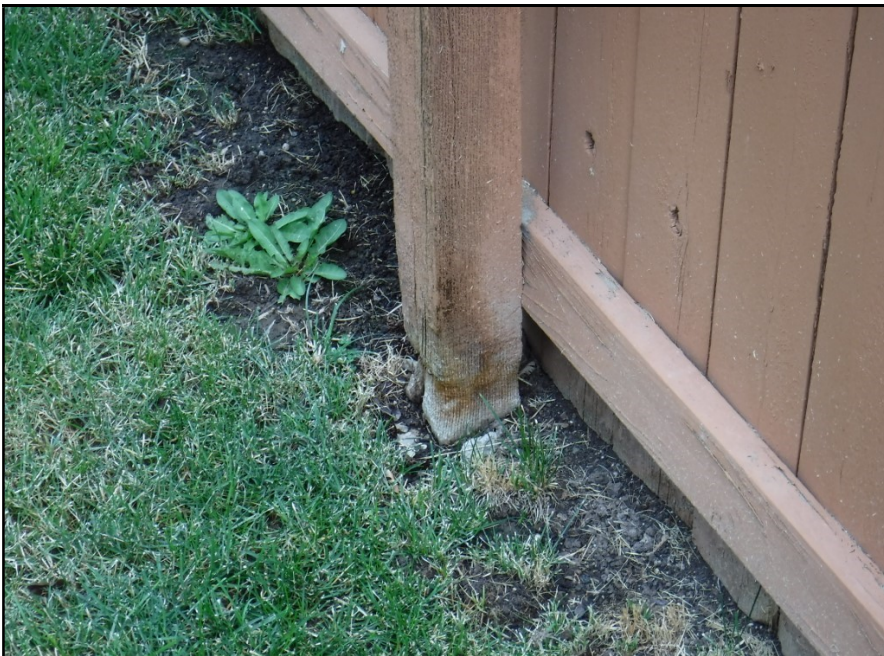
Additionally, I found impact damage from lawn maintenance equipment on the lower sections of the fence posts, as exemplified in the following photo.

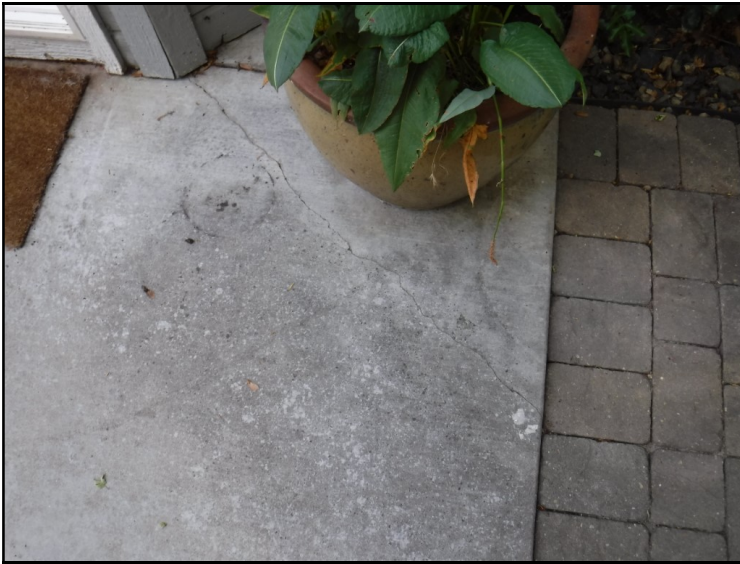
- p. One or more hairline cracks have formed in the concrete flatwork, as exemplified in the following photo.

However, this type and extent of cracking is cosmetic, only. Please refer to further discussion regarding “Sealing Hairline Cracks in Concrete Flatwork”, which I have included in the section titled “Ownership Tips for this Particular Property” near the end of this report.

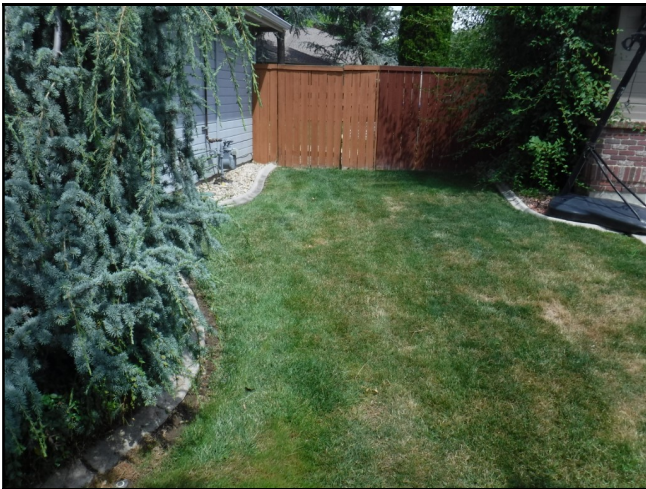
- The landscaping at the right exterior of the garage (shown in the following photo) is "mushy". Perhaps the sprinkler runtimes need adjustment.
