**AAD Inspection Corp.**

# Home Inspection Report

**111 Round Cir  
My Town, ID 83000**

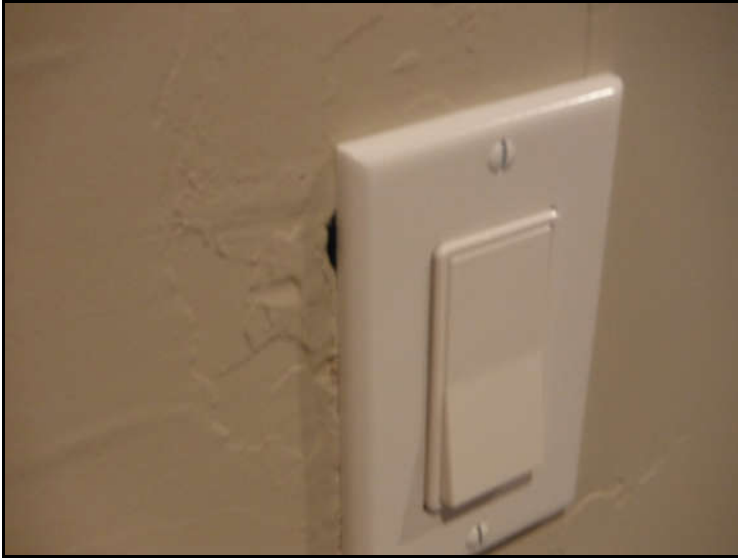
- u. Sheetrock has been cut out a little larger around the light switch for the master closet than the size of the box's cover plate, as shown in the following photo. This is only a cosmetic concern. However, you may wish to have this and any other similar areas patched, as necessary.

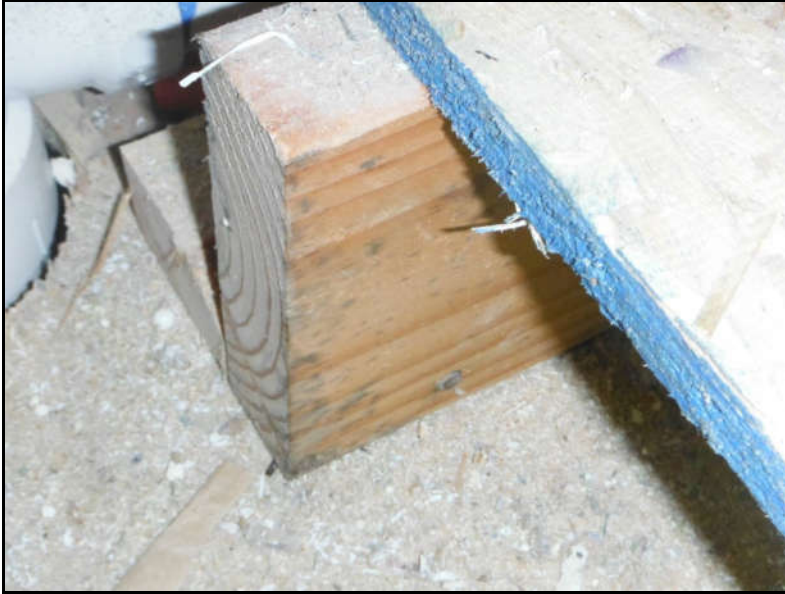
- w. Some minor black spotting is visible on a wooden stud beneath the HVAC platform in the attic, as shown in the following photo. However, this was likely on the wood before construction.

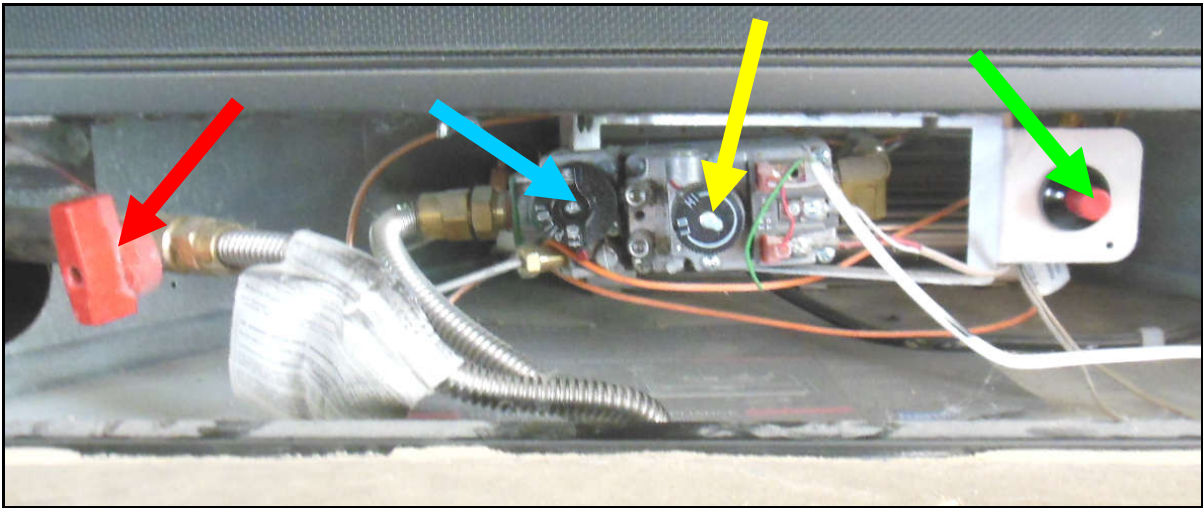
The following photo is a diagram of the fireplace controls behind the removable panel below the flame chamber and viewing glass.

Red Arrow: Gas Shut-Off Valve.

When the knob is aligned with the gas line, gas is flowing. When it is cross-wise to the gas line, gas is stopped.

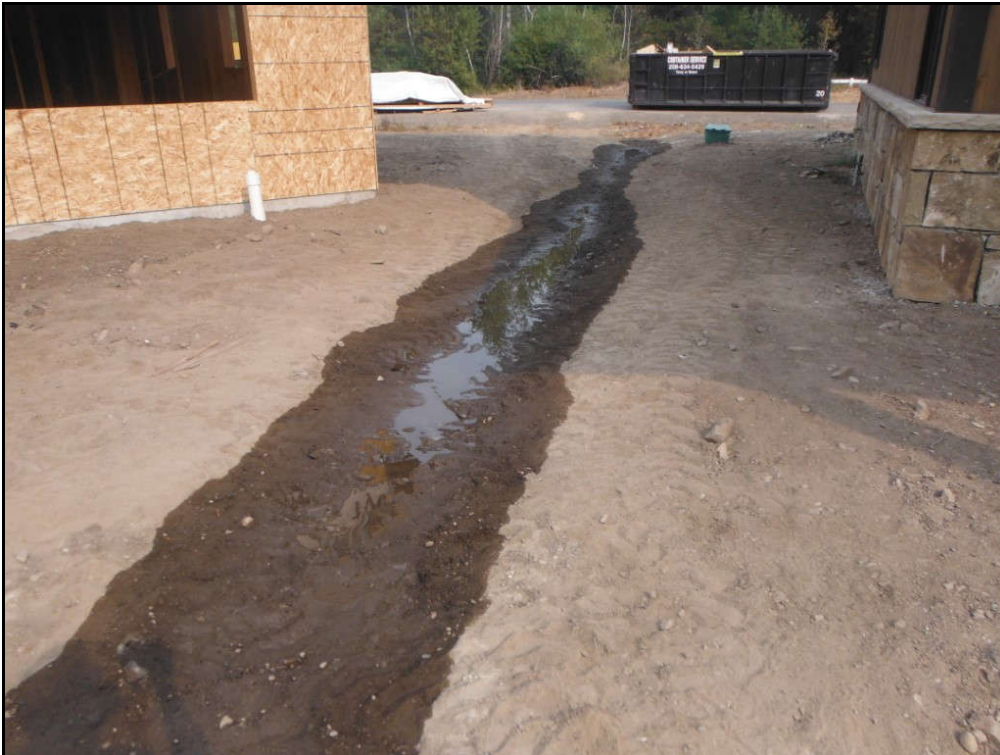
- Swales, drainage ditches, and piping are present on either side of the property, as exemplified in the following two photos. In fact, a pump with a flow switch and garden hose is visible at the left rear of the lot. This could indicate continuous drainage needs. I do not know if any type of perimeter drain system is intended for installation.

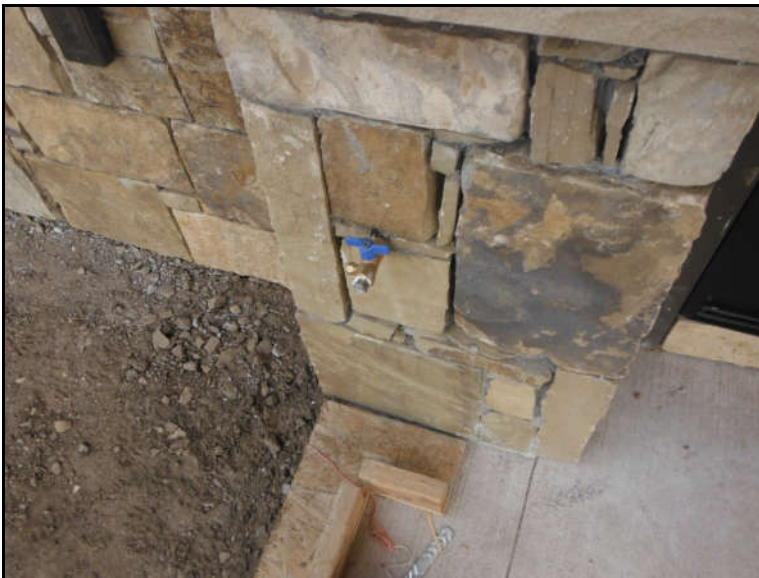
- Gas piping has been stubbed out at the rear patio for a possible future barbeque or other outdoor cooking appliances. However, I suggest always keeping a plug or cap in place over the end of the piping (in addition to any other valves or quick disconnects) whenever appliance hoses are not connected.

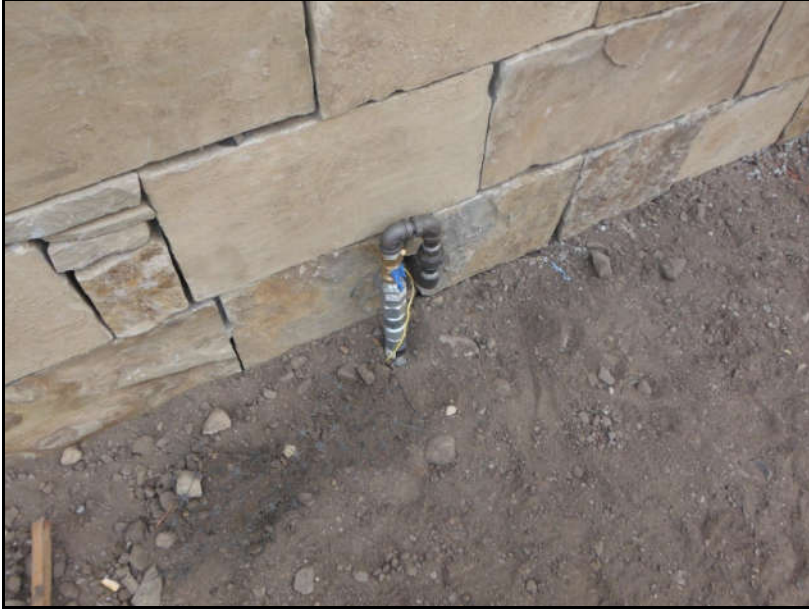
- The gas piping enters the right exterior of the home, as shown in the following photo. A local shut-off valve is present nearby. I suspect this is fed by community tanks. However, they are not located on this property.

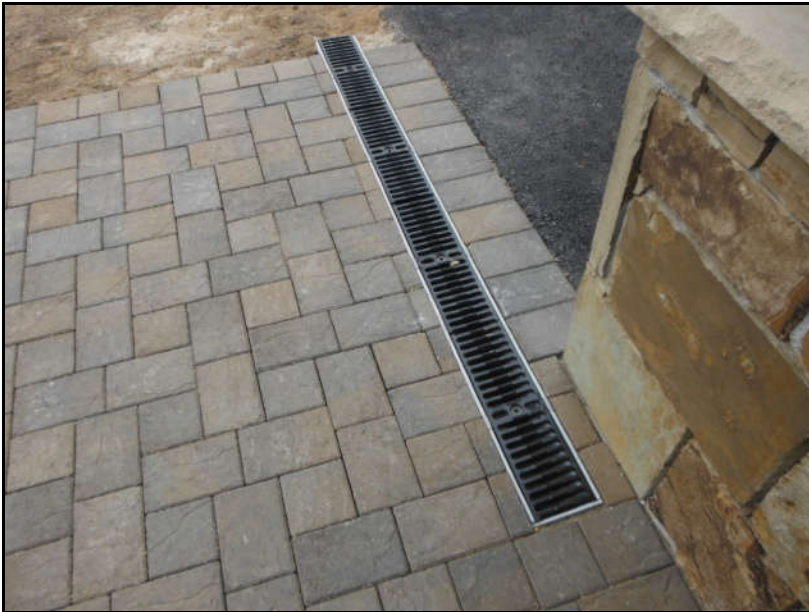
- A drainage trough is built between the entry walking path and the asphalt driveway, as exemplified in the following photo. It has an open ended drain that discharges towards the front of the property.

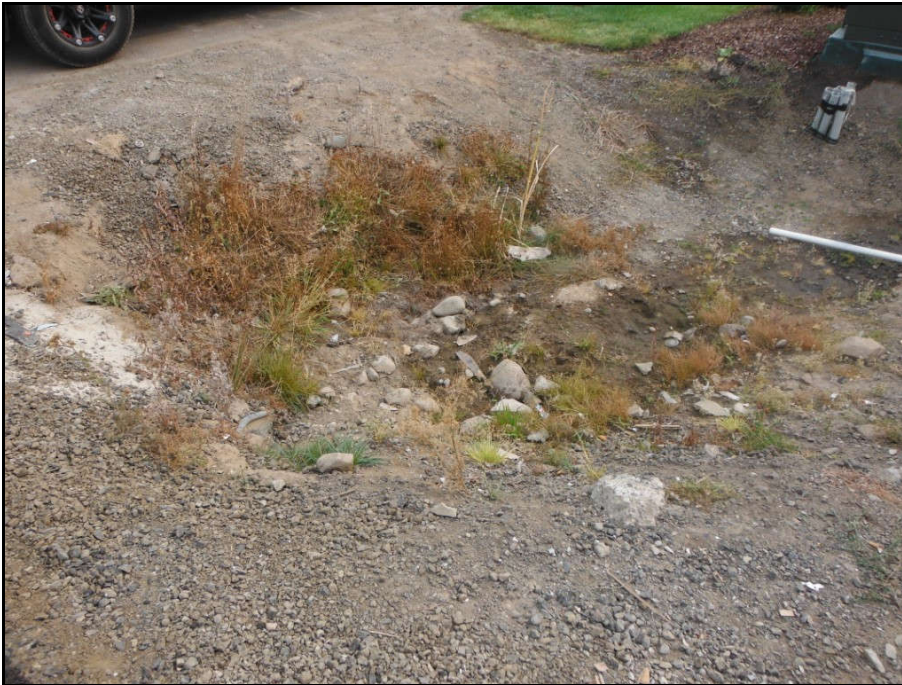
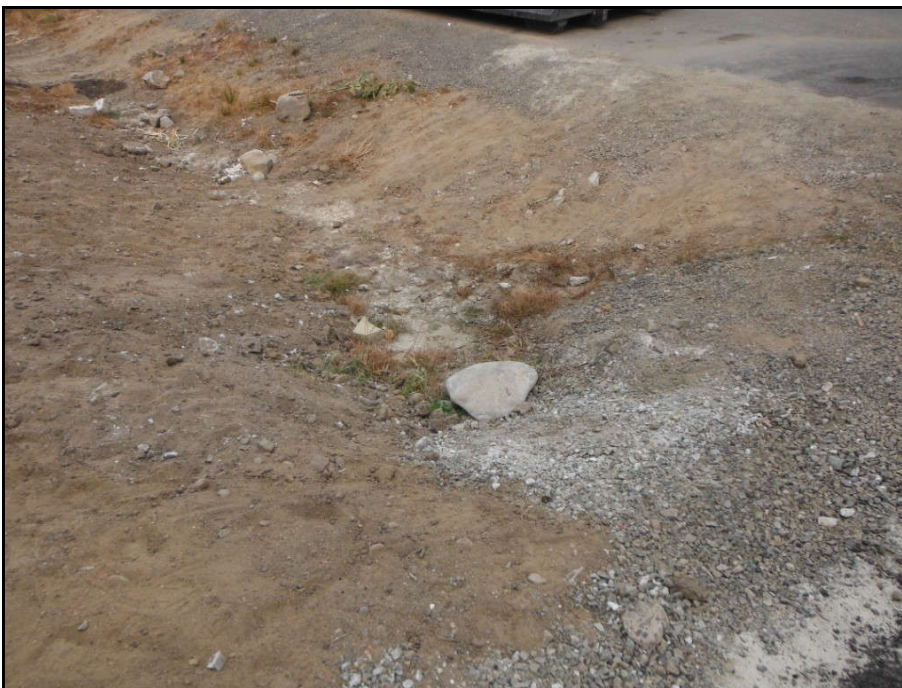
- A drainage ditch runs across the front of the property with culverts below the driveway, as exemplified in the following two photos.

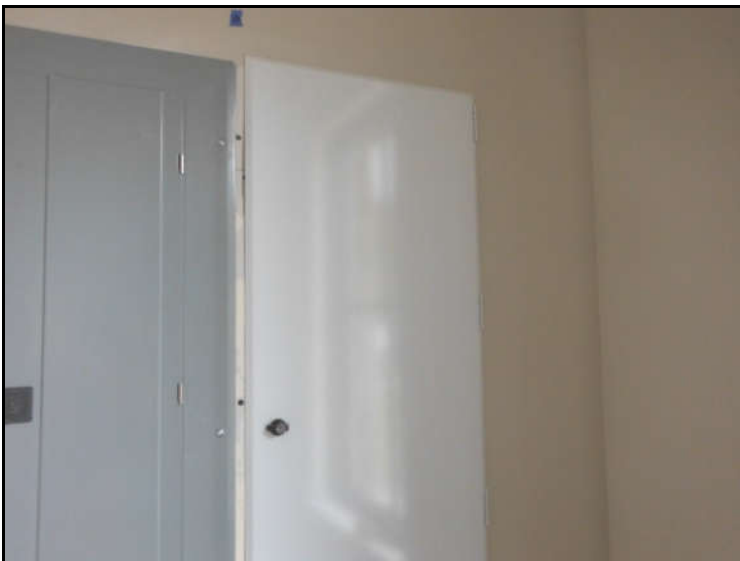
- This building has a data communications junction box installed in the laundry closet, as shown in the following photo.

These boxes facilitate the interconnection of numerous low-voltage cables in the most efficient manner to deliver Internet, intranet, telephone, and TV signals to various points of use throughout the building. This feature is beyond the scope of our inspection. However, local communications contractors should be able to answer all questions and help with any desired modifications.

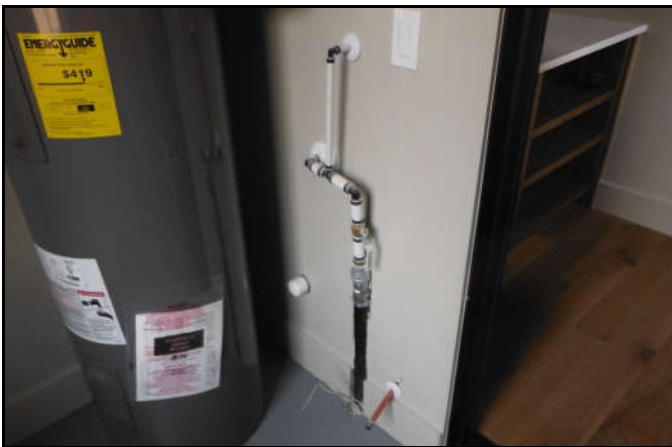
- Piping has been provided in the laundry closet for a possible future water softener, as shown in the following photo. However, no appliance is currently in place.  
NOTE: I strongly suggest that any further piping modifications be made only by a licensed plumber.

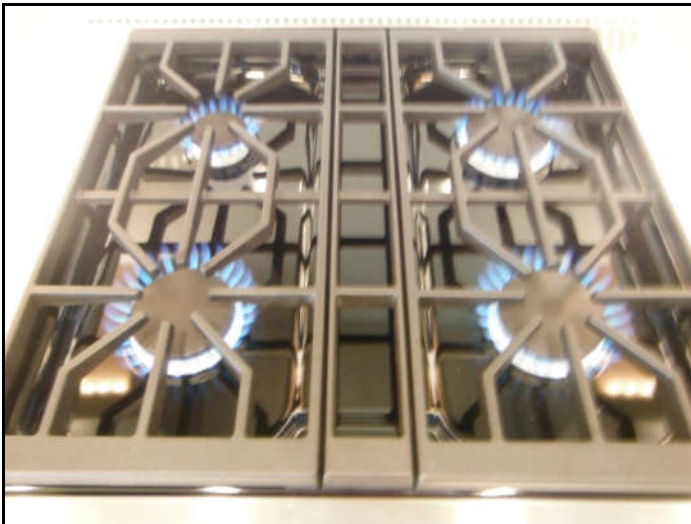
- The kitchen range burners ignited and operated normally during this inspection, as shown in the following photo.

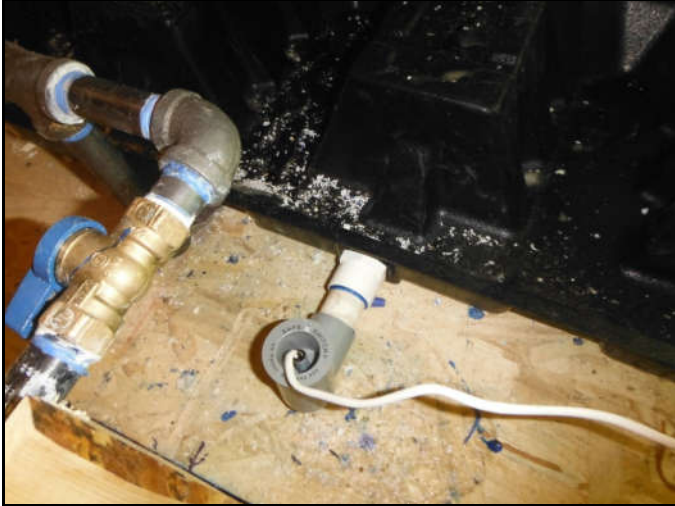
- The HVAC equipment in the attic has a catch tray beneath it with a sensor intended to shut the system down, if it ever fills with moisture, as shown in the following photo. This is an intentional safety device.

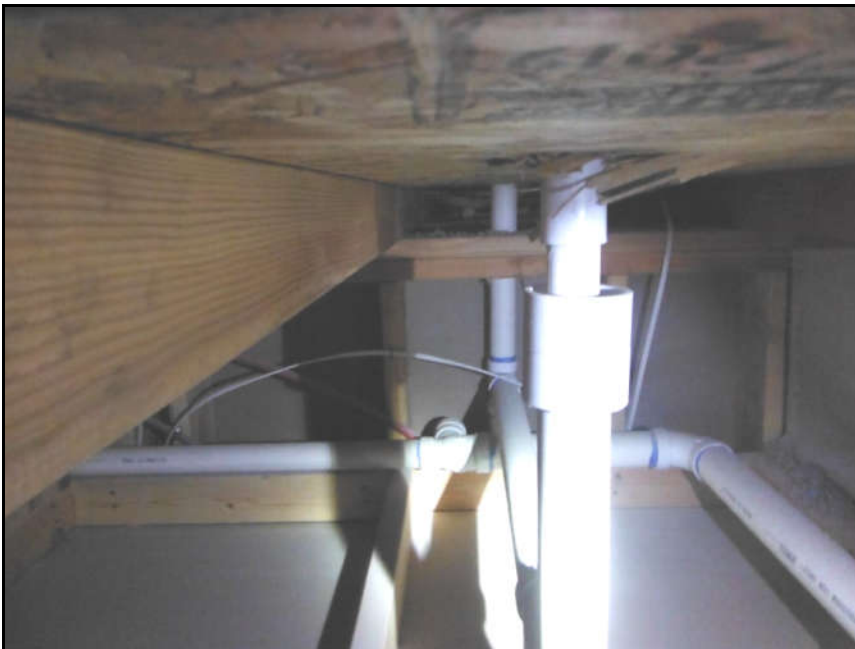
- The HVAC system in the attic drains into an open attic drain beneath the furnace, as shown in the following photo. It has a water trap and should stay wet year-round if heated and cooled. However, any potential clogs or backups could allow moisture to overflow into the attic.

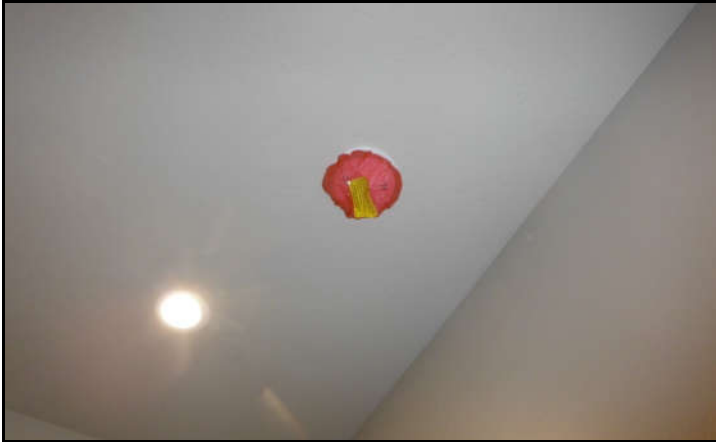
- One or more of the smoke detectors inside the home are covered with masks, as exemplified in the following photo. These are typically removed towards the end of construction.

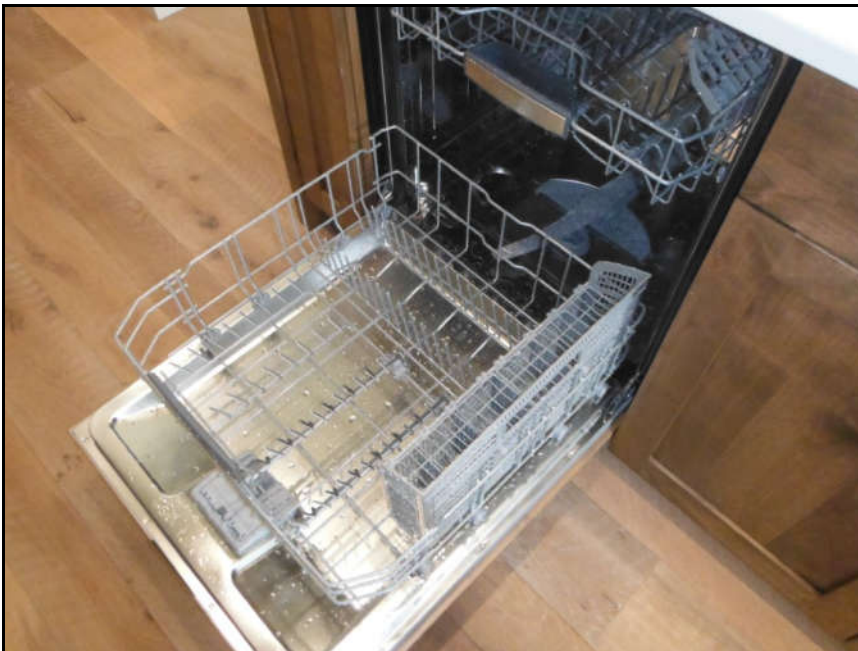
- The dishwasher filled and drained normally at the time of this inspection, as shown in the following photo.
