Home Inspection Report

**123 Any St.
Any Town, ID 86753**

Inspection Date: 07/21/2025

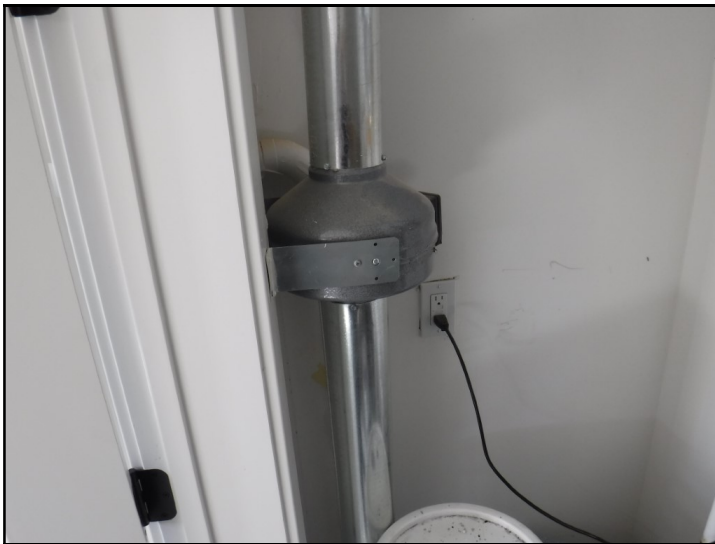
A continually running, low-powered, exhaust fan (shown in the following photo) is used to keep the air moving. This fan is typically installed somewhere in 3-inch-diameter plastic exhaust piping routed between the crawl spaces and the roof. Homeowners should periodically inspect the exhaust fan to ensure that it is running.

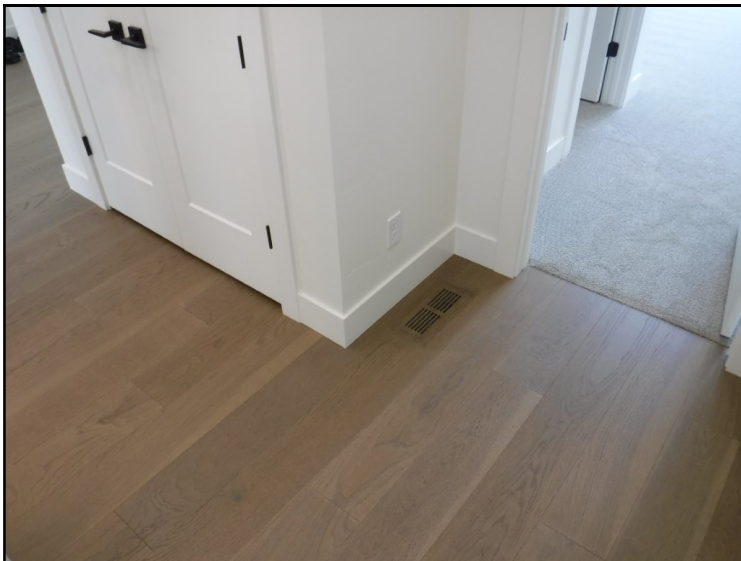
The air inlet for the conditioned crawlspace is located in the floor of the left hallway, as shown in the following photo.

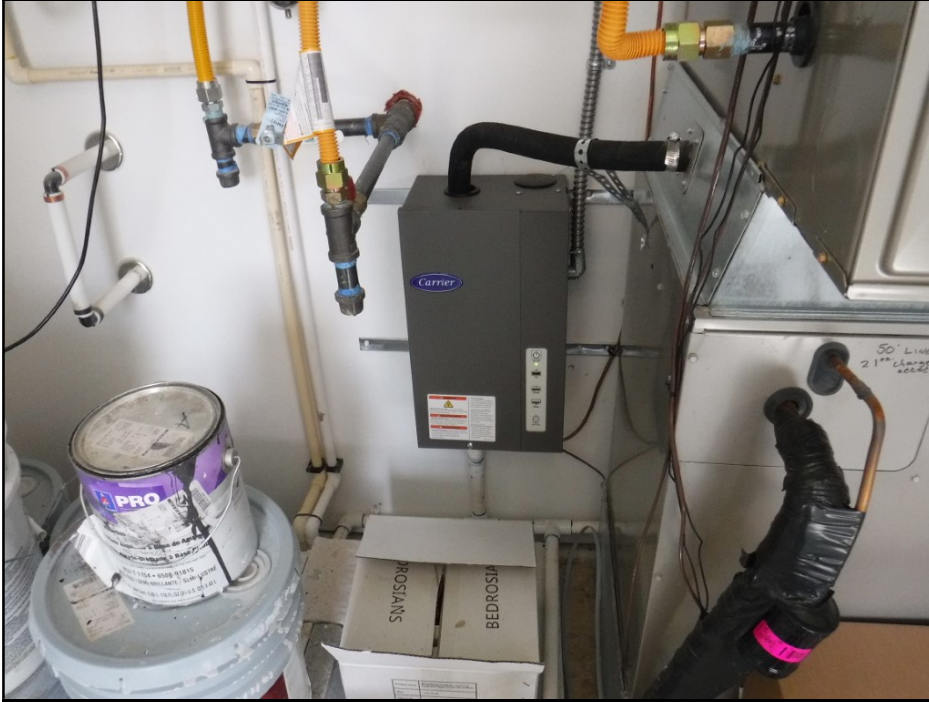
- The HVAC system includes a humidifier, as shown in the following photo. This system is beyond the scope of this home inspection. Therefore, it cannot be covered under our “90-Day Limited Structural and Mechanical Home Warranty”.

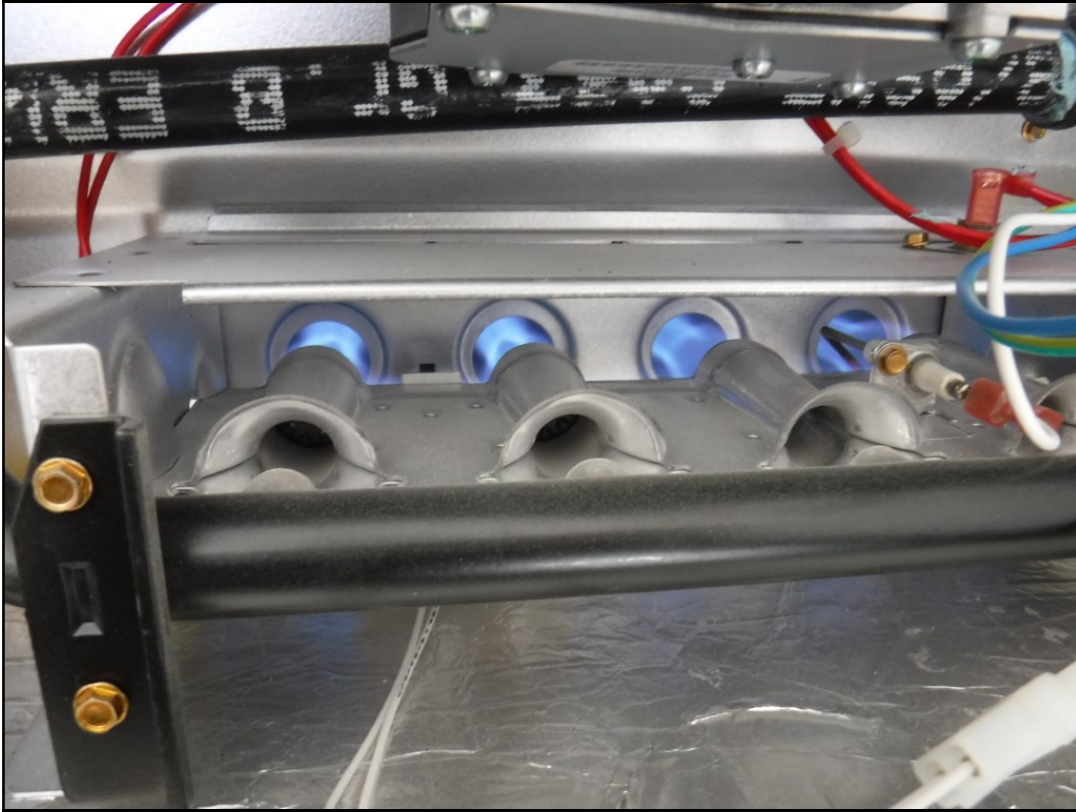
- The furnace operated normally during “heat” mode, as shown in the following photo.

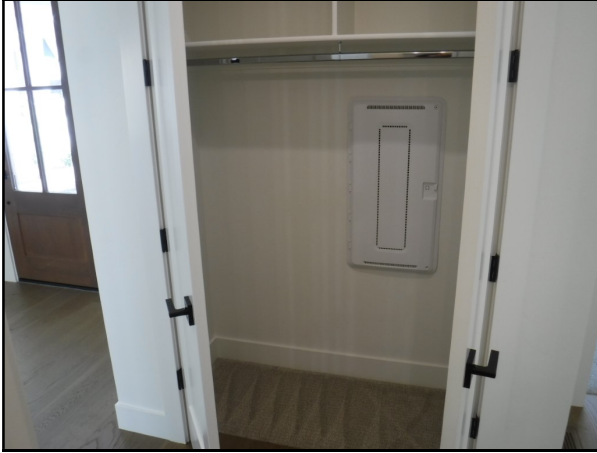
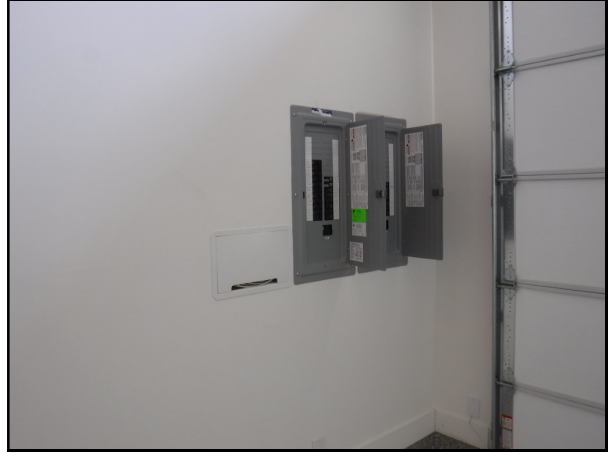
- This building has data communications junction boxes installed in the front entry coat closet and next to the main distribution panel in the garage, as shown in the following photos.

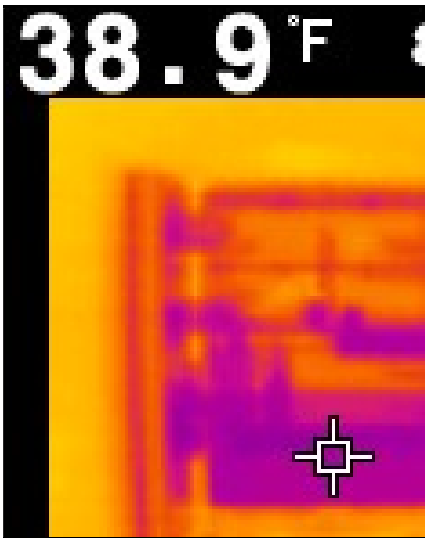
- The refrigerator was operational, as shown in the following photo. This system is beyond the scope of this home inspection. Therefore, it cannot be covered under our “90-Day Limited Structural and Mechanical Home Warranty”.

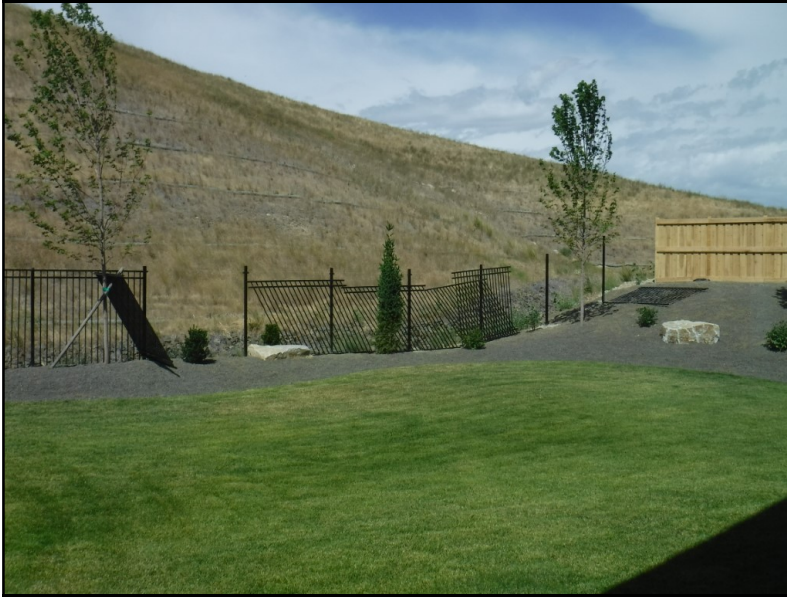
- The fence was being installed during the inspection, as exemplified in the following photo.

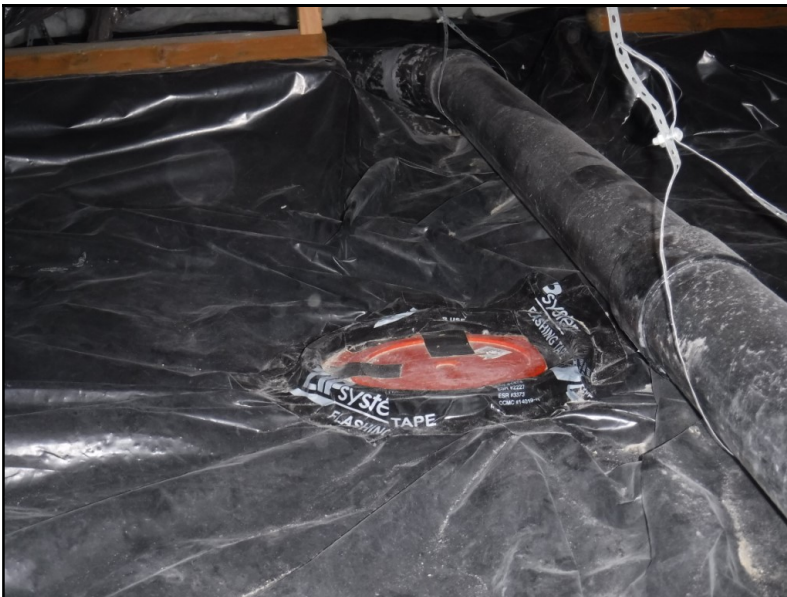
- The crawl spaces have been prepped for a drainage system with a sump pump reservoir located at the front left of the home, as shown in the following photo. If needed, a pump could be added with drain piping to discharge water from the crawl spaces to the exterior. The builder may have installed this preemptively, as a precautionary measure, as the crawl spaces were dry.

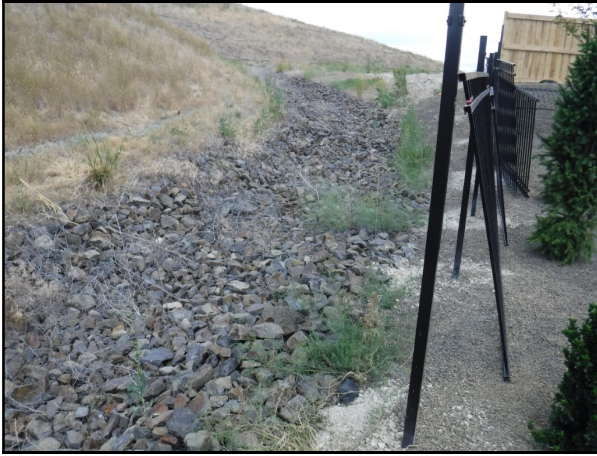
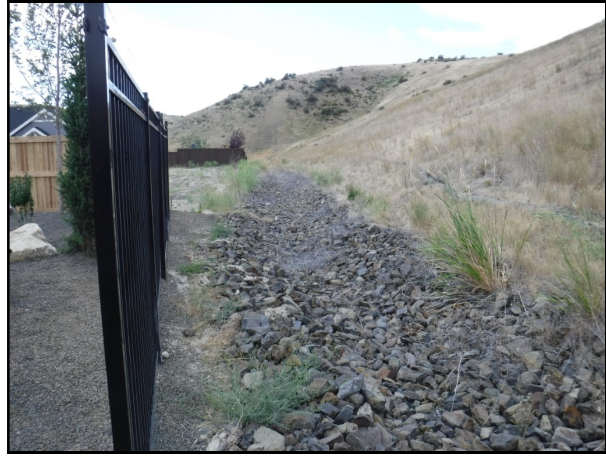
- A drainage swale runs parallel with the rear of the property, as shown in the following photos.

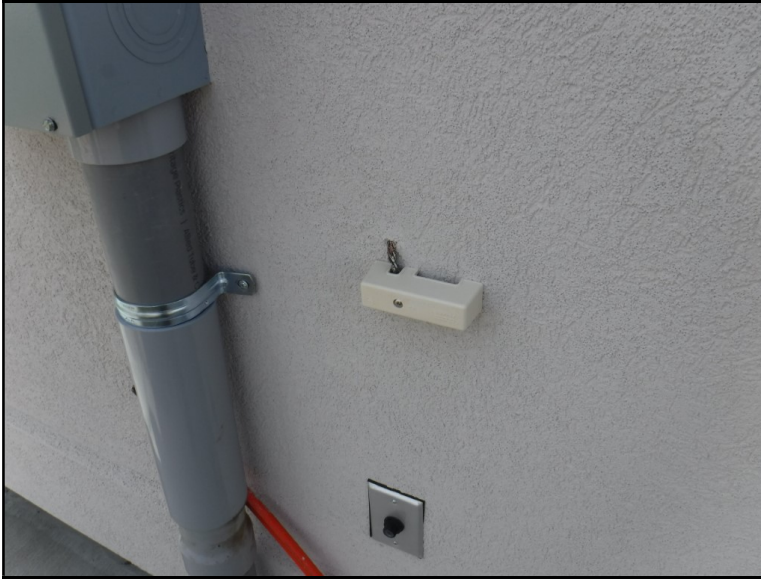
- The small white plastic covered terminal box mounted on the siding near the electric meter, as shown in the following photo, is provided as a “courtesy ground” for the various communications utilities that may be connected to the house. (All utilities providing cable connections are required to bond to the home’s grounding system.)

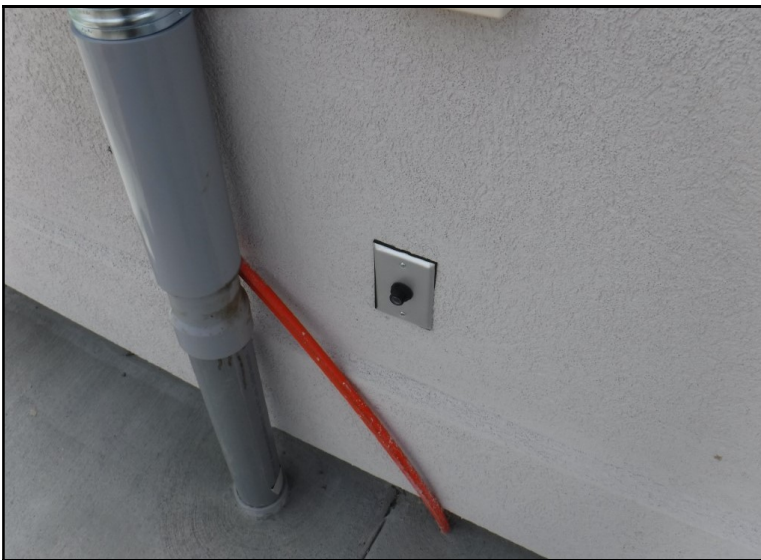
- The exterior-mounted light fixtures at the front of the garage are controlled by a photocell sensor, as shown in the following photo. Therefore, these fixtures were not tested at this time.

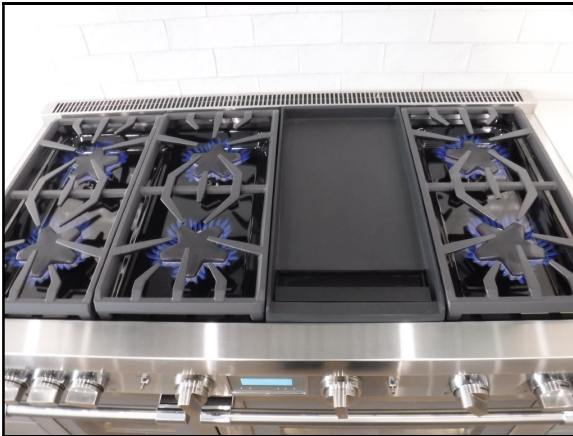
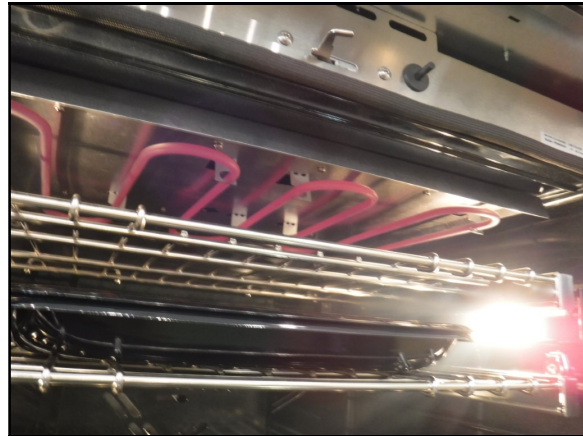
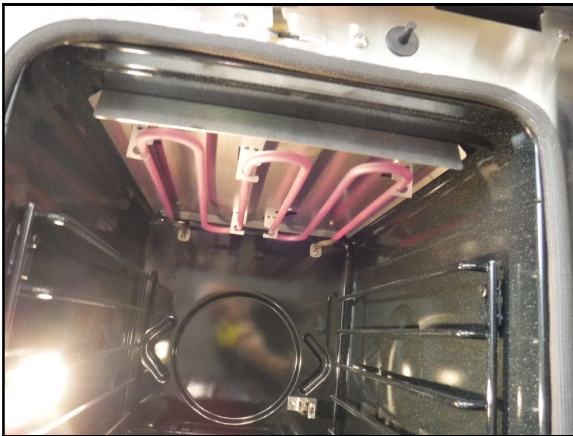
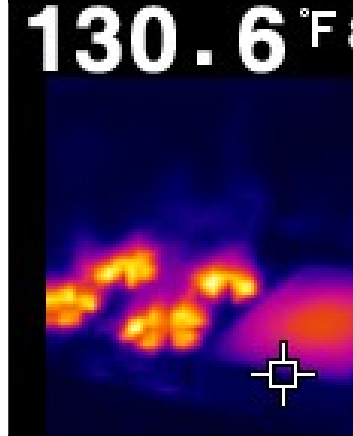
- The range’s heating functions appeared to be working at the time of this inspection, as shown in the following three photos.

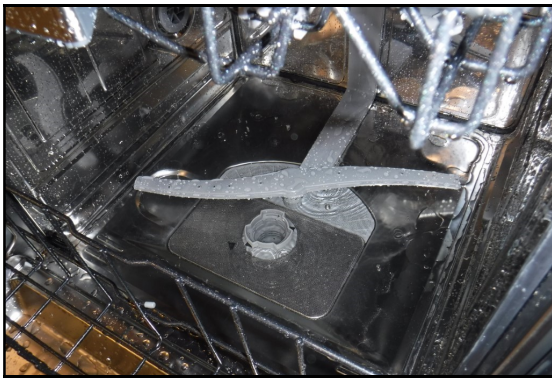
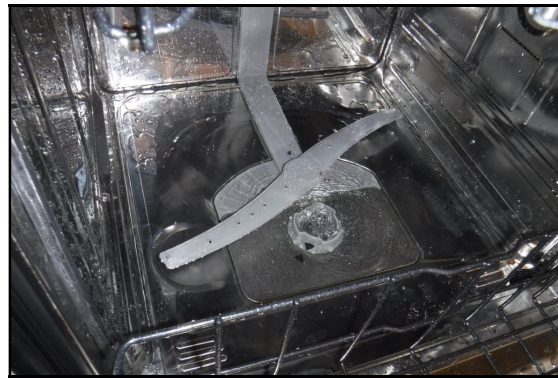
- f. Its basin successfully drained at the end of its wash cycle, as documented in the following photo.

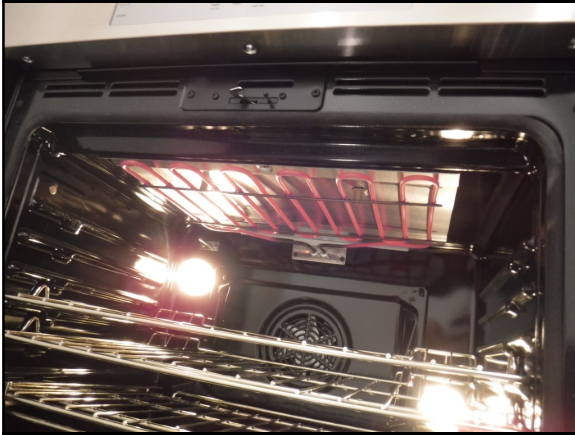
- The built-in oven's bake and broil functions appeared to be working at the time of this inspection, as shown in the following photo.

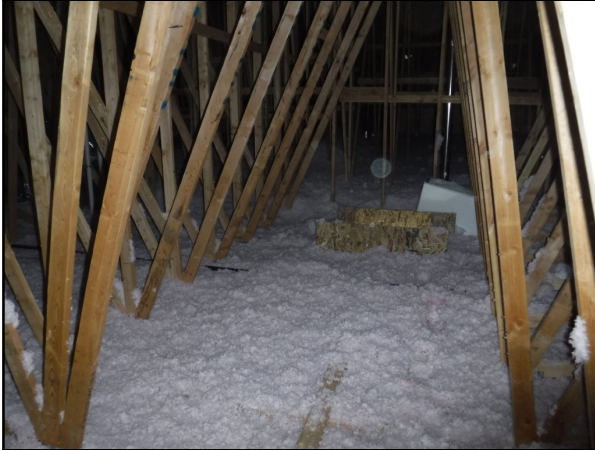
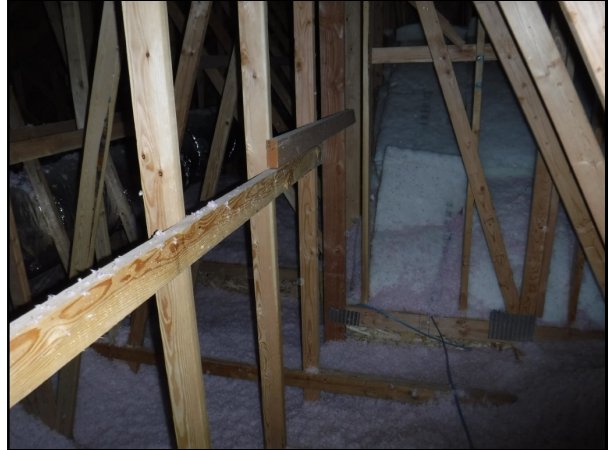
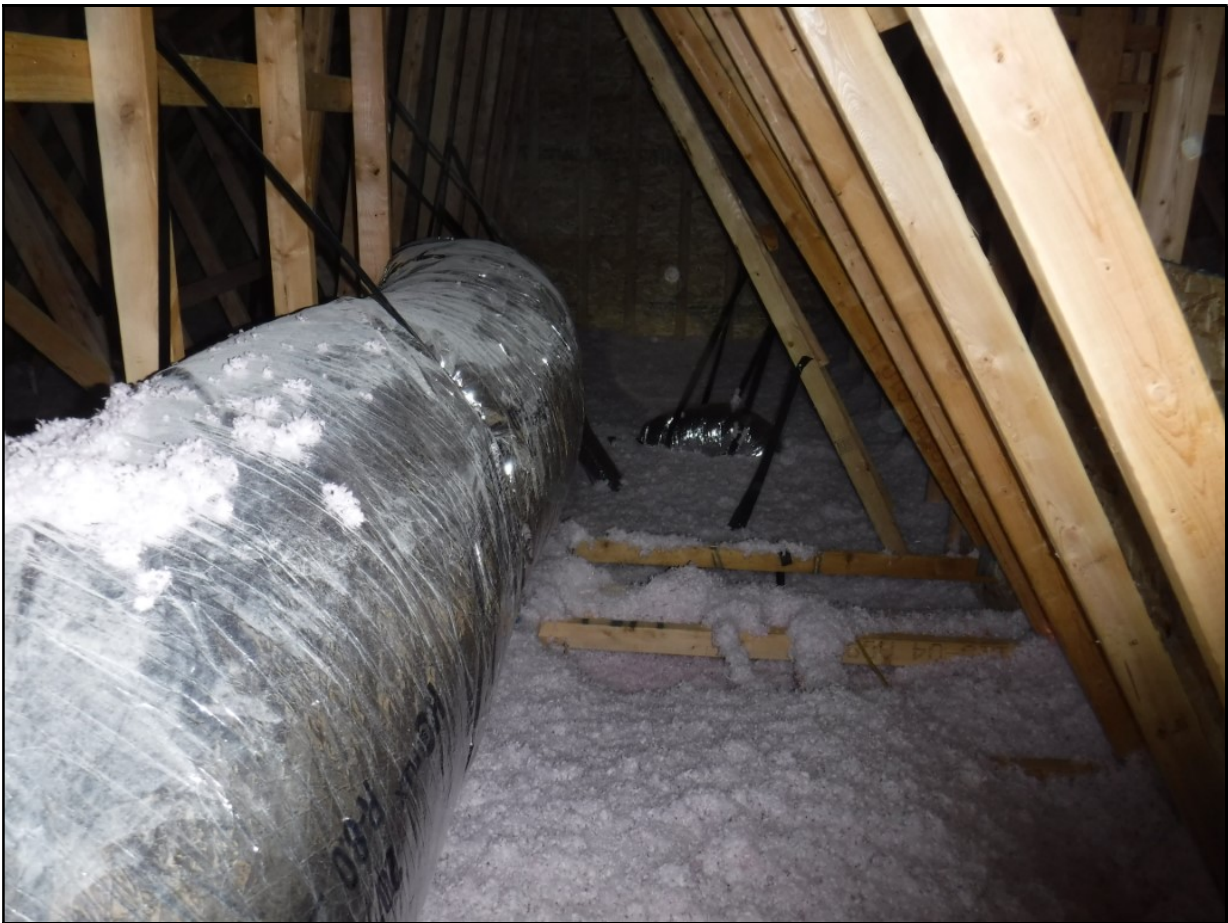
- The following are reference photos of the attic spaces. Any issues found in the attic spaces that adversely affect the health, safety, sanitation, or future integrity of the property will appear in the "Inspection Issues" section of this report.

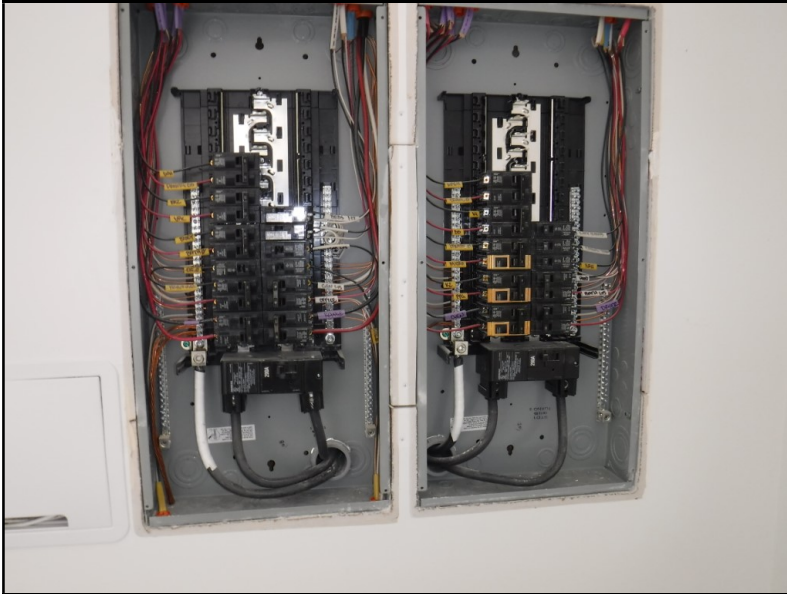
- The following is a reference photo of the main electrical panels. Any issues found in the main electrical panel that adversely affect the health, safety, or future integrity of the property will appear in the "Inspection Issues" section of this report.

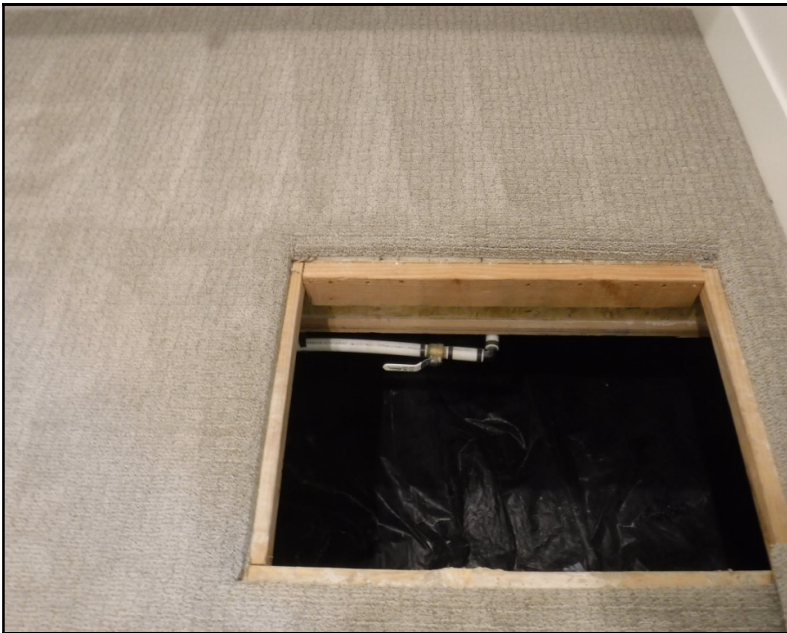
- The following photo shows the main water supply shut-off valve for the building, located just under the master closet crawlspace access.

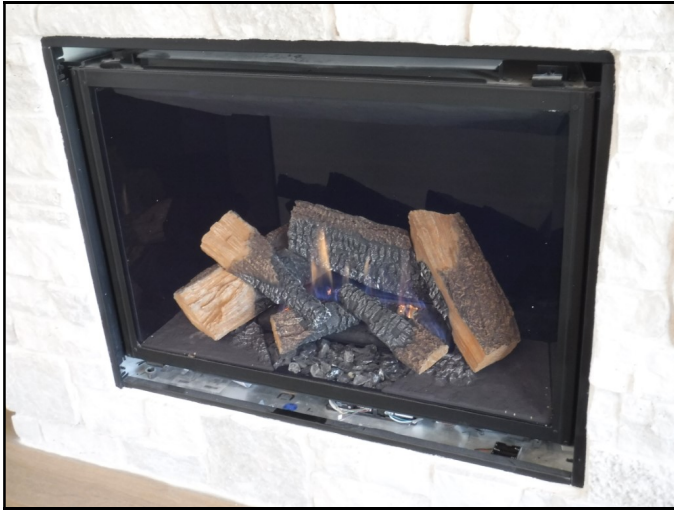
- The following photo documents the natural gas fireplace during operation.
