AAD Inspection Corp.

Home Inspection Report

**123 Any St
Any Town, ID. 86753**

Inspection Date: 07/15/2025

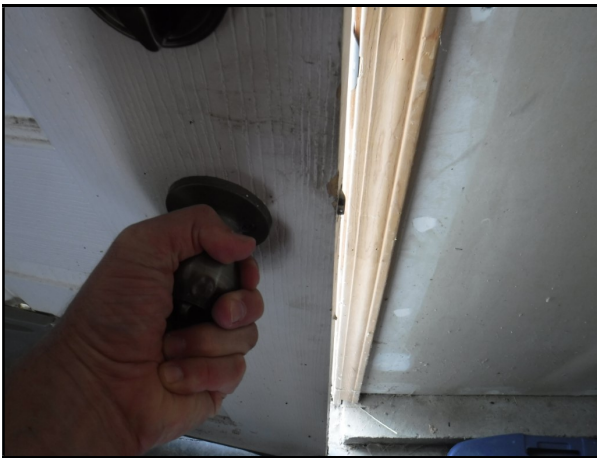
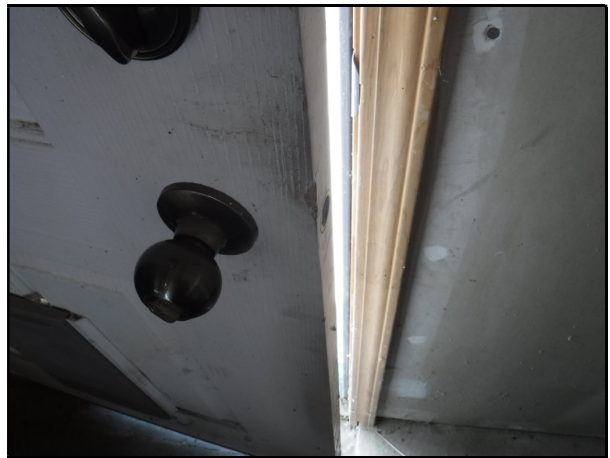
5. The doorknob handleset on the rear garage door has difficulty disengaging its latch bolt if it is rotated counterclockwise, and the latch bolt sticks in the disengaged position when rotated clockwise, as shown in the following two photos.

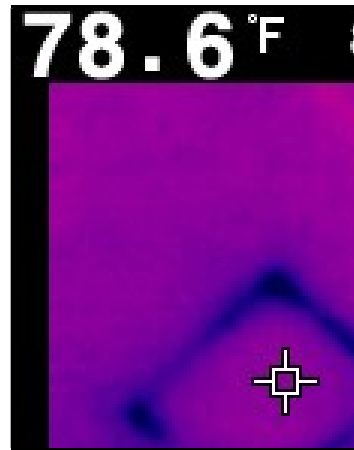
8. The ceiling sheetrock surfaces at the rear right interior of the garage have been patched recently, as shown in the following photos. I could see temperature variations along the seams of the patch, where joint compound is drying. It is my understanding that this area of the garage is underneath the master bathroom. Moreover, the stain patterns around the patched area likely indicate a recent leak repair. I suggest obtaining copies of any applicable receipts from licensed plumbers, for the work performed in this area. It is my understanding that the Buyer's Agent and Buyers were able to see into the unpatched hole prior to this inspection, and by their account, there may be potential microbial growth within the subfloor of this area.

Further investigation by certified mold professionals can provide meaningful information regarding the suspect areas of possible bio growths through the attainment of aerosol and/or adhesive lift samples for analysis by a microbiology lab. The customer may opt to further employ us to perform specific investigations and sampling to help identify the risks of possible health consequences or threats to the future marketability of this property. *(The need for further investigation, sampling, and analyses may be greater and more urgent if any prospective occupants are known to have compromised immune systems, allergies, or asthma.)*

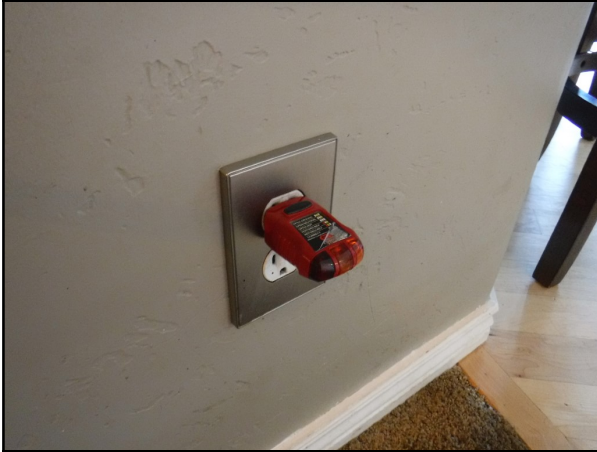
10. The grippers are loose within the duplex outlet receptacles throughout the home, as shown in the following photos. This makes it easier for plugs to back out, and more difficult for prongs to make a solid connection.

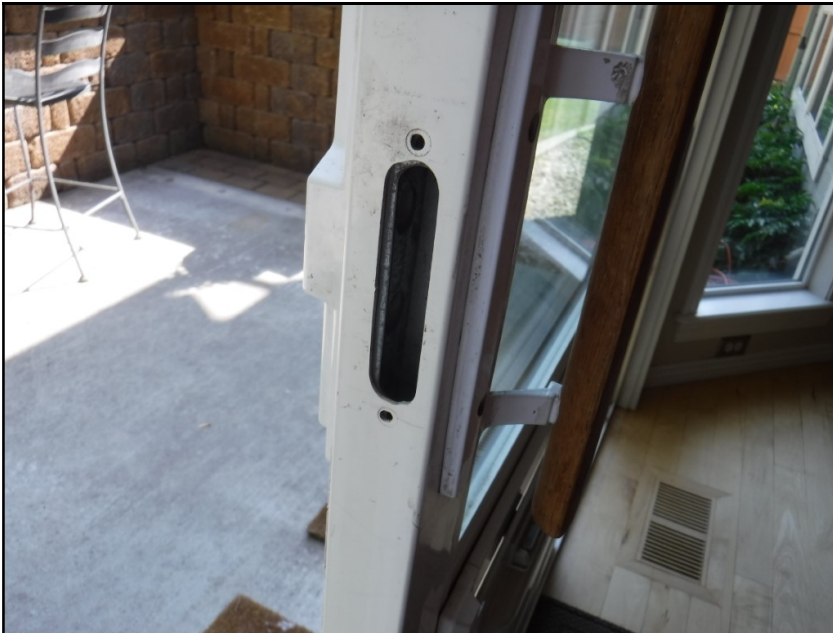
11. The latch hardware has been removed from the sliding door in the kitchen, as shown in the following photo. Therefore, the door can only be locked by placing an obstruction in its tracks.

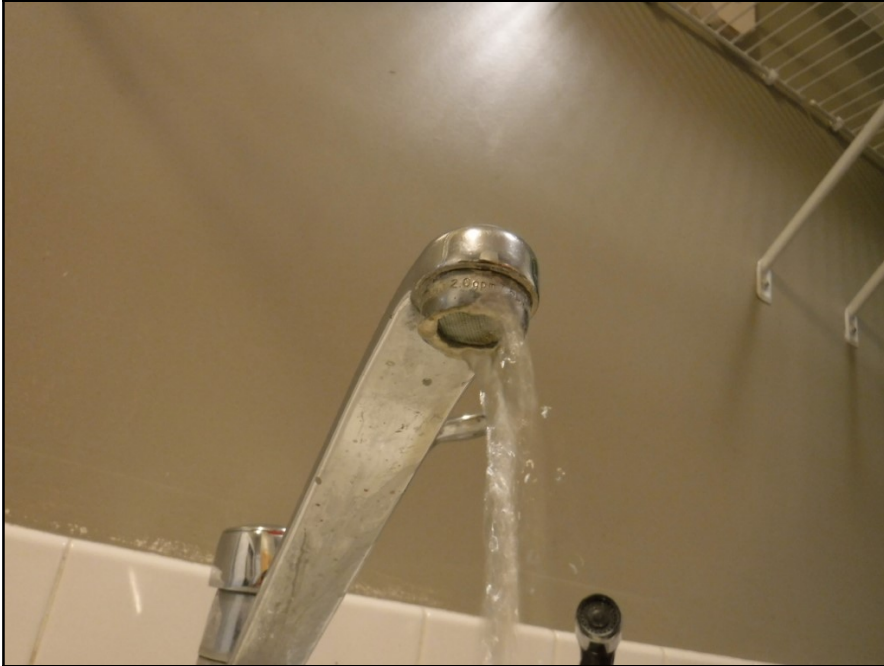
13. The aerator for the utility sink faucet fixture in the laundry room appears to be partially clogged, as shown in the following photo. This affects the flow of water.

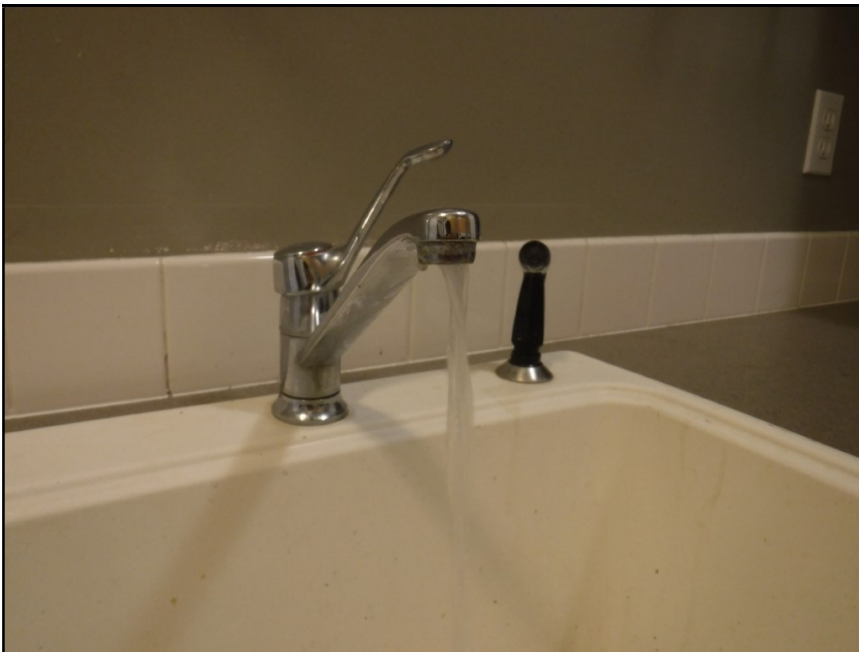
Additionally, water continues to flow from the faucet fixture when the hand sprayer is engaged, as shown in the following photo.

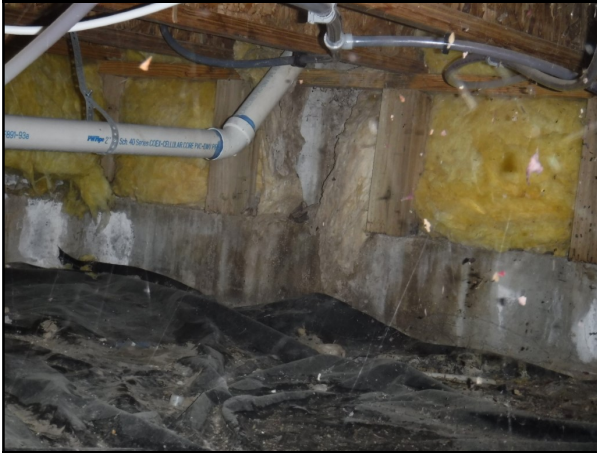
25. I found staining on the concrete foundation, the insulation, and on the subfloor surfaces in the crawl spaces under the kitchen sink, as shown in the following photos. I also found potential microbial growth in this area. This is likely the result of a past leak.

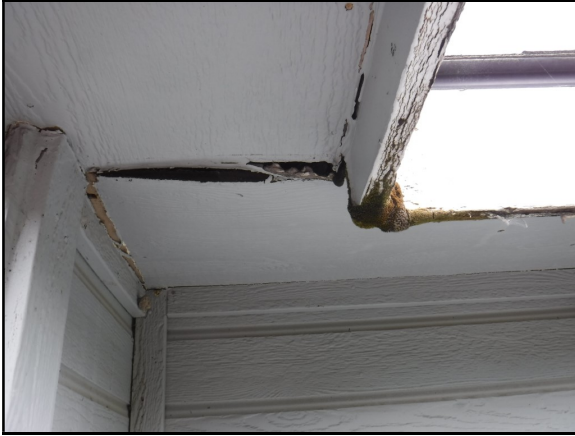
30. The soffit board, trim, and fascia in the upper front right eaves of the home have become deteriorated, as shown in the following photo. Areas like this could benefit from the addition of gutters.

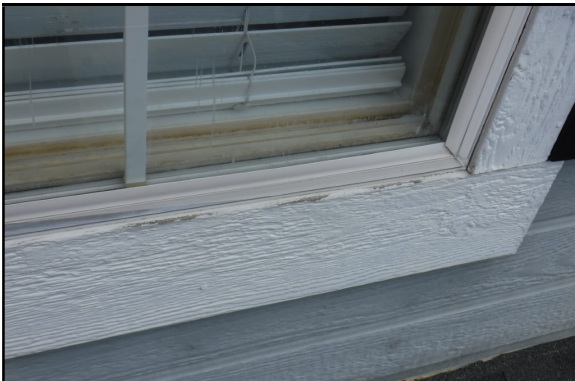
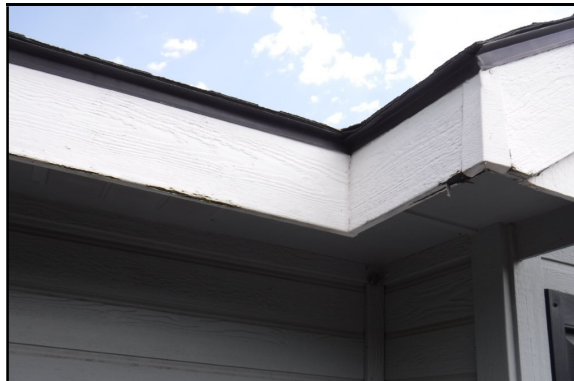
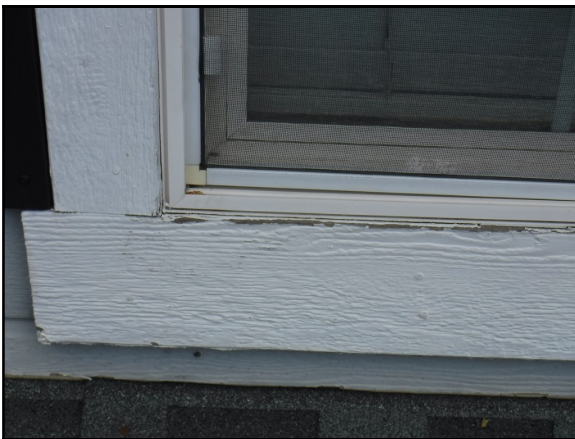
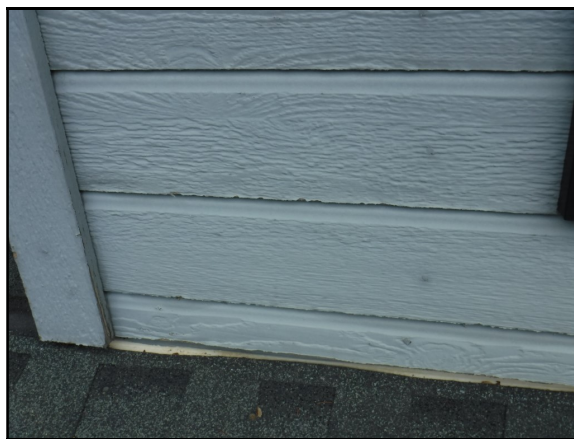
31. Paint is starting to peel from several exterior siding and trim surfaces, as exemplified in the following photos.

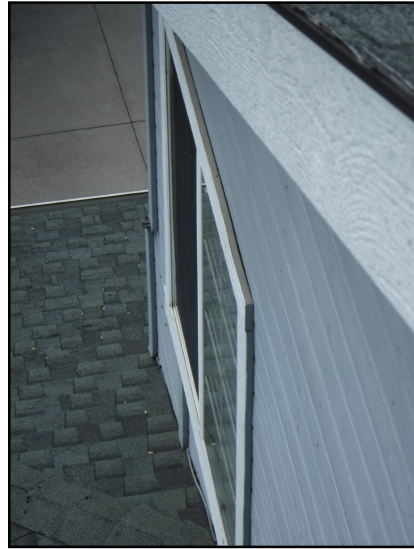
Additionally, paint is peeling from the top edges of the horizontal trim boards around the exterior, as exemplified in the following photos.

Moreover, the exterior paint is appearing “chalky” (due to oxidation with age and long-term exposure to the sun). For this reason, alone, the prospective buyer may wish to budget for a repaint within the next few years. Local painting contractors should be able to better diagnose the present condition and likely remaining longevity, together with meaningful estimates for eventual repainting.

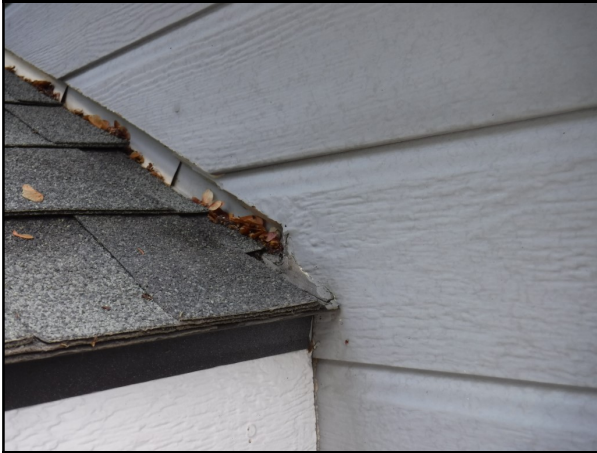
33. The lower ends of the sloped roof-to-wall flashing runs at the front left of the upper eaves and at the rear left of the lower eaves have missing, damaged, or ineffectual diverter flashing ("kicker flashing"), as shown in the following photos. This can allow water to enter the siding where it can cause damage.

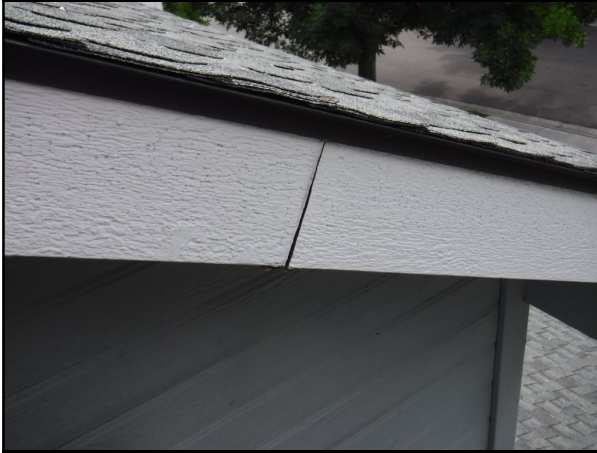
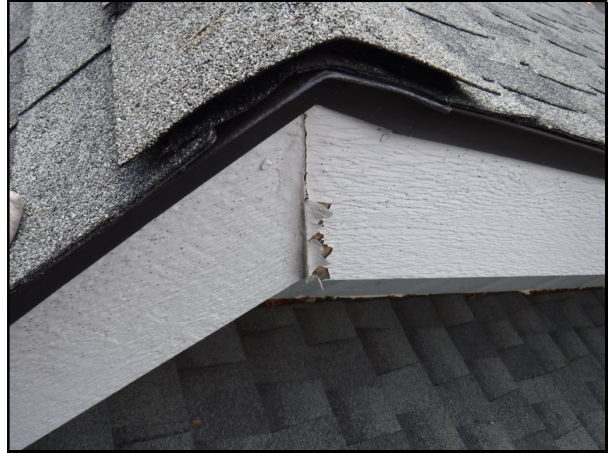
35. Caulking and paint are starting to separate along the seams of the fascia around the home, as exemplified in the following photos.

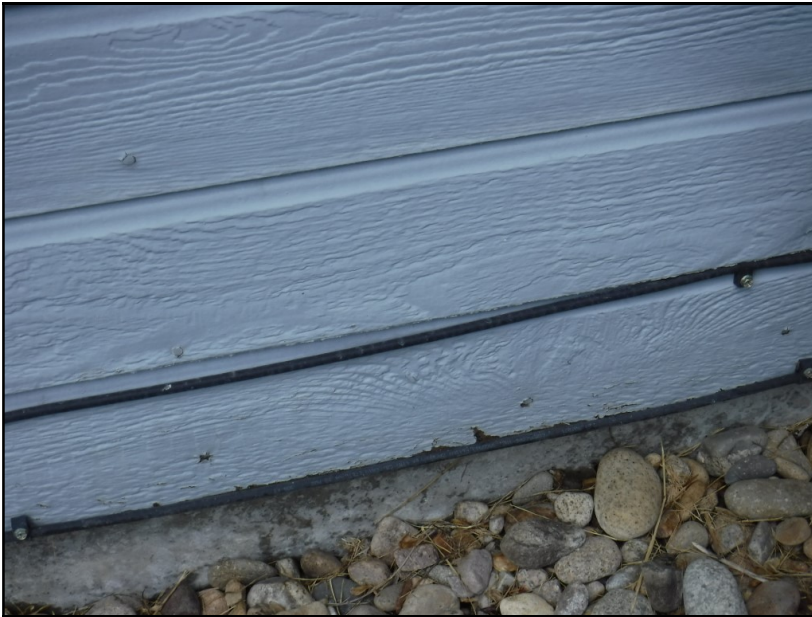
36. The bottom edges of the siding and trim are somewhat unpainted in several locations, as exemplified in the following photo.

This often leads to water absorption and eventual swelling. Therefore, I suggest adding primer and paint to the bottom edges of all siding and trim adjacent to the foundation and around windows to help protect against water damage.

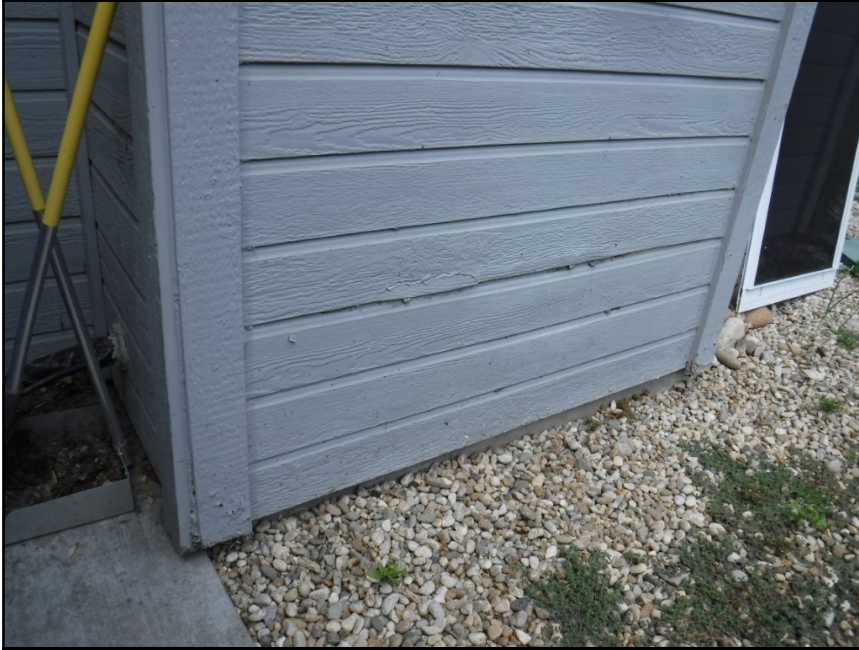
37. The lower sections of the siding are swollen under the flue for the fireplace, as shown in the following photo.

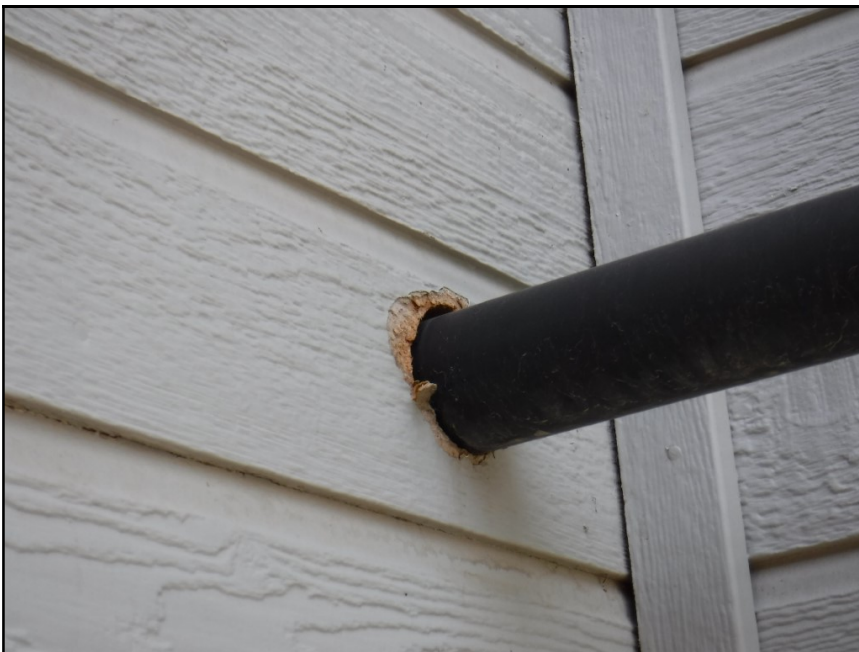
38. Caulking and touchup paint have not been applied around the penetration for the water heater flue, as shown in the following photo.

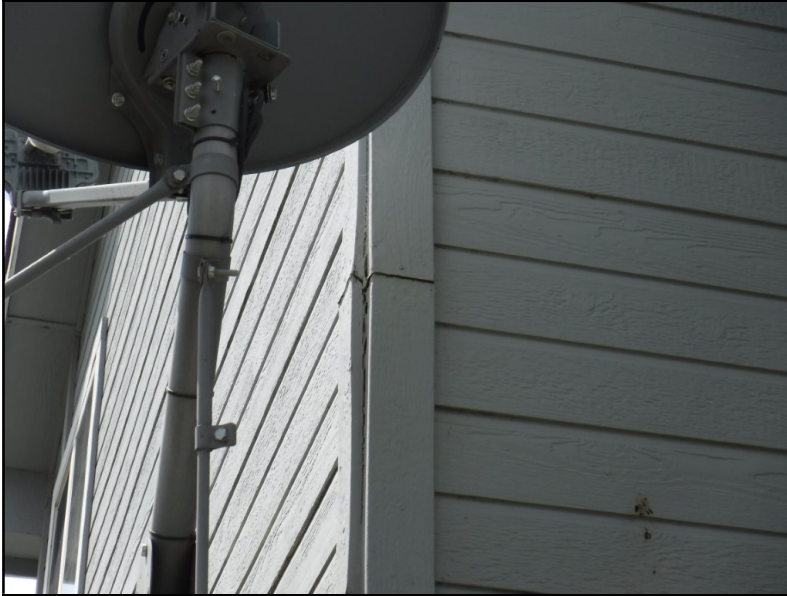
39. Caulking and paint are starting to separate along the seams of the vertical trim boards around the home, as exemplified in the following photo. This has resulted in swelling.

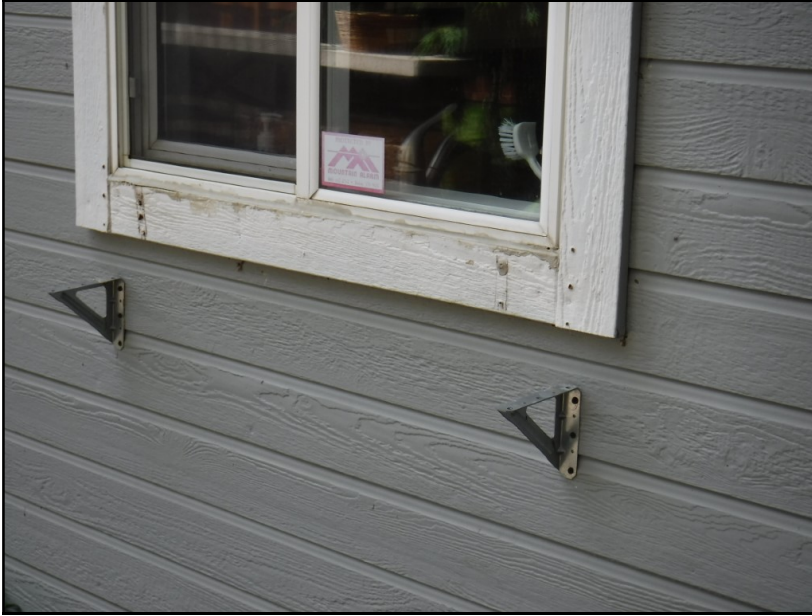
45. It appears that a flower box has been removed from the exterior side of the rear-facing window of the kitchen, as shown in the following photo.

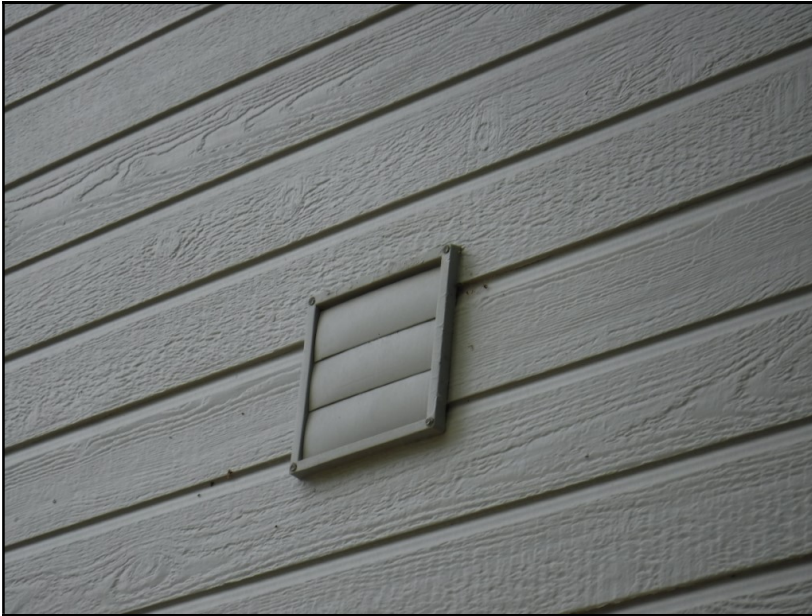
46. One or more loupered plastic exhaust vent caps have been painted, as exemplified in the following photo. Removing the paint would help the louvers open more freely under the relatively light forces of the moving air when the exhaust fans are running ... even if they are not stuck shut by the paint.

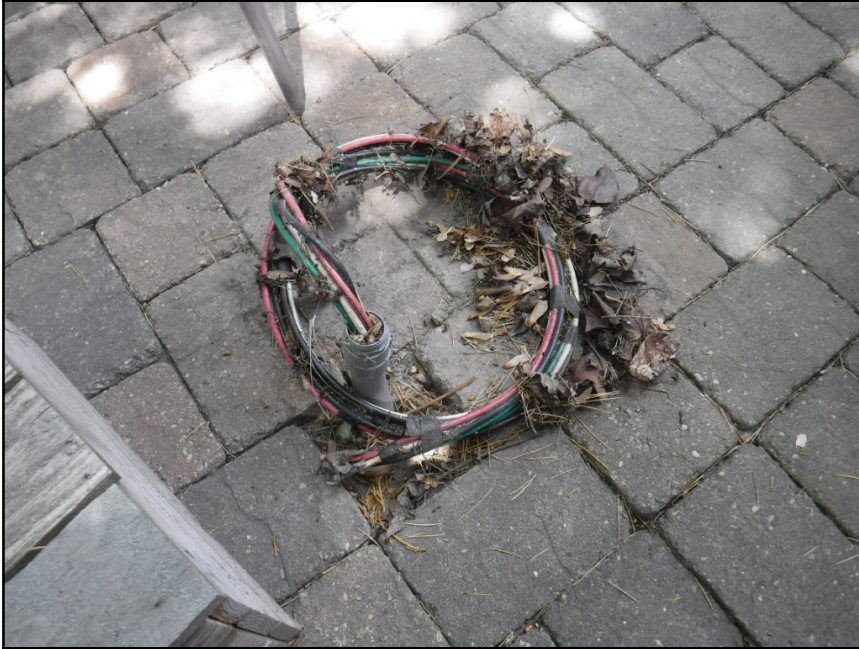
47. The hot tub electrical wiring at the rear left of the backyard (shown in the following photo) has not been fully capped or contained within a junction box rated for exterior use.

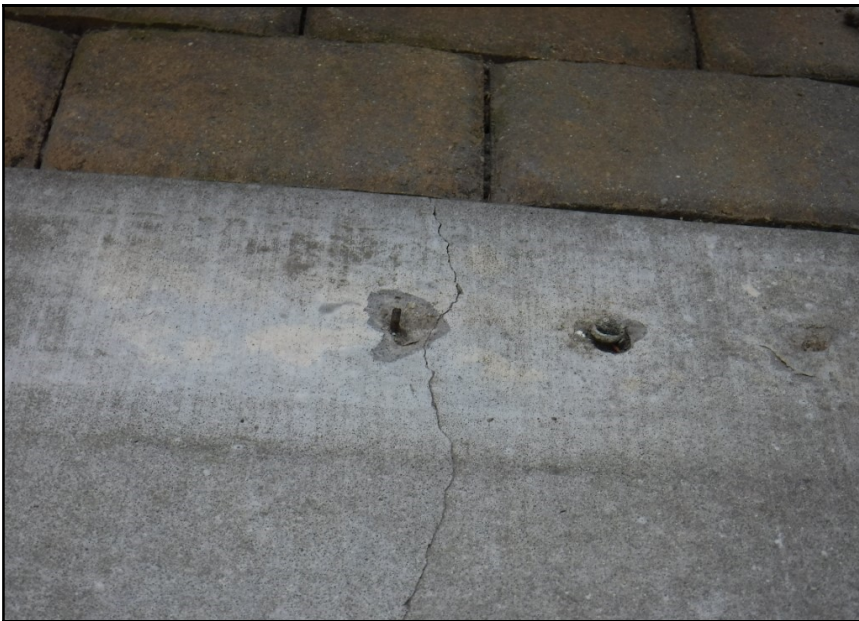
48. A fastener is protruding from the concrete slab at the right side of the rear patio, as shown in the following photo.

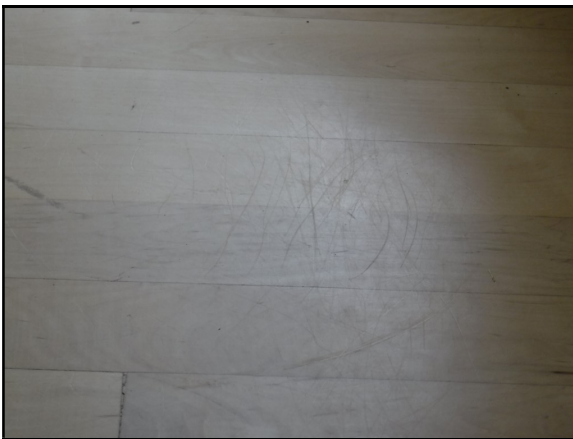
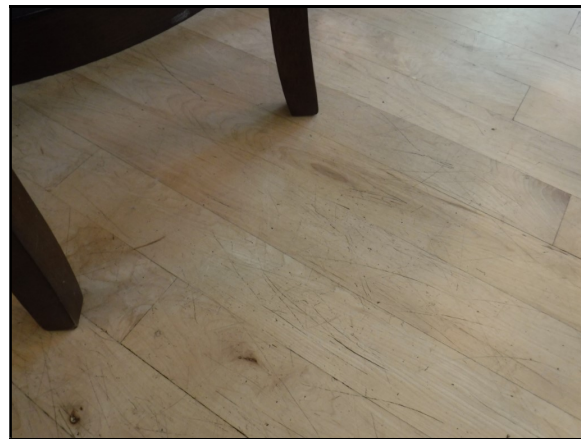
- b. I found multiple scuffs and scratches on the wooden floor surfaces of the home, as exemplified in the following photos.

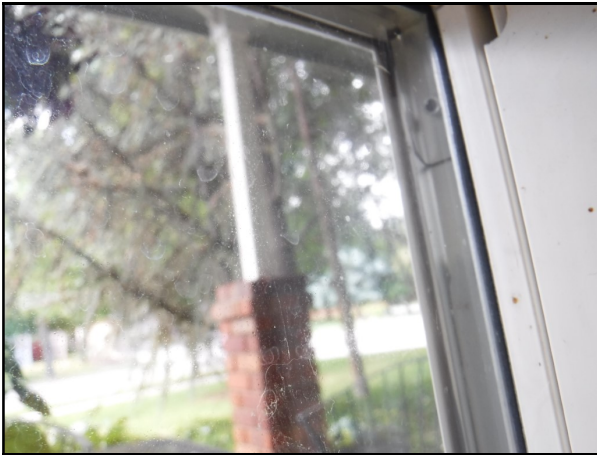
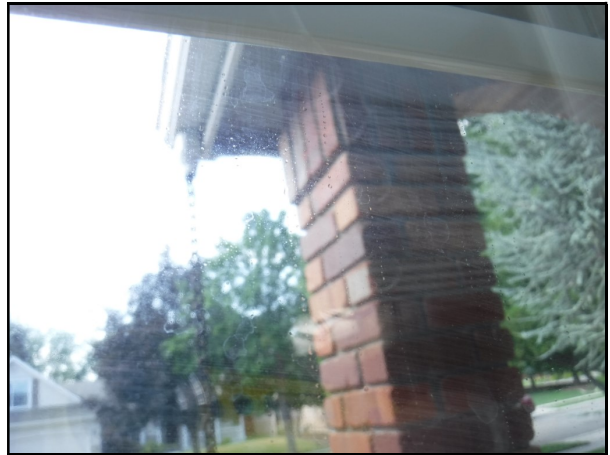
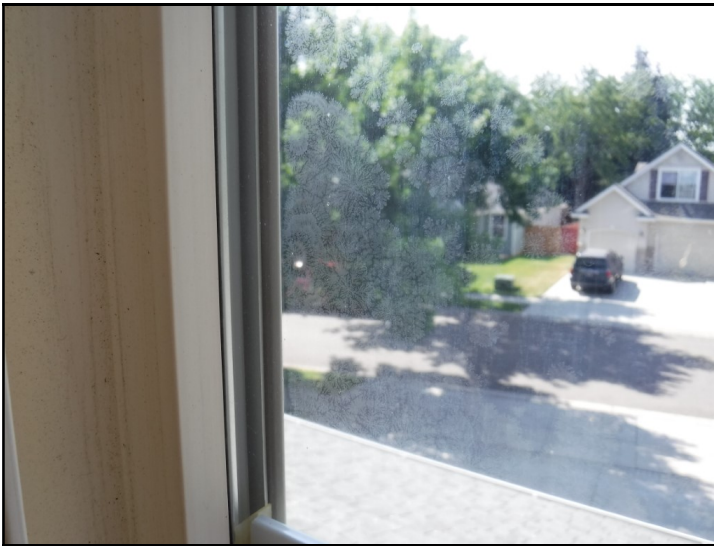
- c. Multiple windows throughout the home are fogged, as exemplified in the following photos. This includes, but is not limited to, the front-facing window in the front left living room, the front-facing window in the main-floor bathroom, the rear-facing kitchen window, the rear-facing windows in the great room, the left center rear-facing window in the master bedroom, the rear-facing window in the upstairs rear left bedroom, and the front-facing window in the upstairs bonus room.

When home inspectors are able to identify even one thermal window that has “fogged”, there are often other windows on the same property that are also fogging or will soon be fogging. Please see additional information I’ve included for you regarding “Dealing with “Fogged” Windows” in the special report section titled “Ownership Tips for This Particular Property”.

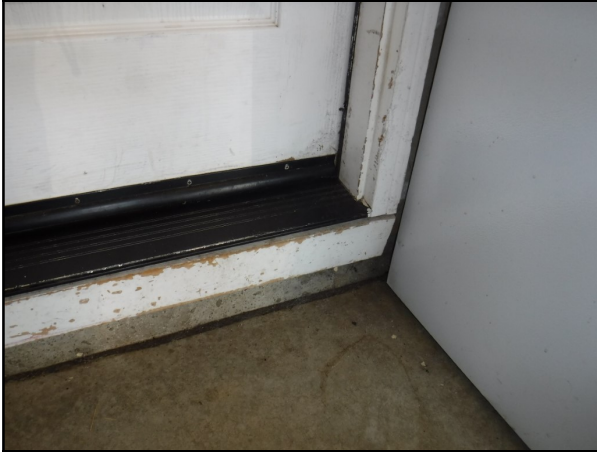
- d. The interior surfaces of this property have the typical amount of blemishes, scratches, dents, scuffs, or dings that may require repair in order to present the best possible visual appearance, as exemplified in the following photos.

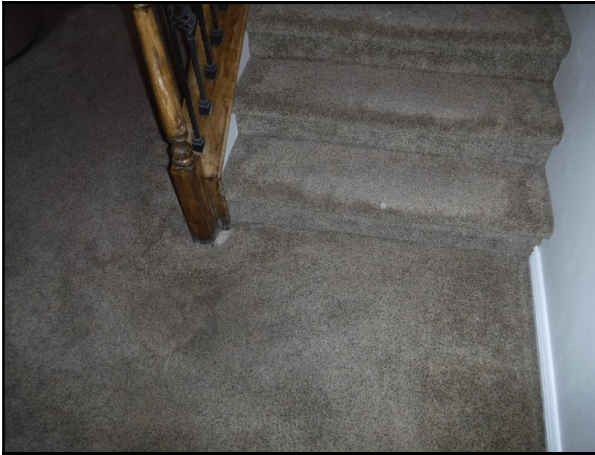
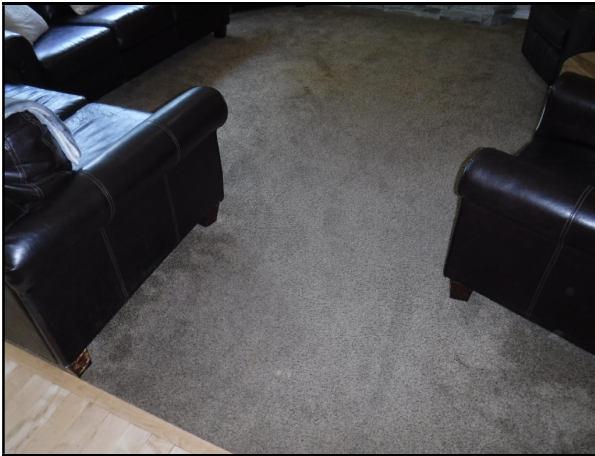
- e. The carpeting throughout the home is worn, loose, damaged, and stained in areas of higher traffic, as exemplified in the following photos.

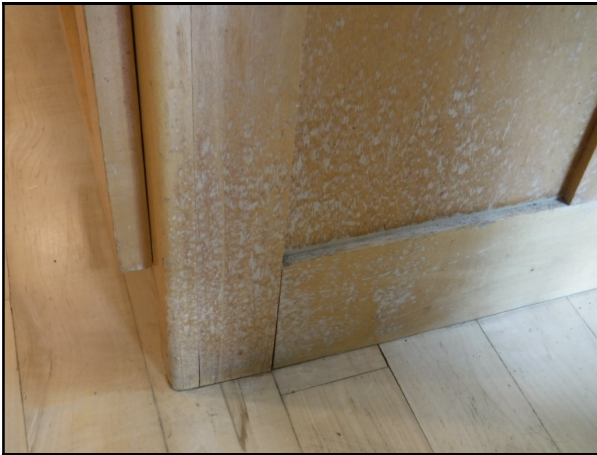
- h. The cabinets and drawers throughout the home are a little worn, as exemplified in the following photos. You may wish to consider rejuvenating these surfaces by rubbing fresh matching stain and/or clear coatings into them with #0000 steel wool pads. (The steel wool pads will scrape away any unsound finish coatings, along with any unwanted oils or dirt, while simultaneously presenting the fresh coating to the wood.)

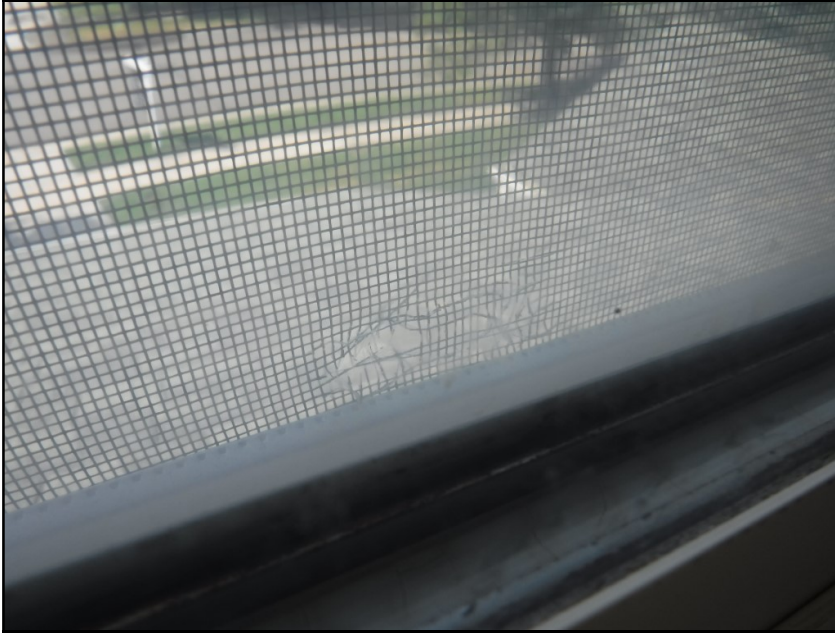
- j. The fabric is a little tattered on some of the window screens around the home, as exemplified in the following photo.

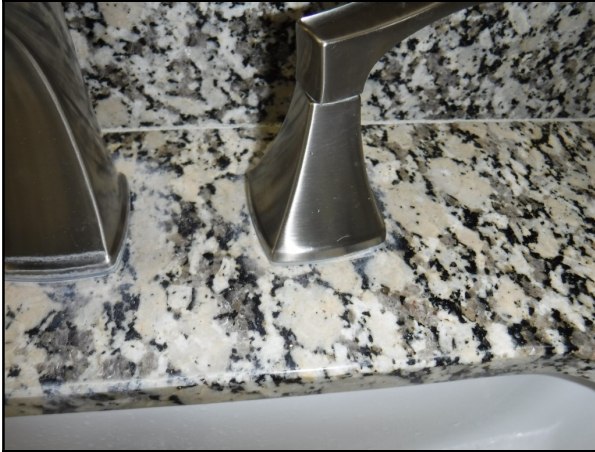
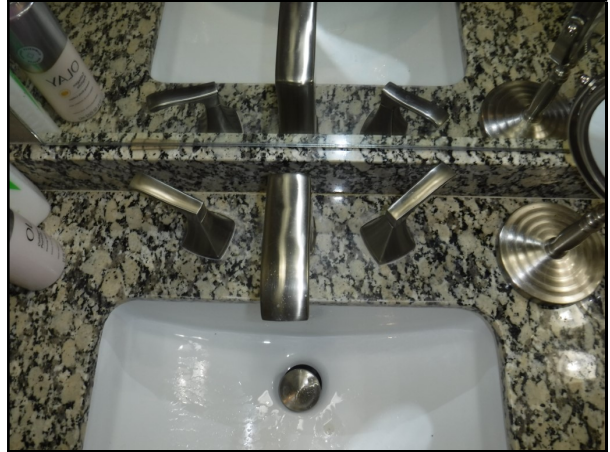
- l. The valve handles for the master bathroom sinks do not rest perpendicular with the faucet fixtures while the valves are in the closed position, as shown in the following photos.

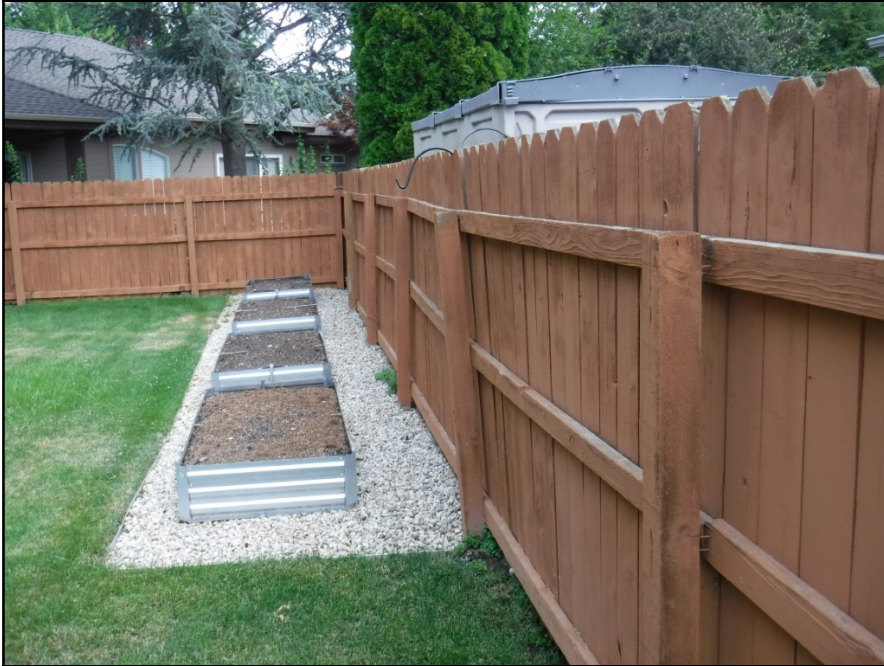
- n. A couple of fence posts around the backyard are leaning in the soil, as shown in the following photo.

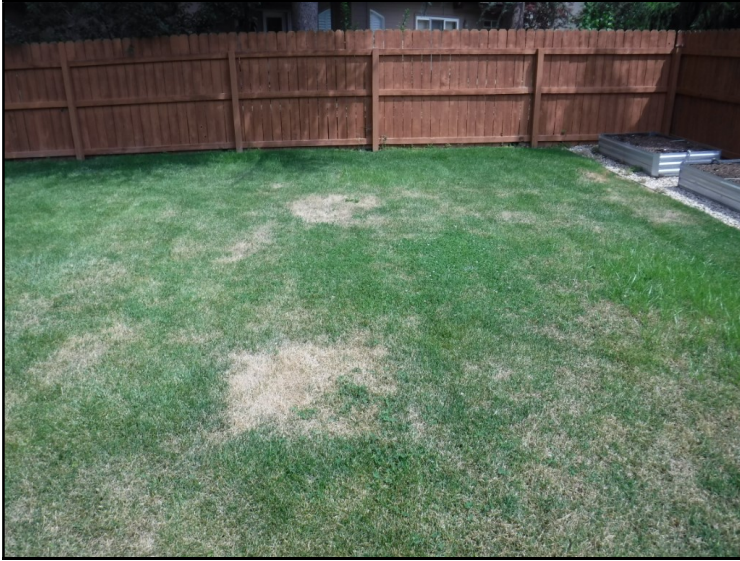
- o. I found a few patches of dead or dying grass in the backyard, as exemplified in the following photo.

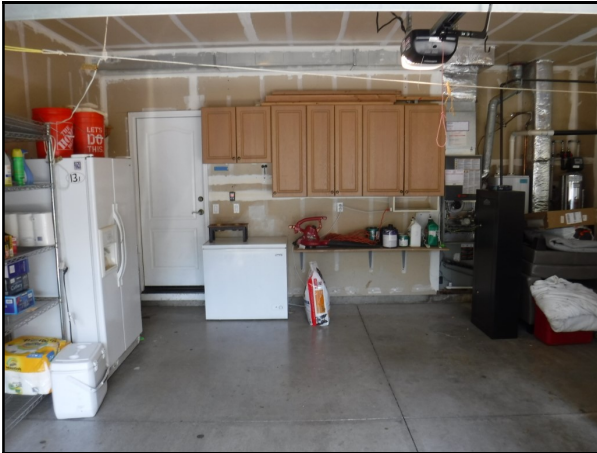
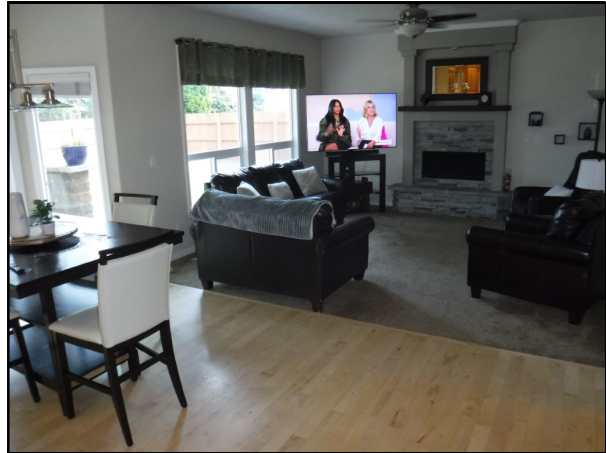
- Since this building was occupied at the time of this inspection, many surfaces and features could not be reasonably viewed, as exemplified in the following photos. (We do not typically move or remove personal property to perform our inspections.) Therefore, some additional discoveries will most likely be made by our customers after the property has been vacated. For this reason, we suggest planning to view all easily accessible areas of the property during a final walk-through before purchase. Please contact us at that time if you have any questions regarding additional defects or imperfections that may have come into view.

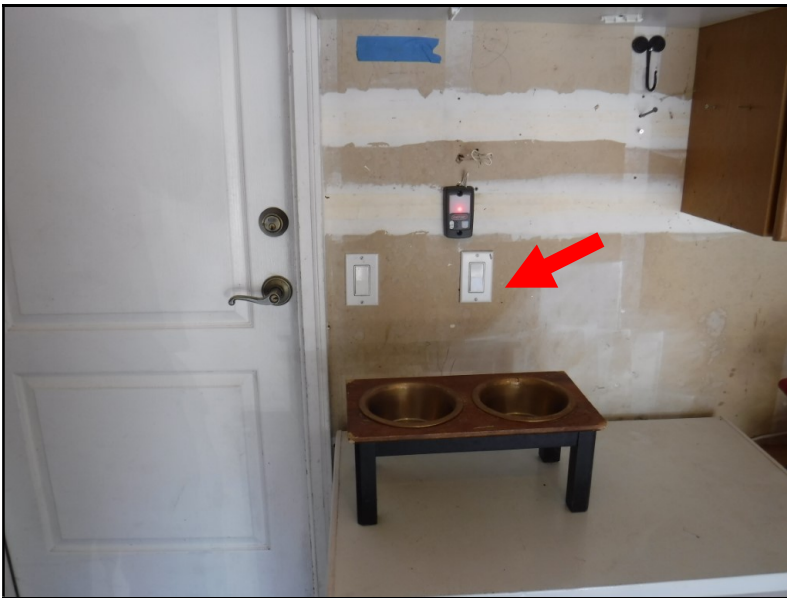
- I was unable to determine the function for the light switch under the garage door opener button near the interior-to-garage door (shown in the following photo).

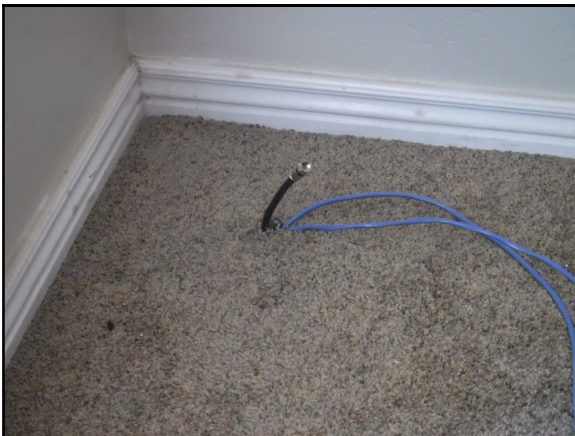
- I noted one or more unsealed floor penetrations for low-voltage wiring in the home, as exemplified in the following photo. This can be a pathway for pests.

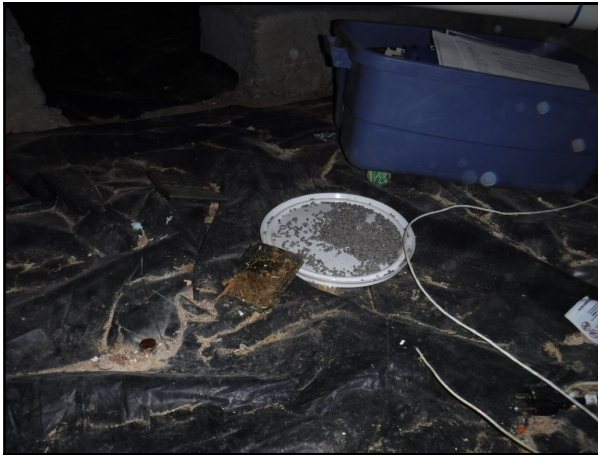
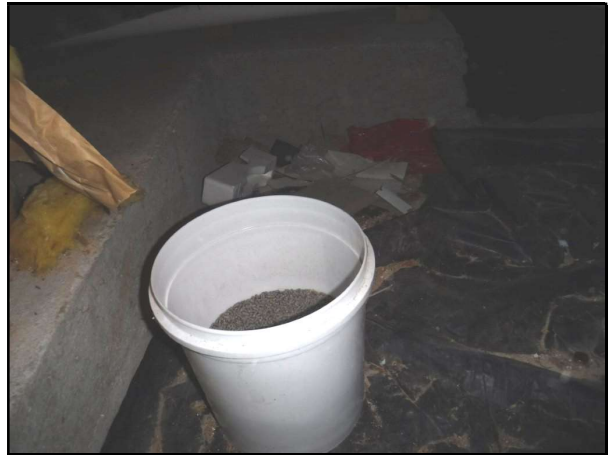
- This home has been pre-plumbed and pre-wired for a possible whole-house vacuum system. However, no central power unit has been installed.
- I found a large bucket of rodent poison under the crawlspace access, as shown in the following photos.

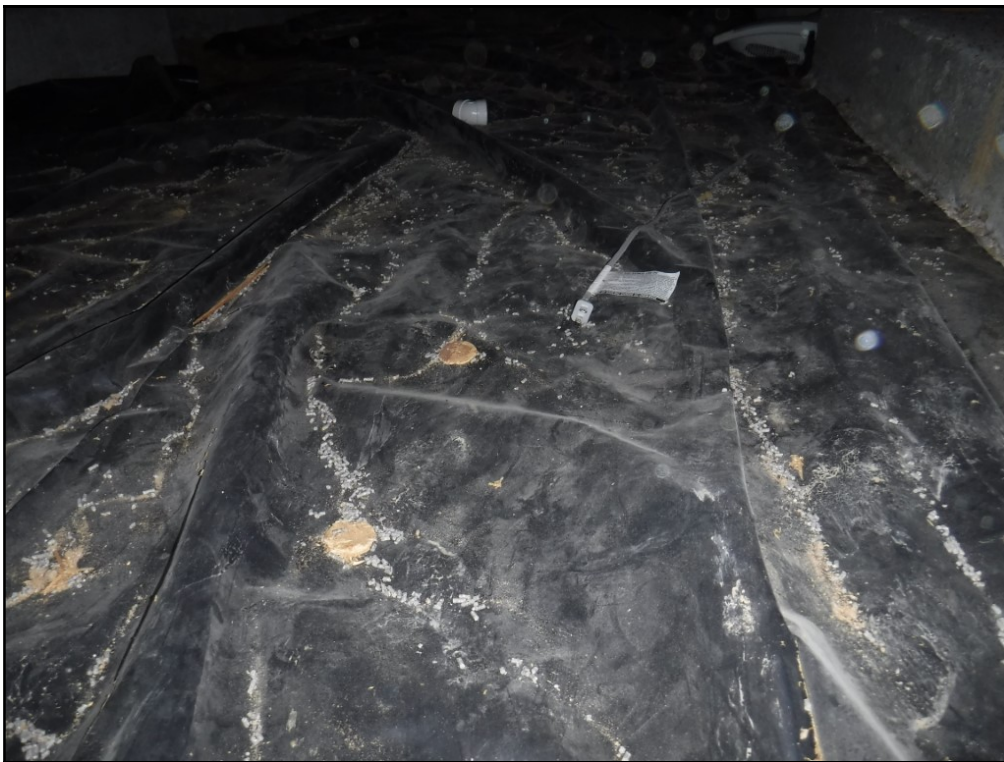
Moreover, pellets of rodent poison have been spread on top of the vapor barrier throughout many areas of the crawl spaces, as exemplified in the following photo.

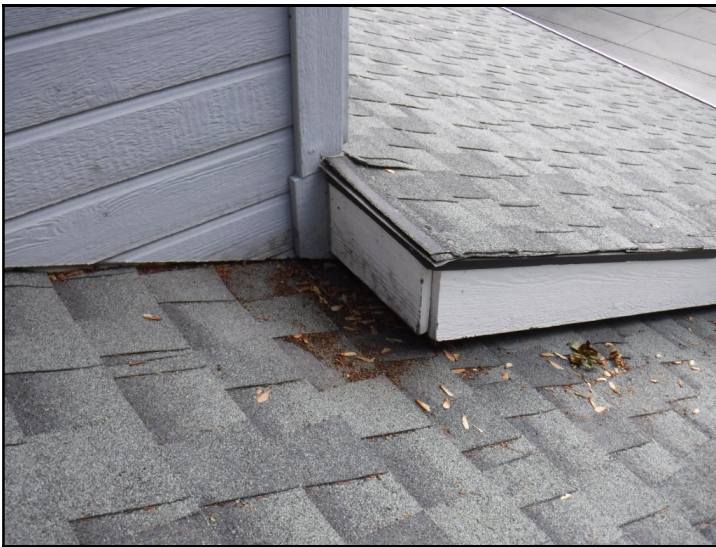
- The roof transition where the lower roof above the front entry meets the lower roof of the garage (shown in the following photo) may be prone to the damming of windblown debris and snow. I suggest keeping this area clear, seasonally.

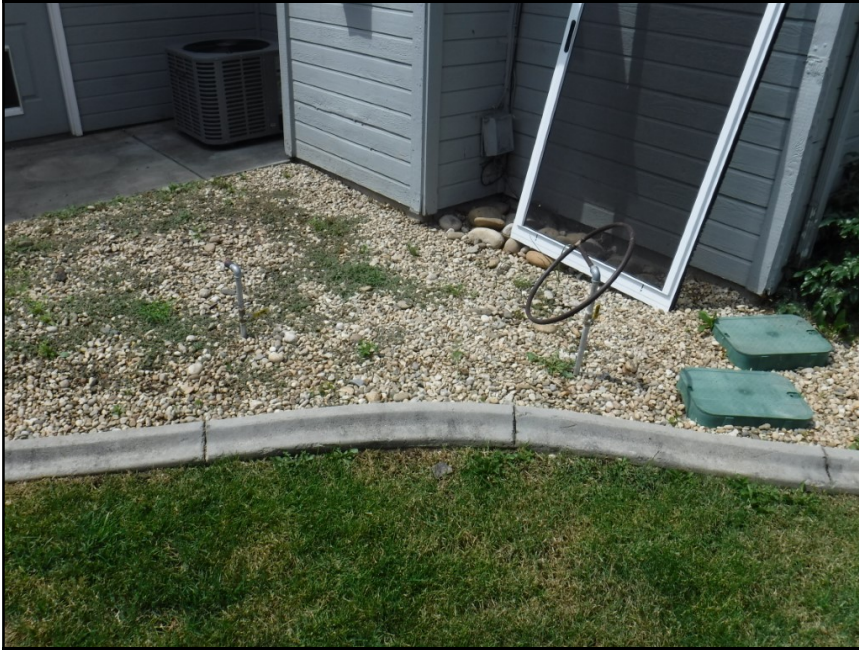
- The freestanding hose bibs around the property do not have stickers or placards indicating non-potable water, as exemplified in the following photo.

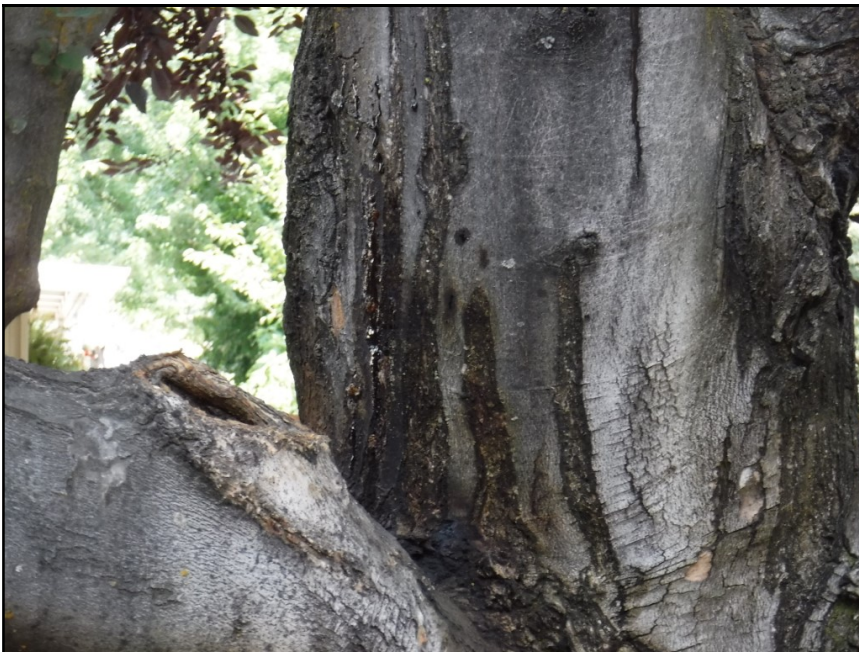
- A couple of trees on the property appear to be unhealthy, as exemplified in the following photo. I suggest involving an arborist.
